**PRE-DESIGN REPORT / ENVIRONMENTAL STUDY REPORT
PORT CREDIT HARBOUR WEST PARKS**

**PORT CREDIT HARBOUR WEST PARKS
PRE-DESIGN REPORT / ENVIRONMENTAL STUDY REPORT**

Dillon Consulting Limited

Shoreplan Engineering Limited

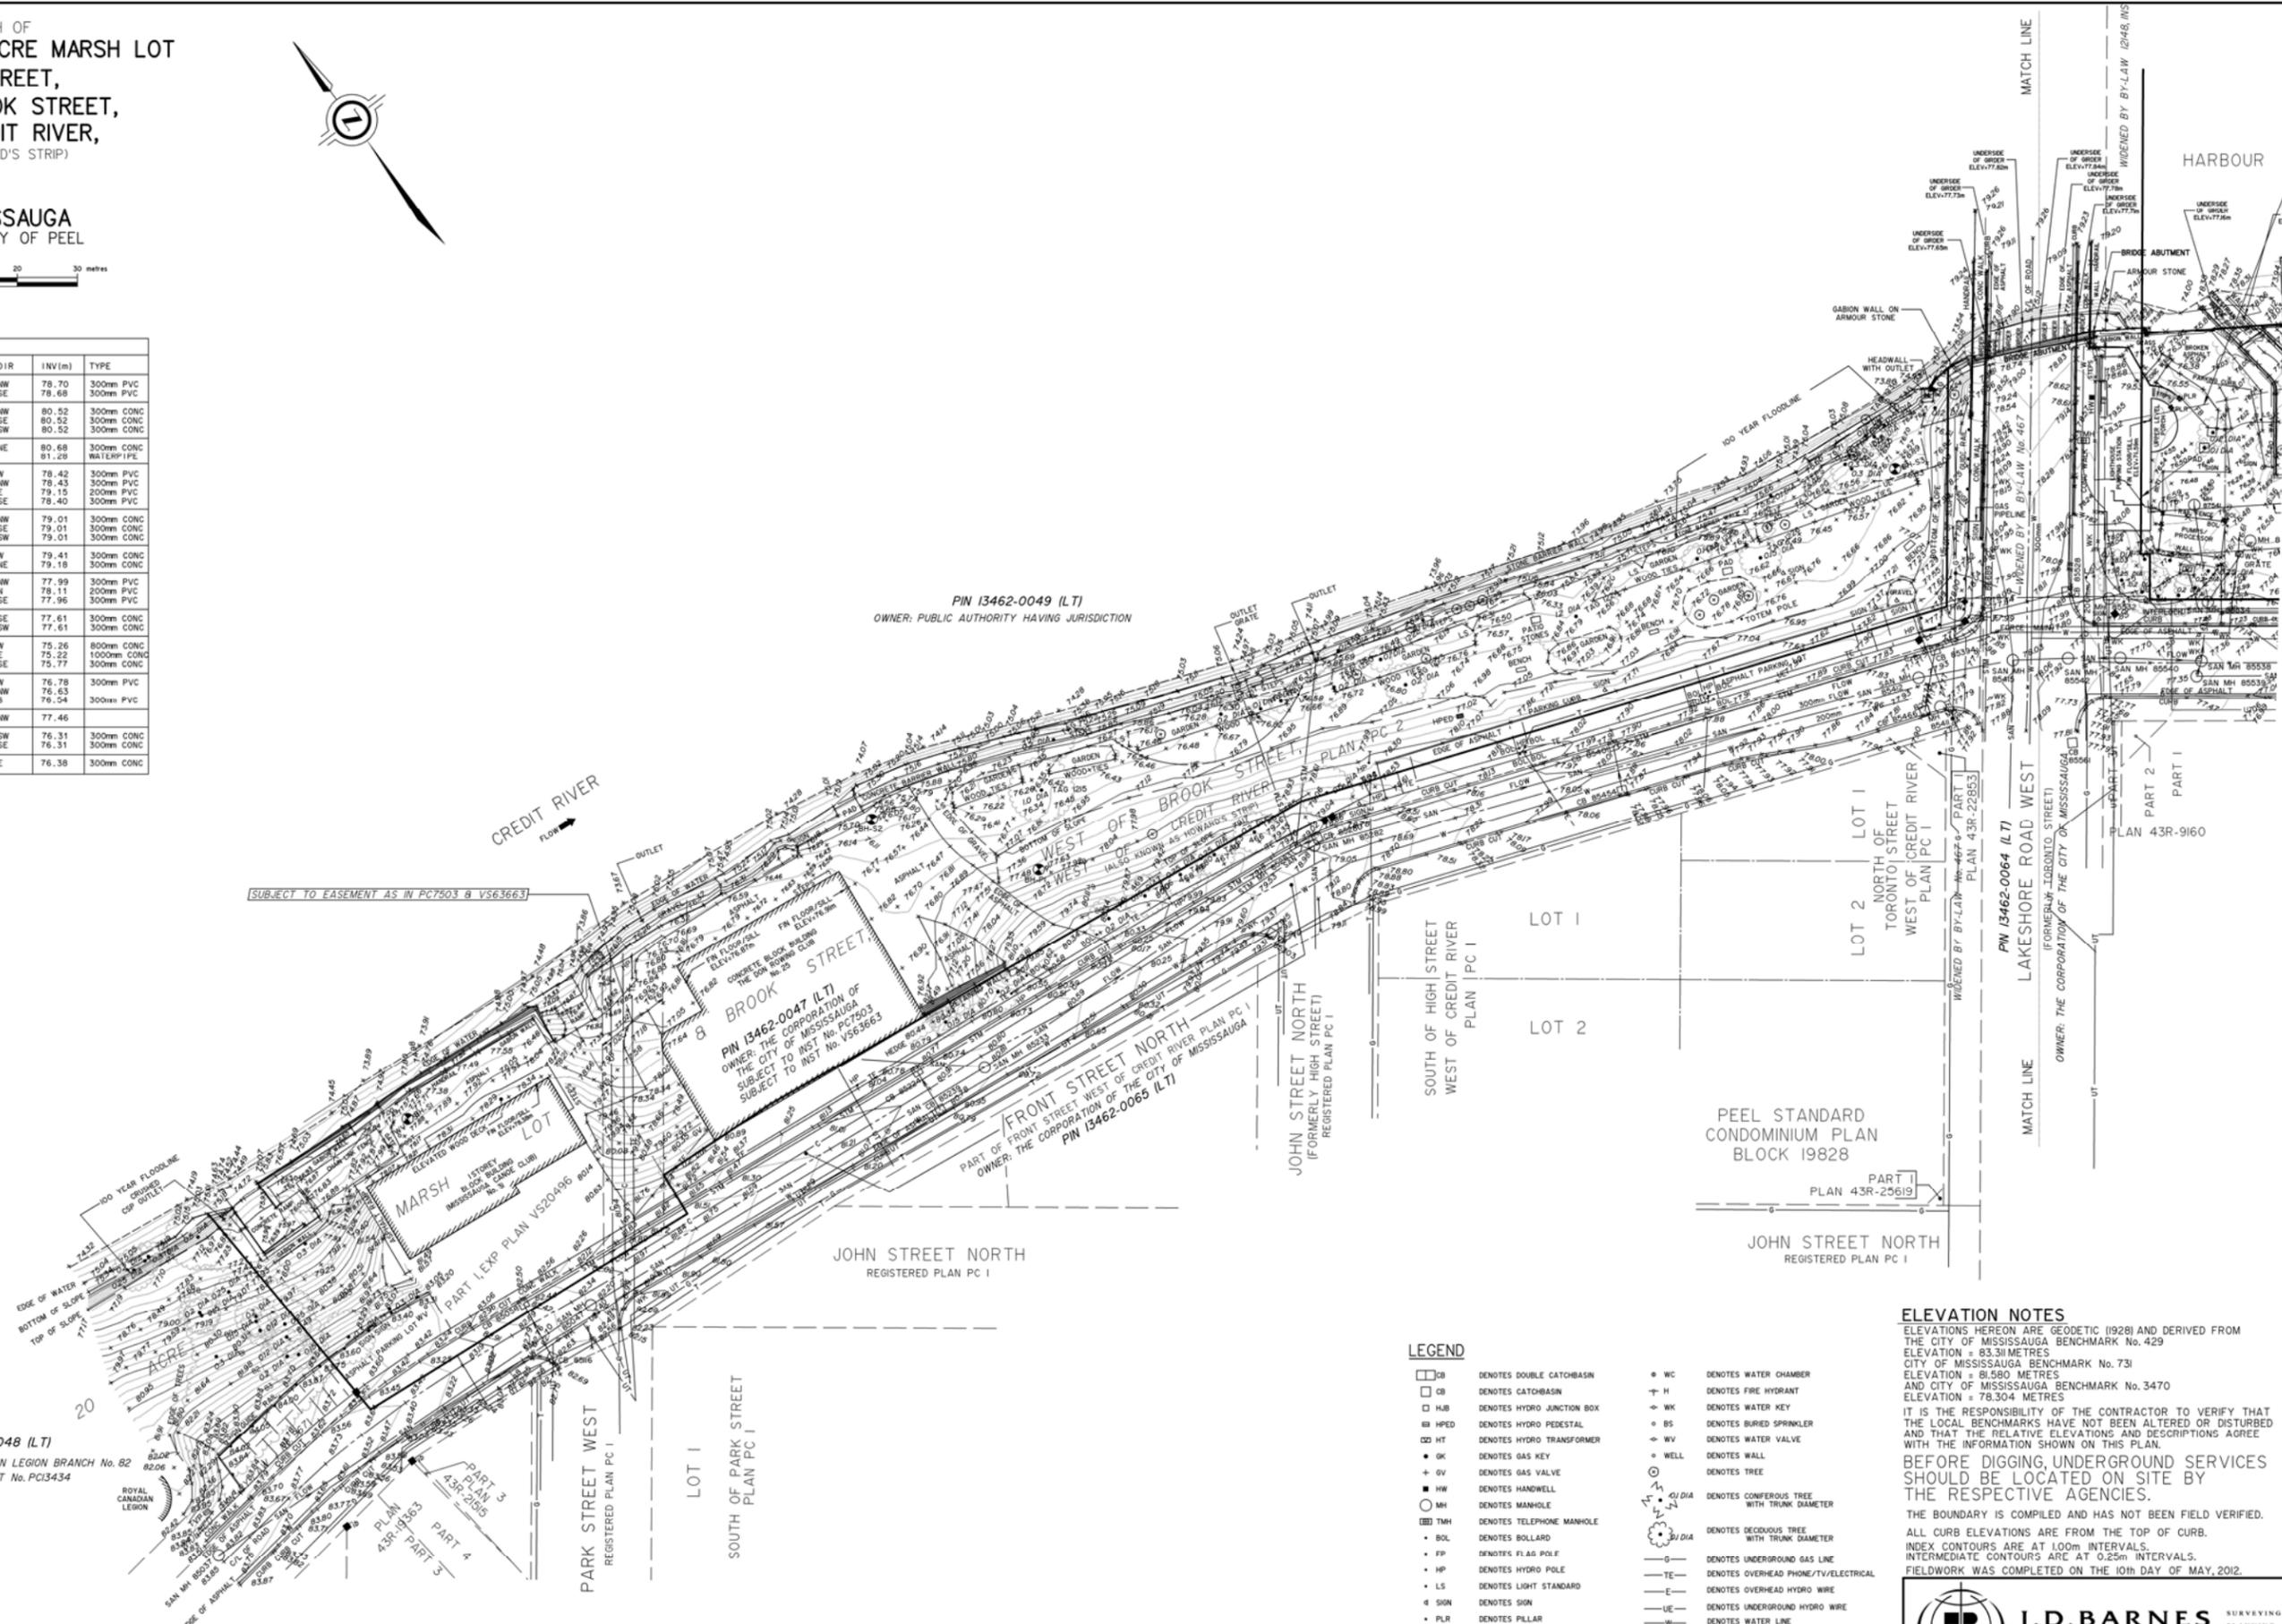
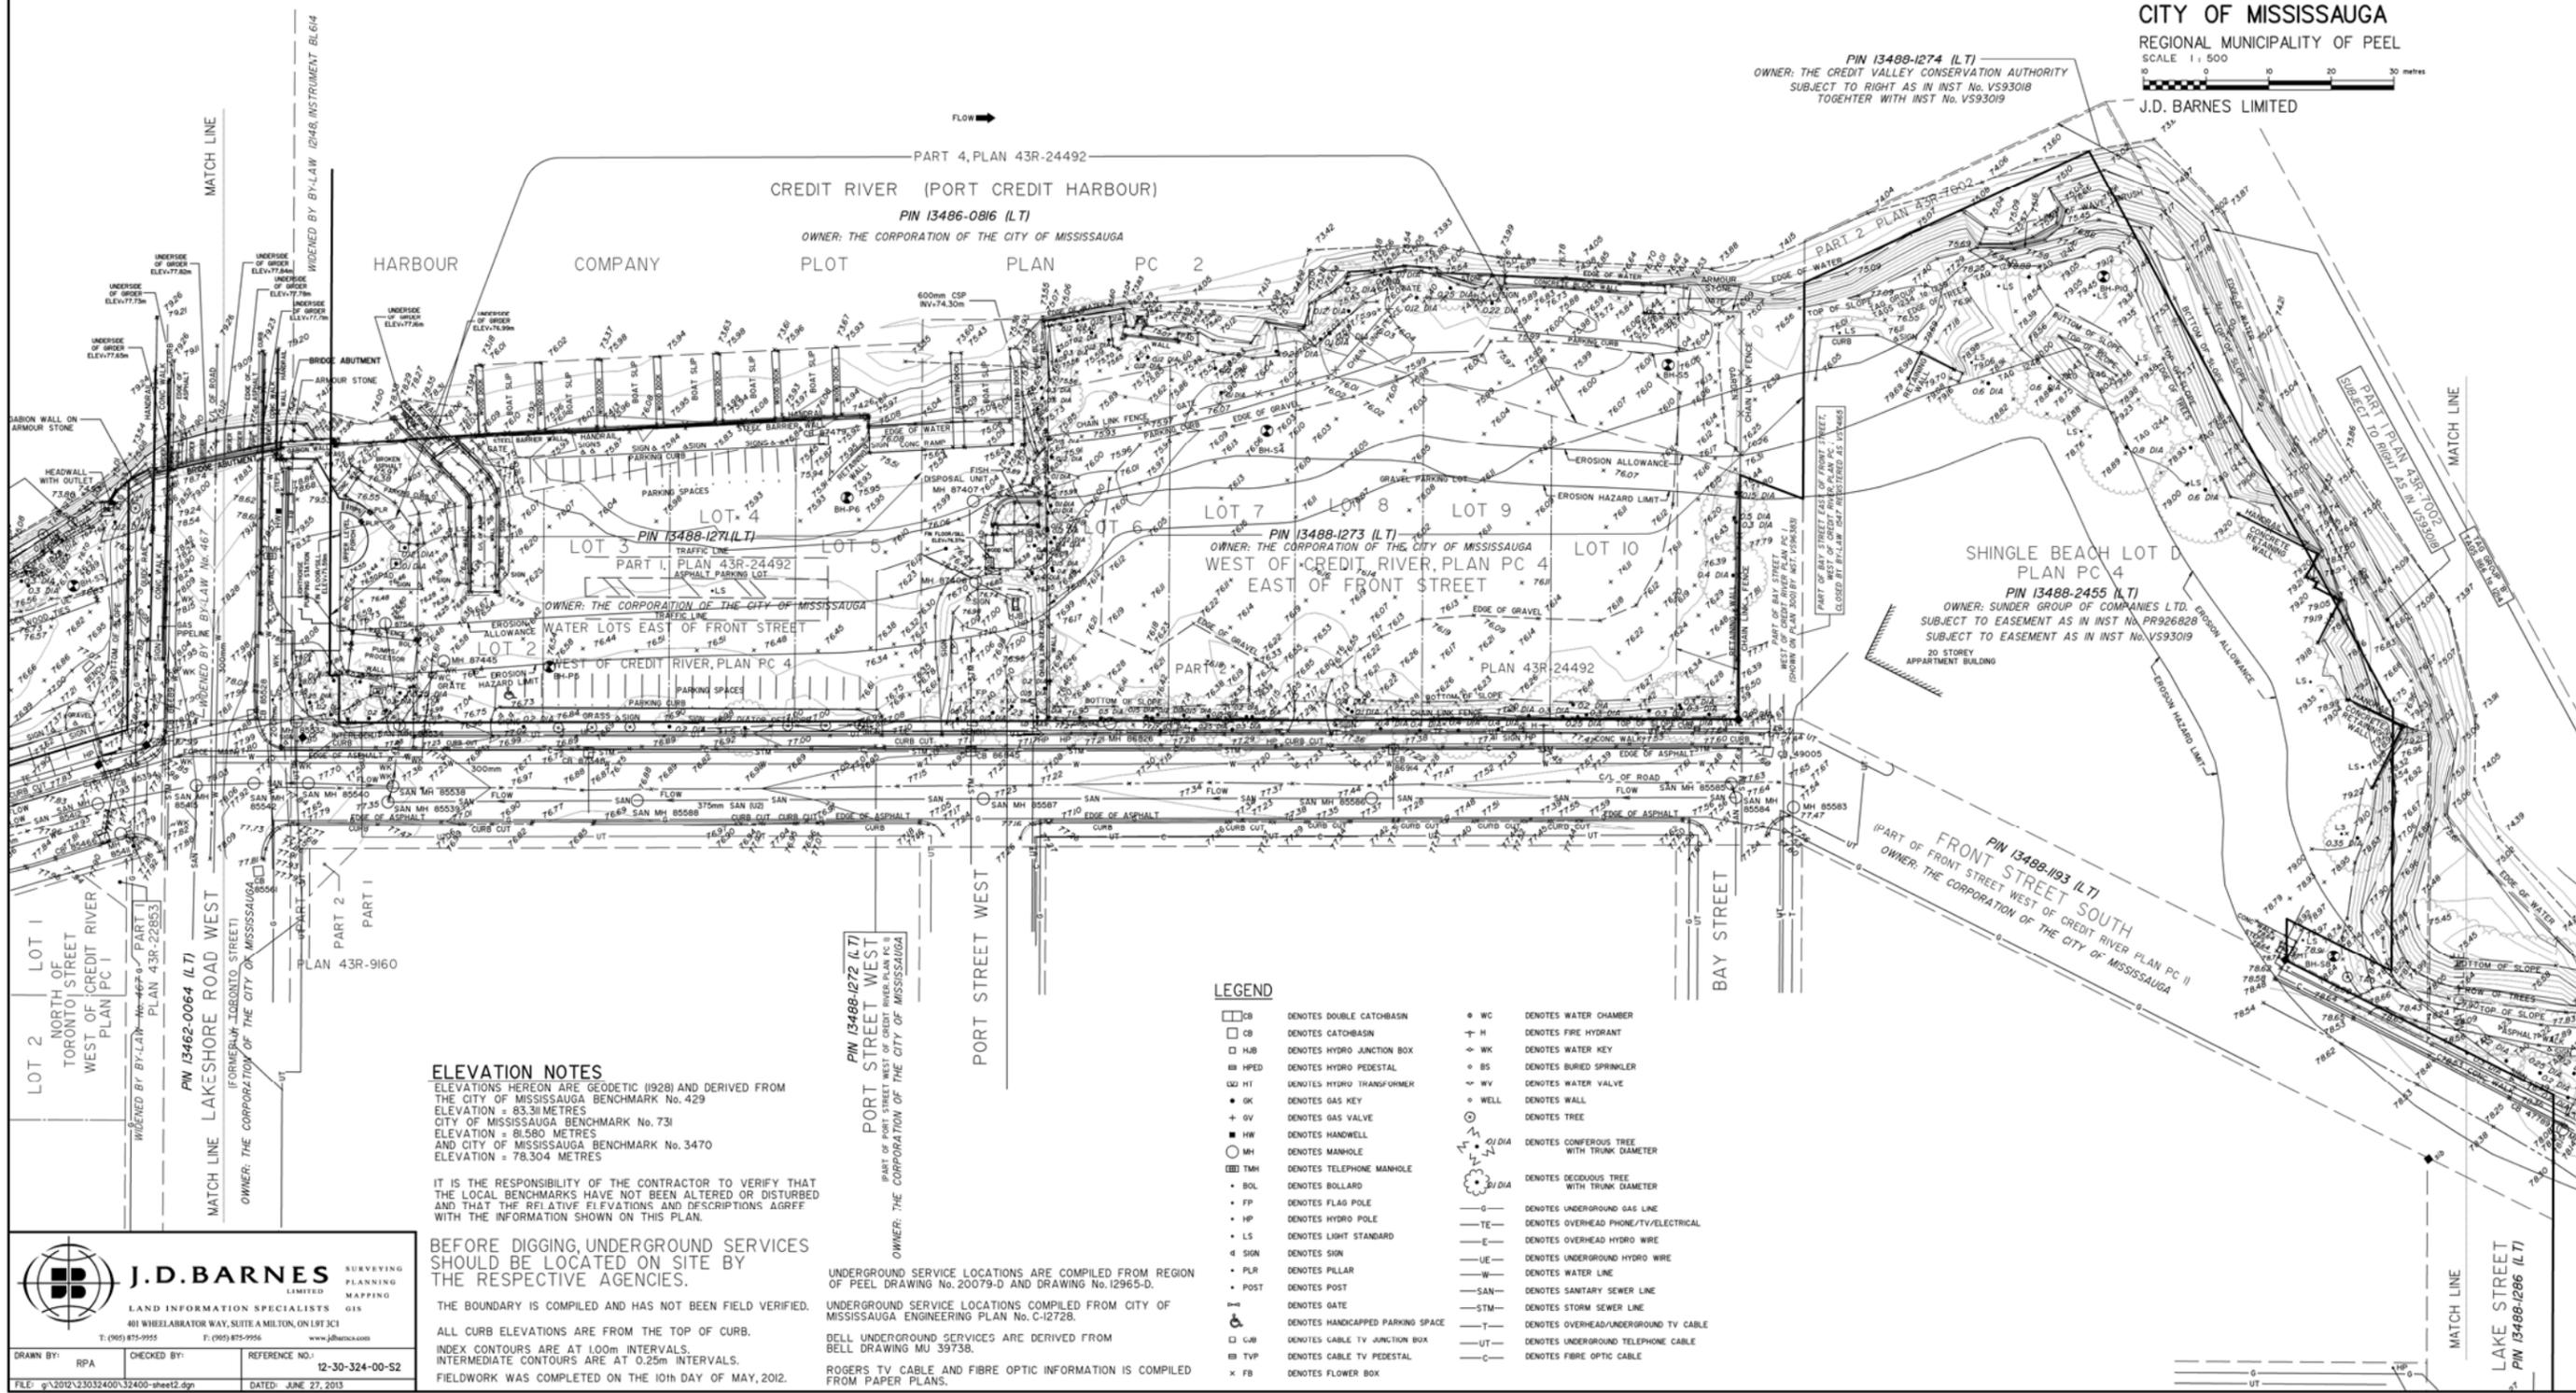
CATCHBASIN-MANHOLE INVERTS				
CB/MH #	LID ELEV(m)	DIR	INV(m)	TYPE
SAN MH 85037	83.82	NW SE	78.70 78.68	300mm PVC 300mm PVC
CB 85058	82.42	NW SE SW	80.52 80.52 80.52	300mm CONC 300mm CONC 300mm CONC
CB 85116	82.63	NE	80.68 81.28	300mm CONC WATERPIPE
SAN MH 85047	82.20	W NW E SE	78.42 78.43 79.15 78.40	300mm PVC 300mm PVC 200mm PVC 300mm PVC
CB 85224	80.77	NW SE	79.01 79.01	300mm CONC 300mm CONC
CB 85239	80.79	W	79.41	300mm CONC
SAN MH 85233	80.81	NW N SE	77.99 78.11 77.96	300mm PVC 200mm PVC 300mm PVC
CB 85303	79.11	SE SW	77.61 77.61	300mm CONC 300mm CONC
STM MH 85283	79.02	W E SE	75.26 75.22 75.77	800mm CONC 1000mm CONC 300mm CONC
SAN MH 85282	78.98	W NW S	76.78 76.63 76.54	300mm PVC 300mm PVC
CB 85280	78.86	NW	77.46	300mm CONC
CB 85401	77.86	SW SE	76.31 76.31	300mm CONC 300mm CONC
CB 85454	77.87	E	76.38	300mm CONC

TOPOGRAPHIC SKETCH OF
**PART OF WATER LOT 1,
 WATER LOTS 2, 3, 4, 5,
 6, 7, 8, 9 AND 10**
 EAST OF FRONT STREET,
 WEST OF CREDIT RIVER, PLAN PC 4
 PART OF HARBOUR COMPANY PLOT,
 PLAN PC 2
 PART OF PORT STREET
 WEST OF CREDIT RIVER, PLAN PC 1
 AND PART OF BAY STREET
 EAST OF FRONT STREET,
 WEST OF CREDIT RIVER, PLAN PC 1
 (CLOSED BY BY-LAW 1547 REGISTERED AS VS74165)
 (TOWN OF PORT CREDIT)
CITY OF MISSISSAUGA
 REGIONAL MUNICIPALITY OF PEEL
 SCALE 1:500
 0 10 20 30 metres

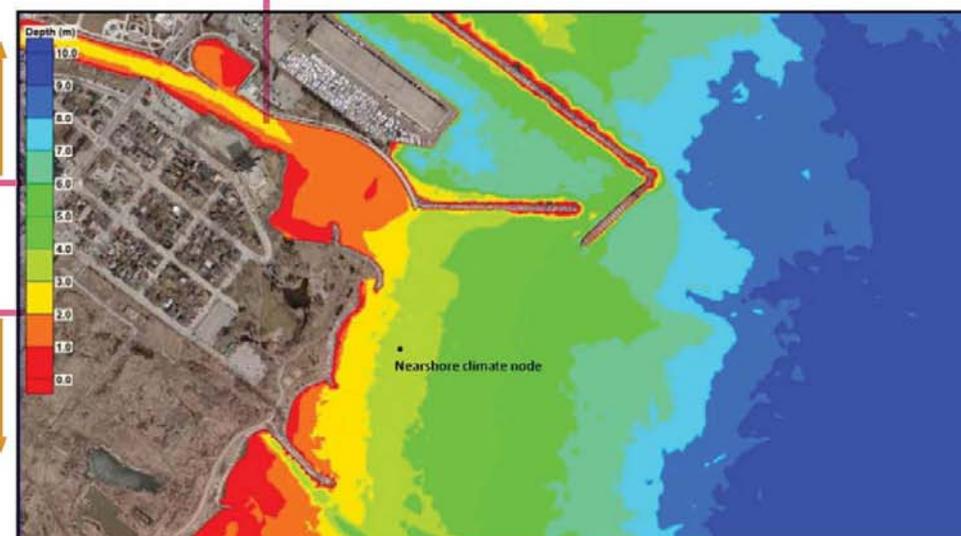
Local Bathymetry

- depths of 6 metres or more are found near the entrance of the Port Credit Marina

- depths of 2 metres or less are found in the mouth of the Credit River

- a deeper channel is found along the east side of the Credit River

- depths of 6 metres or more are found near the entrance of the Port Credit Marina

- depths of 2 metres or less are found in the mouth of the Credit River

- a deeper channel is found along the east side of the Credit River

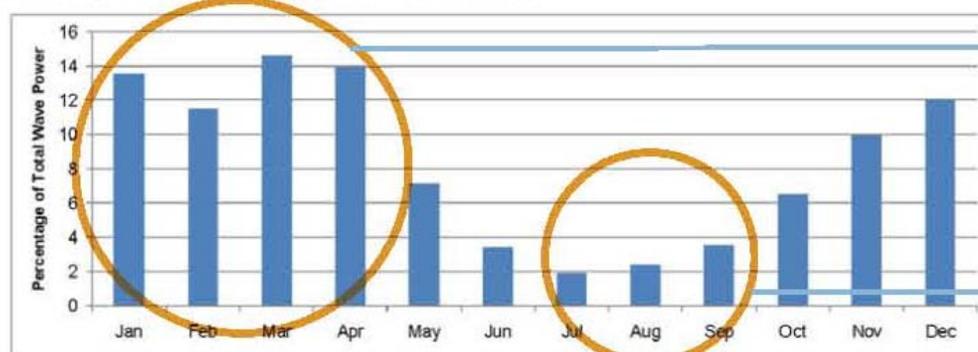
Monthly Distribution of Total Wave Power

- most wave power is generated during winter and early spring months
- June, July and August are the calm months on Lake Ontario

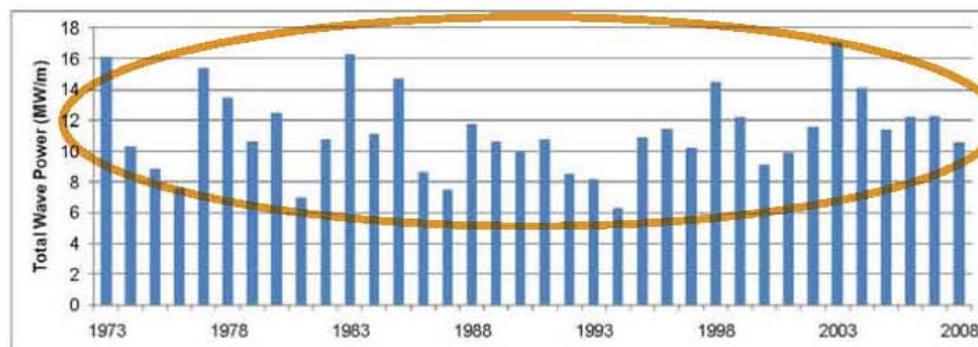
Annual Distribution of Total Wave Power

- wave power varies significantly from year to year

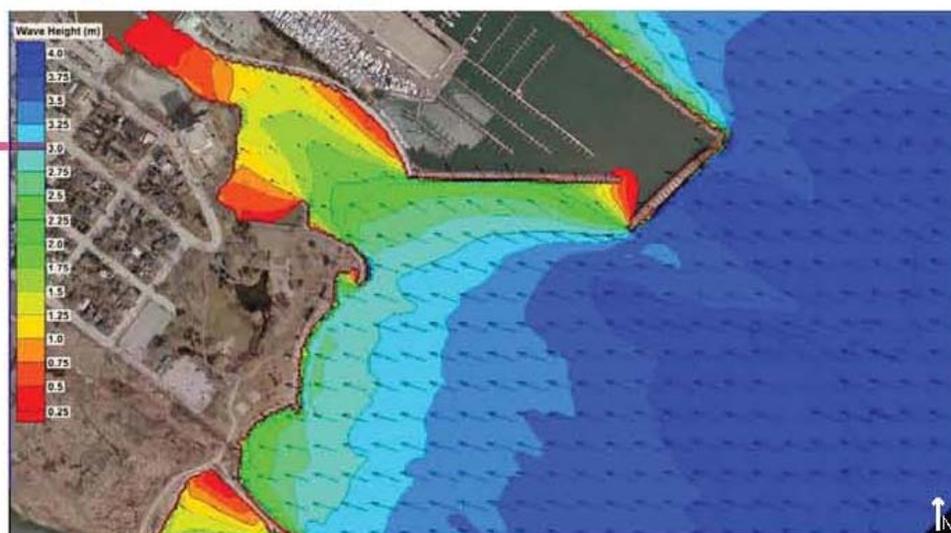
Highest Hindcast Wave Height - East Waves

- diagrams indicate nearshore wave conditions (wave height and direction)
- information used for design of offshore protection structures

(5.5m 10s in deep water, analysis water level 75.0m)

- largest nearshore waves approach the site from the east
- east waves also penetrate furthest into the mouth of the river and up the river channel

- diagrams indicate nearshore wave conditions (wave height and direction)
- information used for design of offshore protection structures

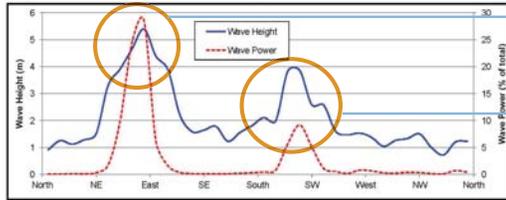
Directional Distribution of Highest Hindcast Wave Heights and Total Wave Power

- highest waves are generated from the east quadrant
- southwest quadrant has most frequent on-shore waves

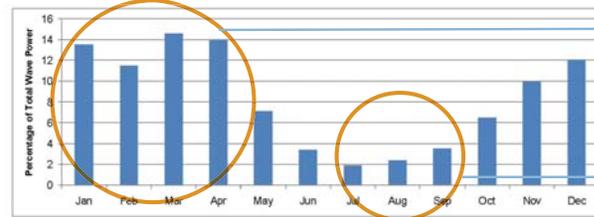
Monthly Distribution of Total Wave Power

- most wave power is generated during winter and early spring months
- June, July and August are the calm months on Lake Ontario

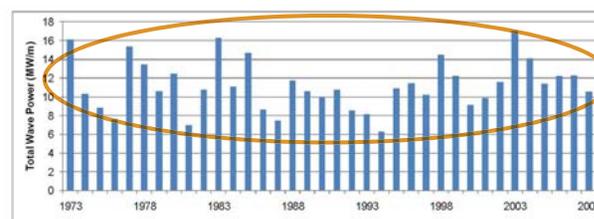
Annual Distribution of Total Wave Power

- wave power varies significantly from year to year

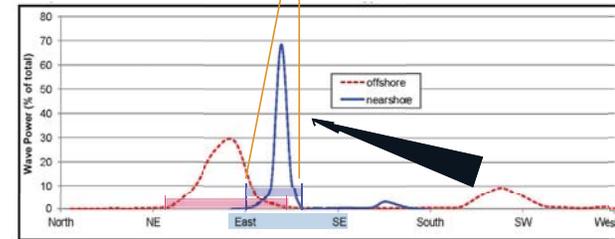
Comparison of Offshore and Nearshore Wave Energy Distributions

- the direction of the wave energy direction at J.C. Saddington Park is generally east-southeast as shown by the arrow

- wave energy becomes focused as it approaches the shore

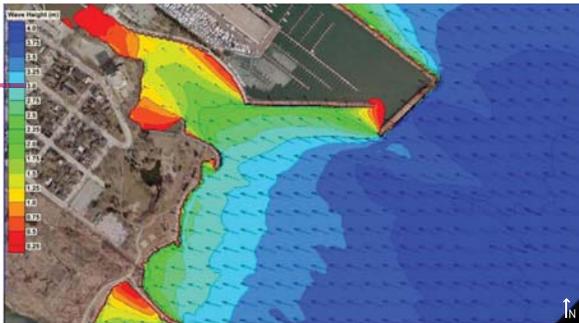
Highest Hindcast Wave Height - East Waves
(5.5m 10s in deep water, analysis water level 75.0m)

- largest nearshore waves approach the site from the east
- east waves also penetrate furthest into the mouth of the river and up the river channel

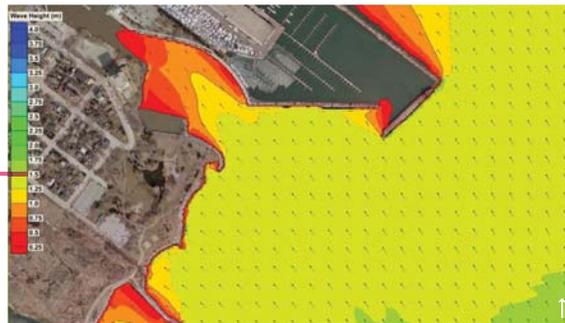
Highest Hindcast Wave Height - South Waves
(2.1m 6s in deep water, analysis water level 75.0m)

Mathematical modelling process that produces wave conditions on a body of water using 36 years of recorded wind speeds and directions from the Toronto Island Airport.

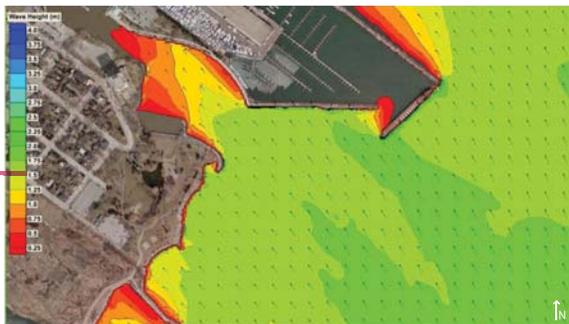
Highest Hindcast Wave Height - Southwest Waves
(4.0m 8s in deep water, analysis water level 75.0m)

- southwest waves also penetrate well into the river mouth

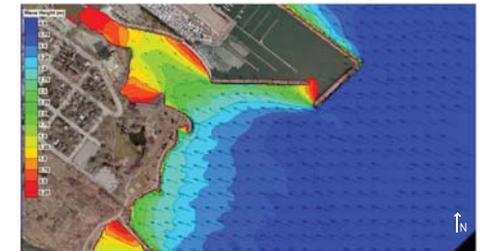
Design Wave (100-yr wave, 100-yr water level)
(6.0m 10s east wave in deep water, analysis water level 75.8m)

Defined as the wave height having a probability of being equalled or exceeded during any year of 1%.

This means that on average, during a 100 year period, the 100 year flood level is expected to be equalled or exceeded once.

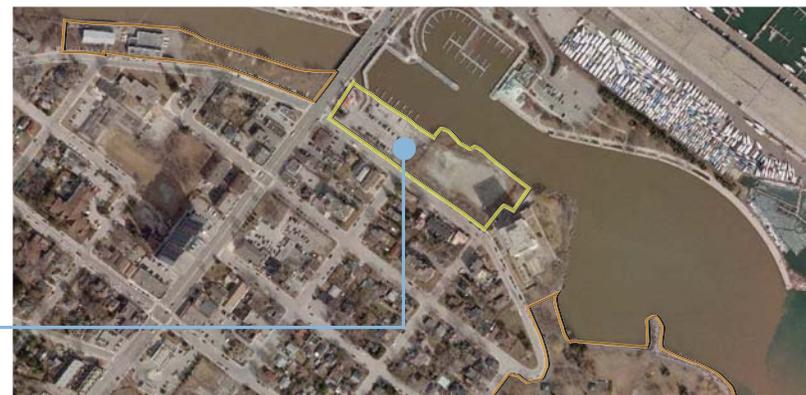
P112 - MARINA PARK

- EXISTING LIGHTHOUSE AND FRONT STREET PUMPING STATION
- SEASONAL KIOSK
- POTENTIAL UNDERBRIDGE CONNECTION TO PORT CREDIT MEMORIAL PARK (WEST)
- MULTI-USE CIVIC SPACE
- EXISTING CHARTER BOAT AREA
- EXISTING BOAT LAUNCH RAMPS
- EXISTING PEDESTRIAN BRIDGE
- TRANSITIONAL ZONE
- OPEN GREEN SPACE
- MULTI-USE CIVIC SPACE

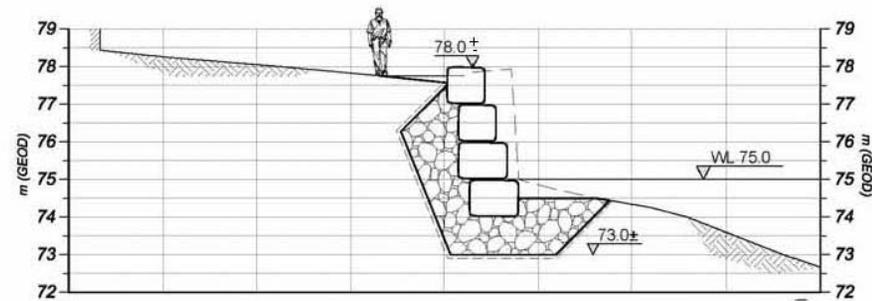
Section AA BOAT CLUBS - HARD SHORE

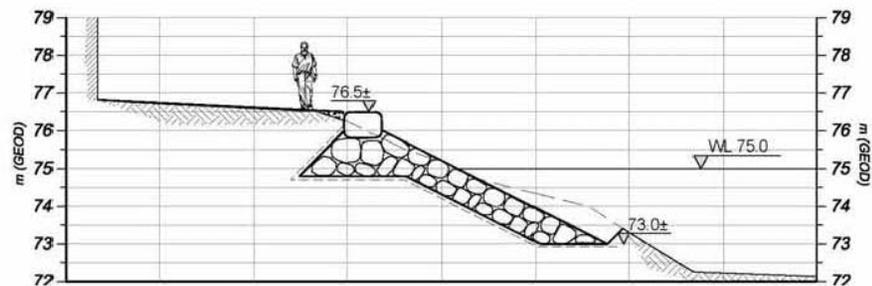
Section A2 HARD SHORE OPTION

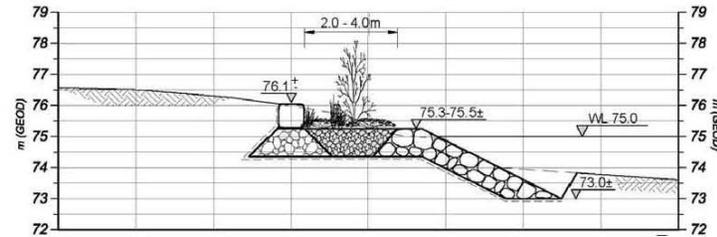
Section B1 SOFT SHORE OPTION

- Upgrades include live cribs and live stakes
- Softening the shoreline increases potential fish habitat
- Allows for educational components
- Protection from wave, river and ice conditions low to moderate
- Design life between 10 to 20 years

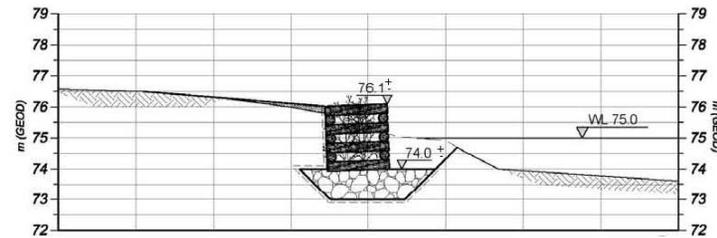
Section B2 SOFT SHORE OPTION

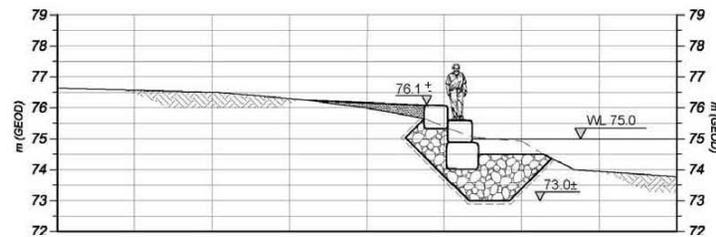
Section B3 HARD SHORE OPTION

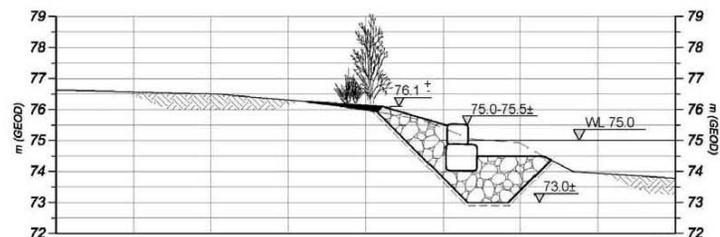
Section B4 HARD SHORE OPTION

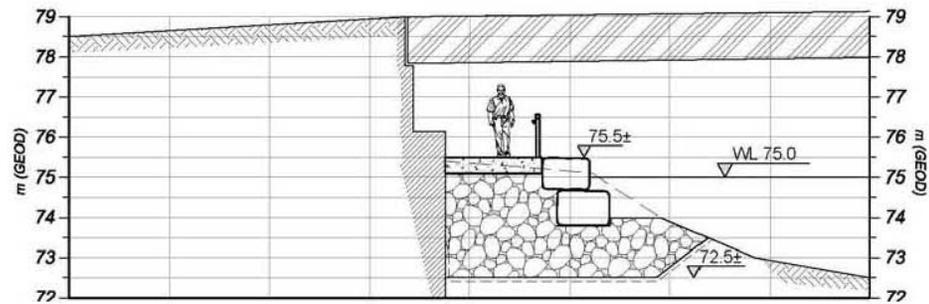
Section C LAKESHORE ROAD UNDERPASS

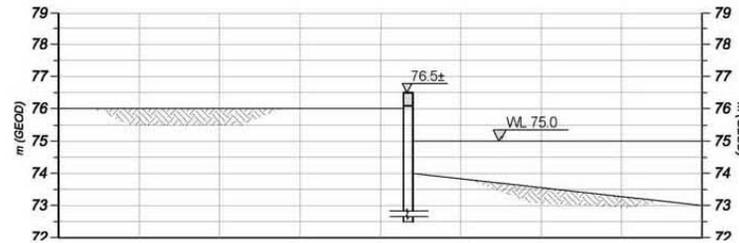
Section D1 EXISTING SHORE WALL WITH NEW CAP

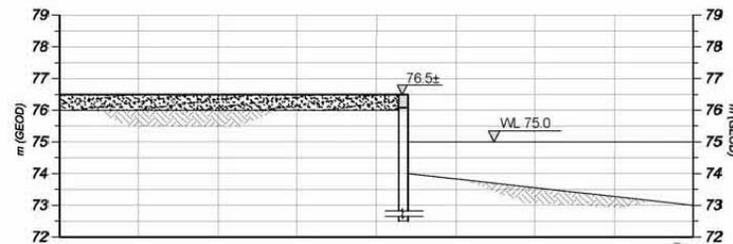
Section D2 PROPOSED SHORE WALL WITH NEW CAP

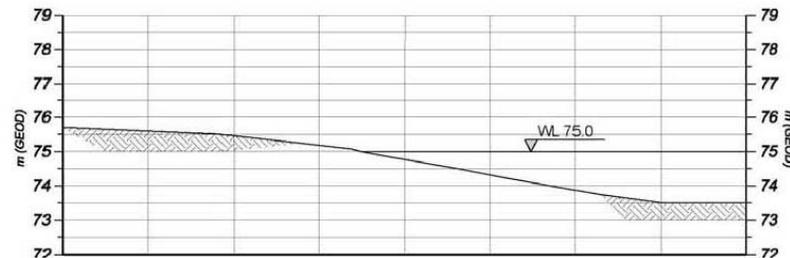
Section E EXISTING LAUNCH RAMP

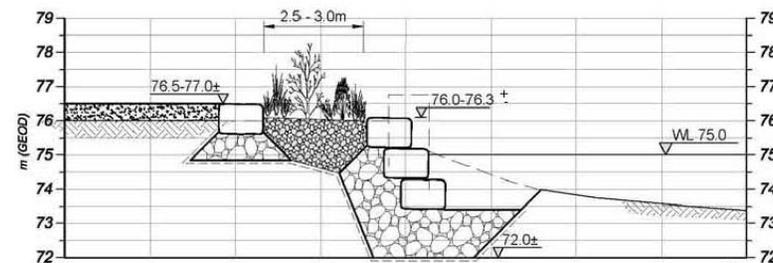
Section F3 MARINA PARK SHORELINE*

*hard shore required for stabilization but is naturalized where possible

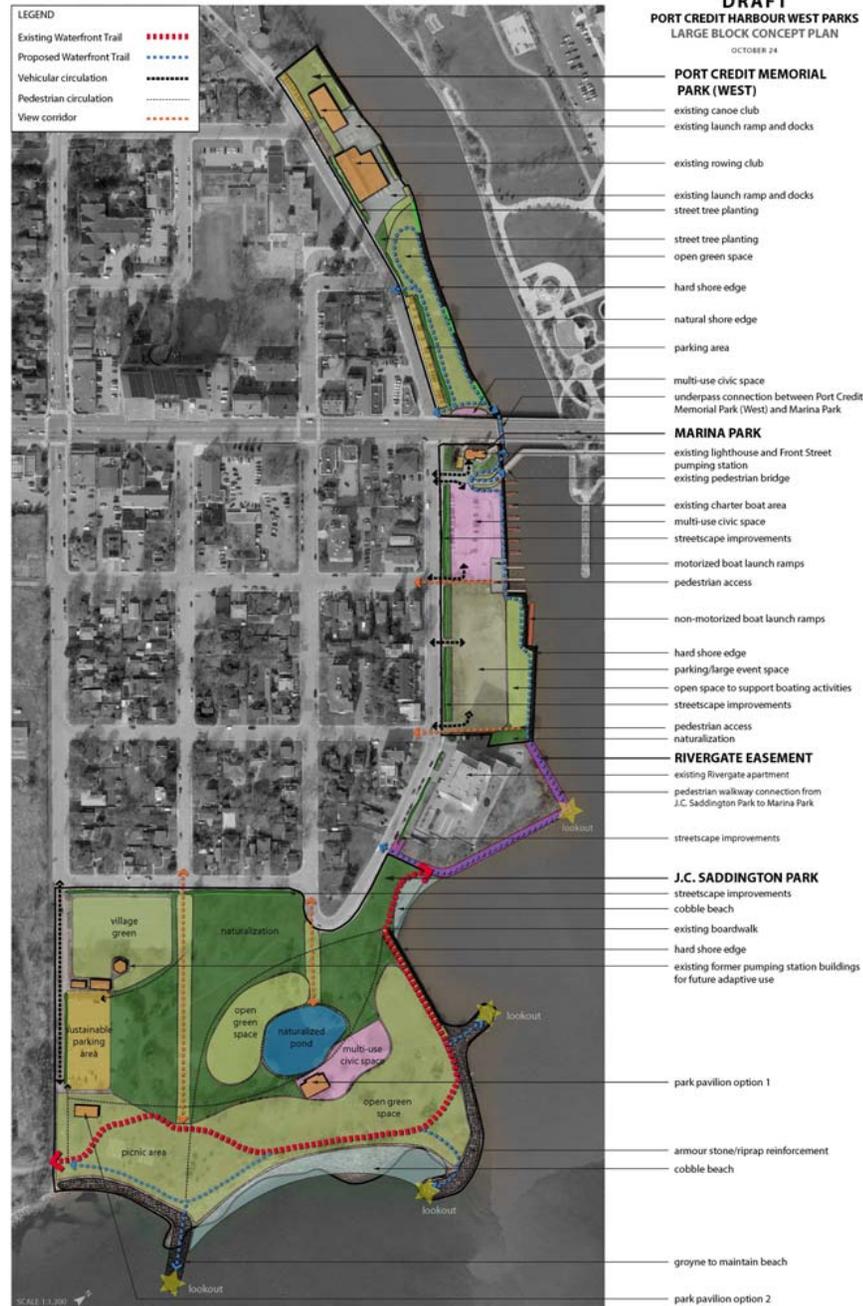
Preliminary Large Block Concept Plan

- **Port Credit Memorial Park (West)** - live cribs/live stakes and armour stone shorewall
- **Underpass** under Lakeshore Road on the west bank of the Credit River
- **Marina Park** - raise the shoreline and construct new shorewall
- **Non-Motorized Boat Launch** - relocate further south in Marina Park
- **Rivergate Easement** – construct waterside boardwalk around the easement
- **Hacienda Bay** - enhancement of the cobble beach
- **J.C. Saddington Park** - cobble beach along the Lake Ontario shore; additional armour stone along the west side where required
- **J.C. Saddington Park Pond** – naturalize the pond by re-lining, adding substrate and plantings

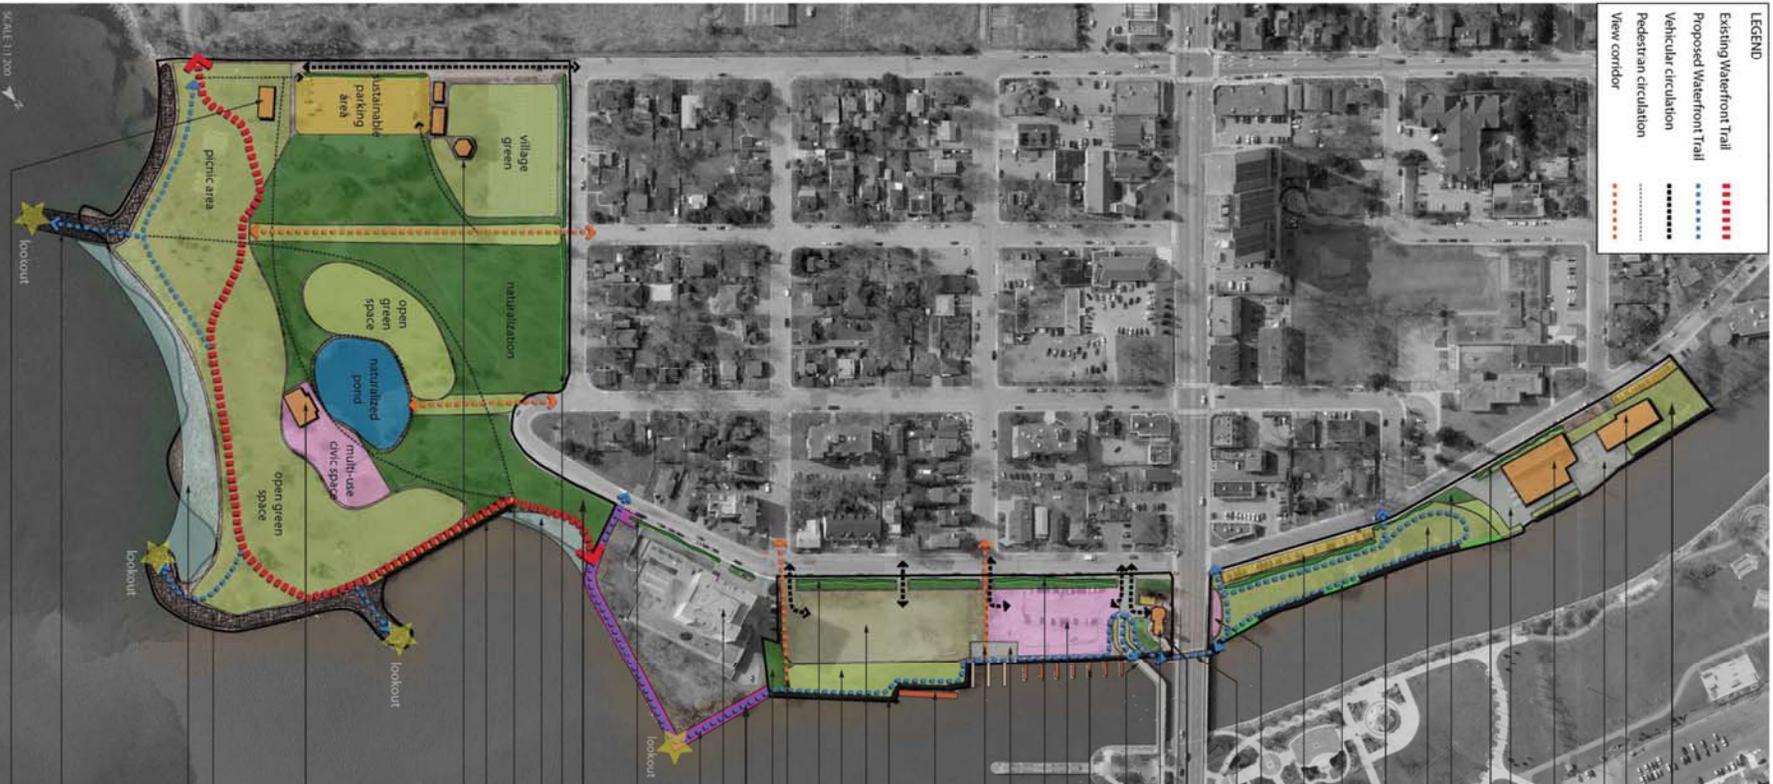
Large Block Concept Plan

- DRAFT**
PORT CREDIT HARBOUR WEST PARKS
LARGE BLOCK CONCEPT PLAN
OCTOBER 24
- PORT CREDIT MEMORIAL PARK (WEST)**
 - existing canoe club
 - existing launch ramp and docks

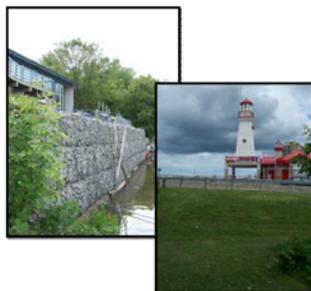
Do Nothing

- Existing concrete slab revetments will remain
- No changes or impacts to the Natural Environment
- No change or disruption to the Socio-Economic and Cultural Environment; misses opportunity to improve shoreline use
- Existing structure will continue to deteriorate

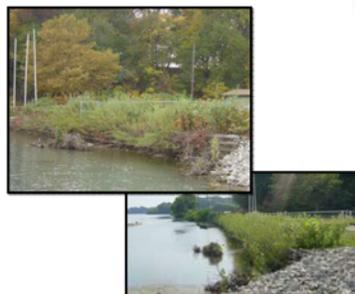
Natural Shore

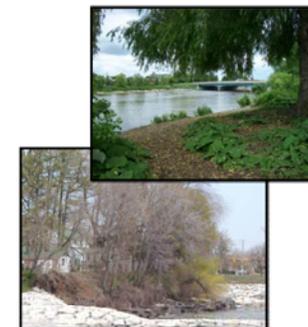
Combination

- Combination of both natural and hard shore
- Habitat opportunities in some areas
- Can appeal to a variety of users
- Moderate protection provided from wave, river and ice conditions
- Areas with different design life and maintenance requirements

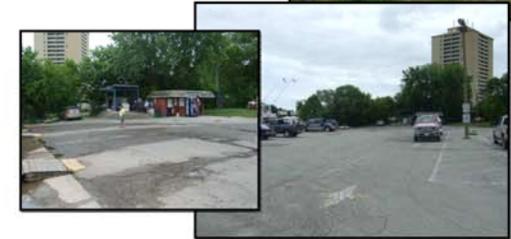
✓ Do Nothing at North End & Flood Proof South End

- Raise elevation and improve shore wall at south end
- Opportunity to increase vegetation and landscaping where elevation is raised
- Minimal disruption at north end during construction
- Design life 25 to 50 years
- Extent of maintenance is likely low

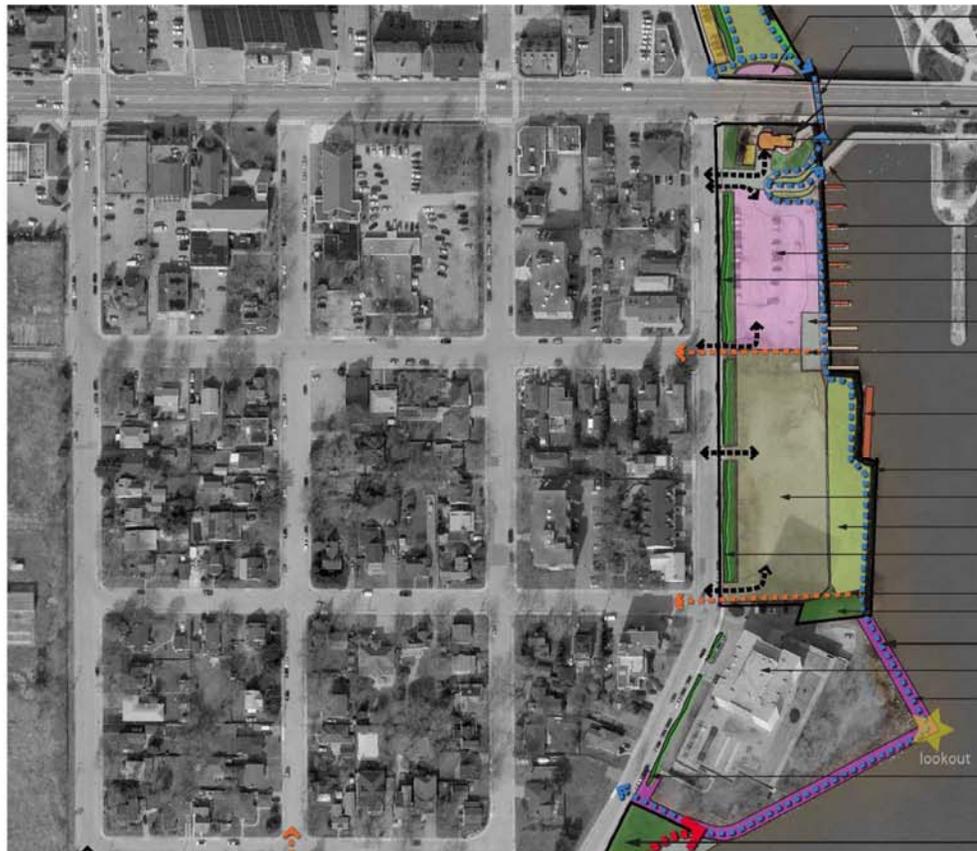
Marina Park & Rivergate Easement Large Block Concept Plan

multi-use civic space
 underpass connection between Port Credit Memorial Park (West) and Marina Park

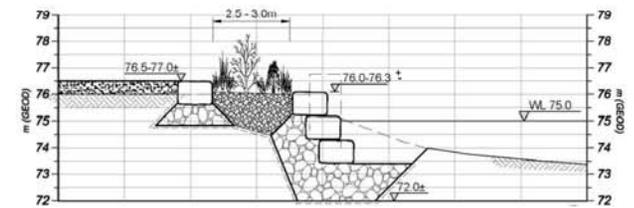
Section F3 MARINA PARK SHORELINE*

*hard shore required for stabilization but is naturalized where possible

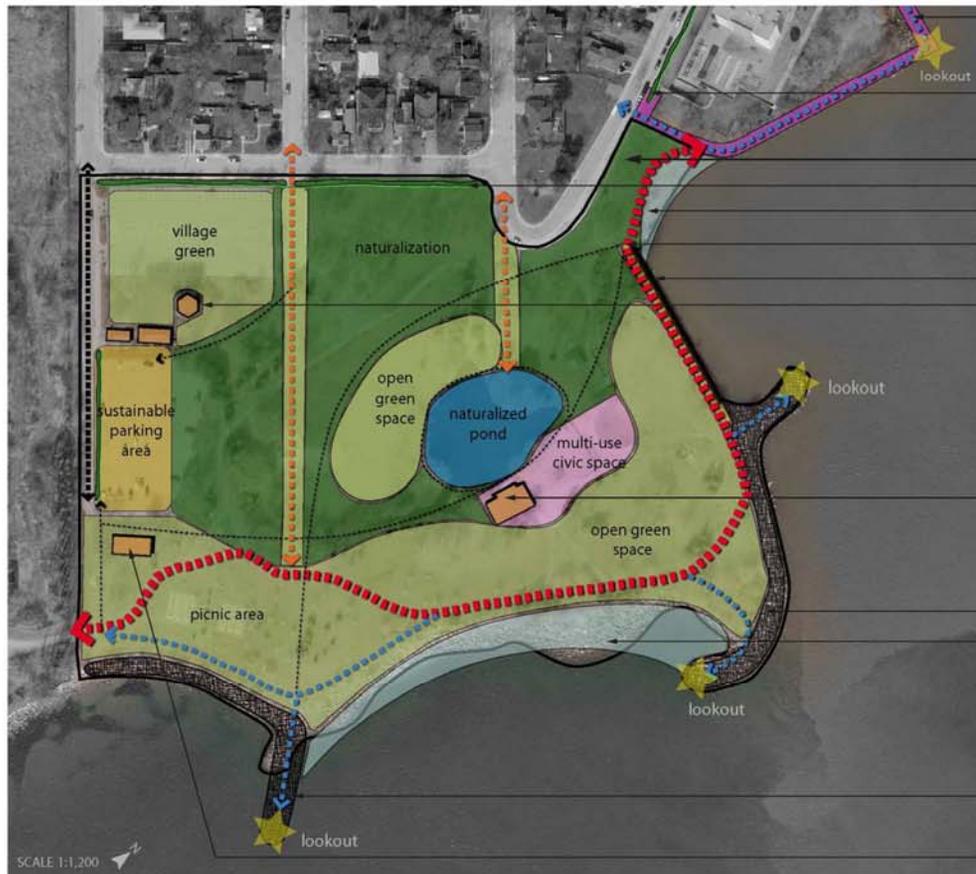
J.C. Saddington Park Large Block Concept Plan

- pedestrian walkway connection from J.C. Saddington Park to Marina Park
- lookout
- streetscape improvements
- J.C. SADDINGTON PARK**
- streetscape improvements
- cobble beach
- existing boardwalk
- hard shore edge
- existing former pumping station buildings for future adaptive use
- lookout
- park pavilion option 1
- armour stone/riprap reinforcement
- cobble beach
- lookout
- groyne to maintain beach
- park pavilion option 2

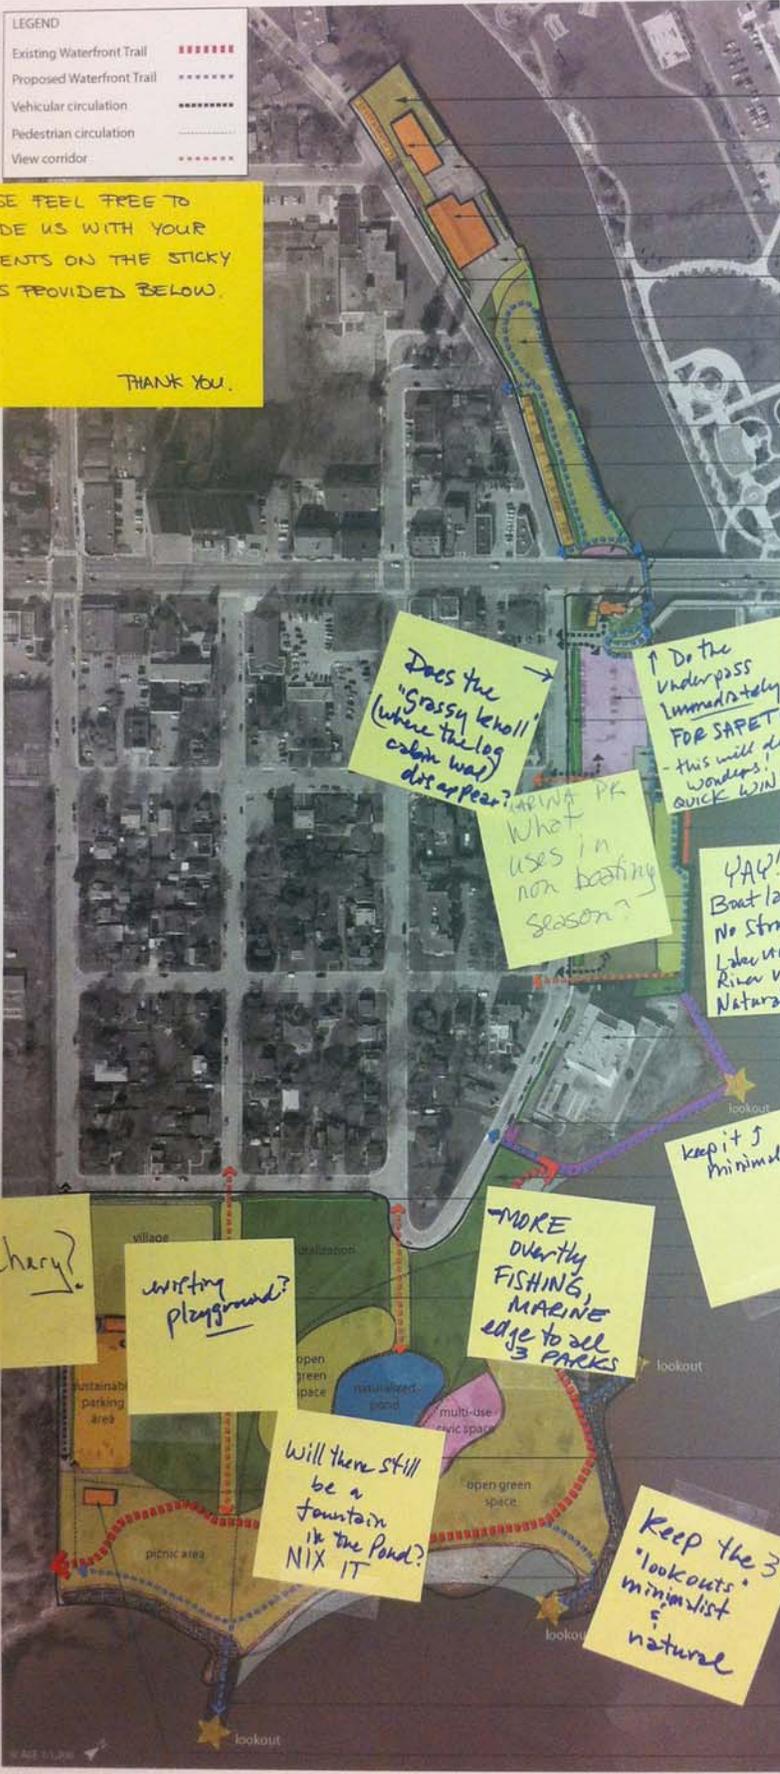
DRAFT
PORT CREDIT HARBOUR WEST PARKS
LARGE BLOCK CONCEPT PLAN
OCTOBER 24

PORT CREDIT MEMORIAL PARK (WEST)

- existing canoe club
- existing launch ramp and docks
- existing rowing club
- existing launch ramp and docks
- street tree planting
- street tree planting
- open green space
- hard shore edge
- natural shore edge
- parking area
- multi-use civic space
- underpass connection between Port Credit Memorial Park (West) and Marina Park

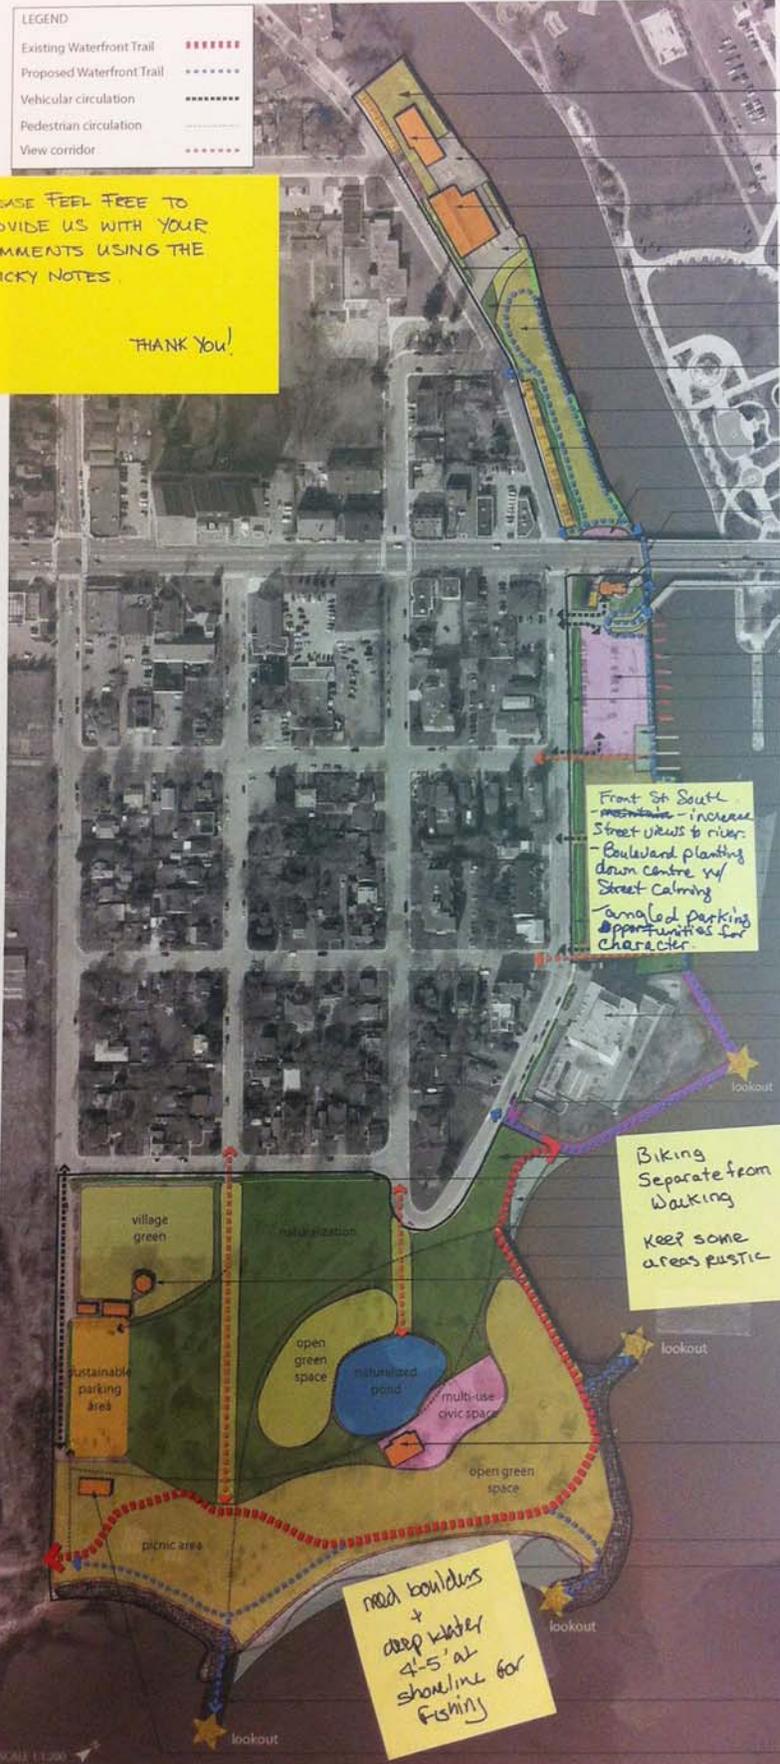
DRAFT
PORT CREDIT HARBOUR WEST PARKS
LARGE BLOCK CONCEPT PLAN
 OCTOBER 24

PORT CREDIT MEMORIAL PARK (WEST)

- existing canoe club
- existing launch ramp and docks
- existing rowing club
- existing launch ramp and docks
- street tree planting
- street tree planting
- open green space
- hard shore edge
- natural shore edge
- parking area
- multi-use civic space
- underpass connection between Port Credit Memorial Park (West) and Marina Park
