**PRE-DESIGN REPORT / ENVIRONMENTAL STUDY REPORT
PORT CREDIT HARBOUR WEST PARKS**

**PORT CREDIT HARBOUR WEST PARKS
PRE-DESIGN REPORT / ENVIRONMENTAL STUDY REPORT**

Dillon Consulting Limited

Shoreplan Engineering Limited

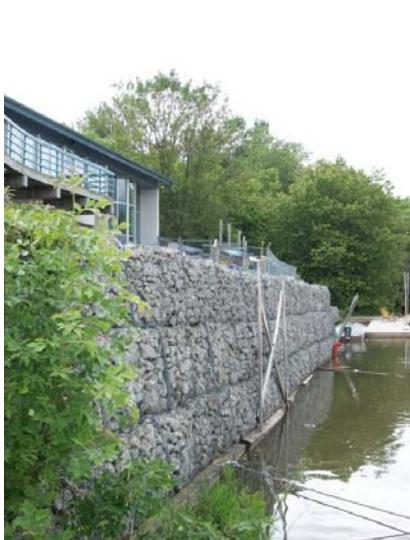
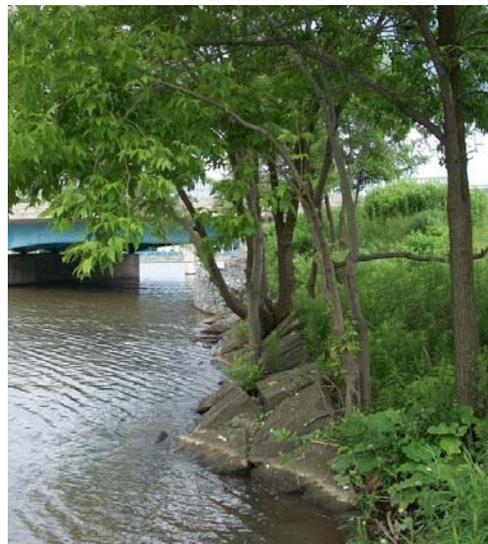
Do Nothing

The “do nothing” alternative leaves the existing concrete slab revetments “as is” with no improvements made to the shoreline.

The existing shoreline at Port Credit Memorial Park (West) is at the end of its life, therefore the “do nothing” alternative provides low protection of the shoreline and will require significant maintenance in the future to provide the necessary protection. The greatest level of protection provided from wave, river and ice conditions is derived from the construction of a hard shore, moderate protection from the “combination” alternative and low to moderate protection from the “natural shore” alternative. Similarly, the longest design life and lowest maintenance is achieved with a “hard shore” alternative, and the “natural shore” and “combination” alternatives provide a variety of shorter design life and maintenance considerations.

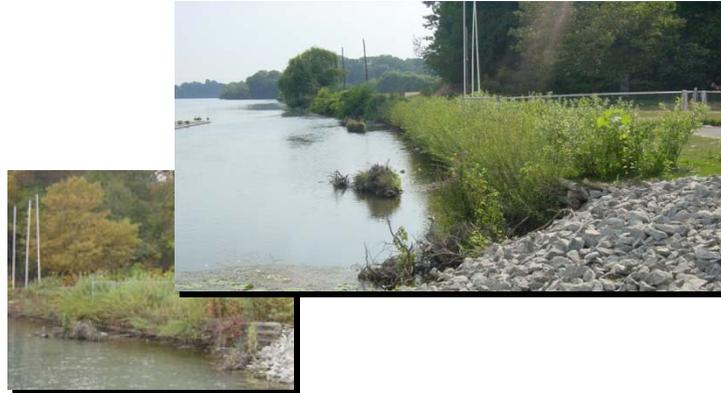
Natural Shore

The “natural shore” alternative involves the construction of live cribs and live stakes to create a natural shore. Stakes are live woody cuttings of a species that have the ability to root and grow, and over time can provide slope stabilization, improve aesthetics of a shoreline and provide habitat for wildlife. A live crib wall is a box-like, interlocking arrangement of log walls with live vegetation placed between the seams of each layer.

Changing the Port Credit Memorial Park’s (West) shoreline to a “natural shore” is the preferred alternative from the natural environmental perspective as it provides the most significant opportunity to increase fish habitat and naturalized park areas. It is noted that the “combination” alternative also provides natural environment advantages.

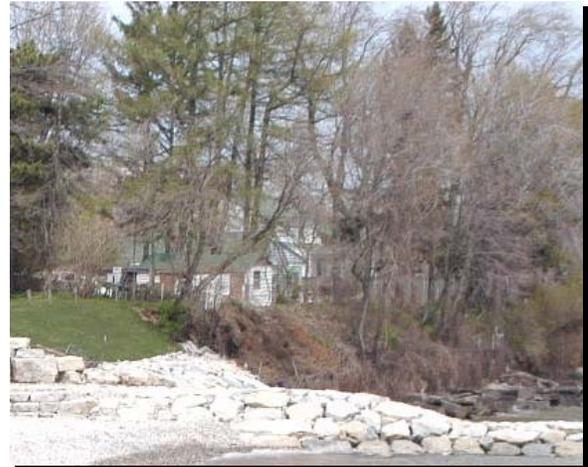
Hard Shore

This shoreline alternative involves the replacement of the current shoreline with a hard shore. There are a number of different types of hard shore including:

- stone revetments - sloping structures extend from the shore into the water to protect the shore from the action of waves
- seawall - a protective vertical or near vertical structure of stone, concrete or steel that protects the shore from the action of waves
- steel sheet piles - interlocking steel piles commonly used to construct a seawall with deep foundations providing protection from the action of waves
- concrete – a structure providing protection as a vertical retaining wall

All types of hard shore treatments stabilize the shore by mostly reflecting the energy of incoming waves and helping to preserve the existing uses of the park and to protect against erosion.

The “natural shore”, “hard shore” and “combination” alternatives provide an improved level of protection over the existing shoreline conditions, however, the “hard shore” alternative is preferred from a technical perspective as it is a well-known method of providing shoreline protection, provides the most protection from the physical environment, and its constructability is the easiest and most understood by contractors. The do-nothing alternative is least preferred as it will require significant maintenance in the future.

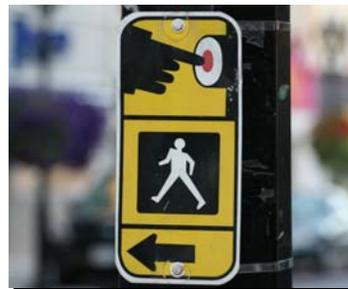
At Grade

The “at grade” alternative involves improving the connection between Port Credit Memorial Park (West) and Marina Park by constructing an at-grade crosswalk with lights across Lakeshore Road West at Front Street

The “at grade” alternative is preferred over the “do-nothing” alternative as it has the advantage of very limited impacts to the community, traffic and park users. However, it does not provide the same level of public safety as the other two alternatives that separate pedestrians and cars. The “overpass” alternative is also preferred over the “do-nothing” alternative as it provides an improvement in safety, however it has the potential to cause significant disruption to park users due to construction related closures. The “overpass” alternative involves a permanent removal of park land for ramps or elevators and to traffic on Lakeshore Road West as a result of visual distraction during construction.

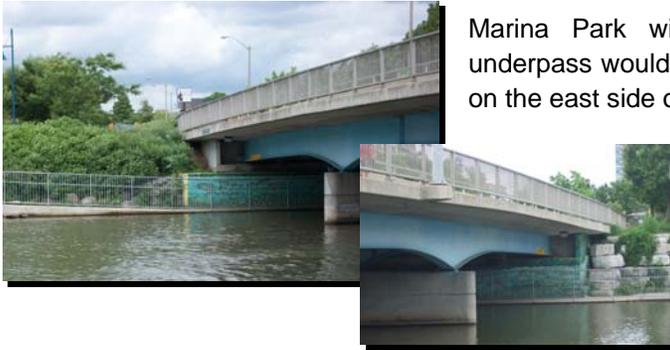
Underpass

The “underpass” alternative involves construction of an underpass passage below Lakeshore Bridge connecting Port Credit Memorial Park (West) and

Marina Park with concrete access ramps. This underpass would be similar to the existing underpass on the east side of the Credit River.

The “underpass” and “at grade” alternatives are preferred as they are relatively straight forward to construct. The underpass would require a moderate degree of maintenance and the existing utilities and a storm sewer outfall in the area that can be incorporated into the reconstruction. This alternative will also provide a moderate to high level of protection from wave, river and ice conditions, but would be prone to occasional flooding (similar to limitations of the underpass on the east side of the Lakeshore Road Bridge).

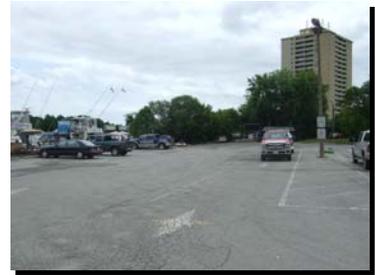
Do Nothing at North End and Flood Proof South End

This alternative leaves the current north end shoreline “as is”, but flood proofs and improves the shoreline at the south end by raising the backshore elevation of the existing topography and providing stone revetment and armour stone along the shore.

From a cost perspective the “do nothing at north end and flood proof south end” alternative is the most preferred as it has a moderate cost and will address the need for significant and ongoing maintenance costs to address the immediate failures of the south end shoreline infrastructure.

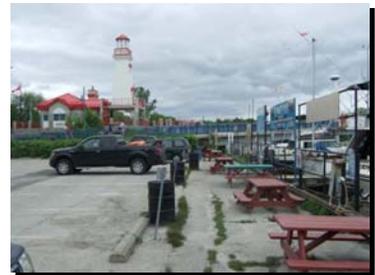
Flood Proof North and South Ends

This alternative involves flood proofing and improving the shoreline for both the north and south sections of Marina Park by raising the backshore elevation of the existing topography for both the north and south ends, reconstructing and repairing the existing steel sheet pile wall along the shoreline in the north section of the park, and providing stone revetment and armour stone along the south shoreline.

The greatest level of protection provided from wave, river and ice conditions in Marina Park comes from flood proofing and making shoreline improvements at both the north and south ends, moderate to high protection from addressing the south end and low to no protection from the “do nothing” alternative. The longest design life and lowest maintenance is achieved with flood proofing and shoreline improvements at both ends of Marina Park, and the “do nothing” and “do nothing at north end and flood proof south end” alternatives result in shorter design life and the likelihood of greater maintenance considerations. The existing south end shoreline structure is at the end of its life requiring significant improvements to provide the necessary shoreline protection.

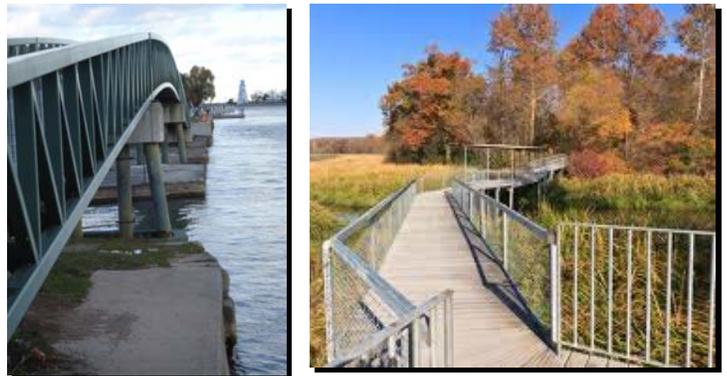
Shoreline Connection

The “shoreline connection” alternative involves creating a shoreline pedestrian connection between Marina Park and J.C. Saddington Park through the construction of an elevated fixed walkway.

The “do nothing” alternative does not need to be protected from wave, river and ice conditions as it is not located on the water, however the “shoreline connection” would be more susceptible to these conditions and would require appropriate design considerations to withstand these conditions. The design life of the “shoreline connection” is 25 to 50 years, but both alternatives require regular maintenance.

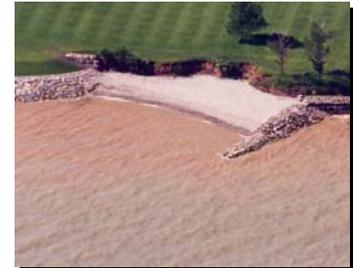
The “cobble beach” alternative involves the placement of cobble where suitable, and otherwise improving the existing conditions.

The “cobble beach” alternative encourages and provides a safer access to the water’s edge, whereas the “improve existing” alternative has limited change over current conditions.

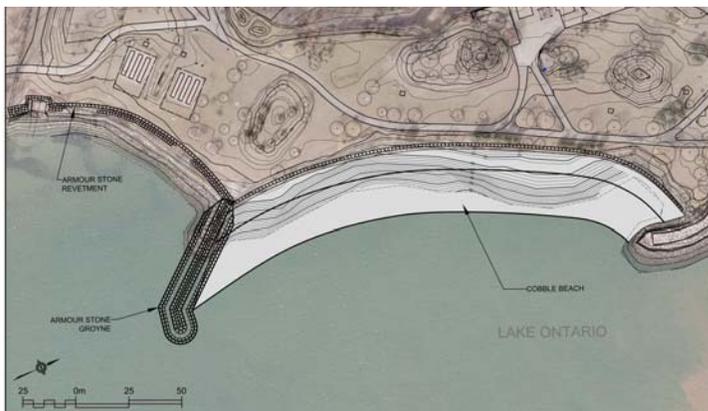
Figure A: Groyne Option for Cobble Beach, J.C. Saddington Park

A review of these stabilization options clearly identified that there were no advantages to a detached headland over groyne extension. A detached headland would need to be more than double the length of the groyne extension. It would also be built in deeper water and thus result in over double the cost of the groyne extension. From the perspective of natural environment, a detached headland has a greater impact due to its footprint. Overall, it was determined that the groyne option is the only reasonable design for anchoring the proposed cobble beach.

For this project it is suggested that the end of the groyne be angled to the south east more directly into the direction of the large easterly waves to minimize wave reflection into the beach. The proposed cobble beach requires a 40-metre long extension to the existing groyne (see **Figure A**)

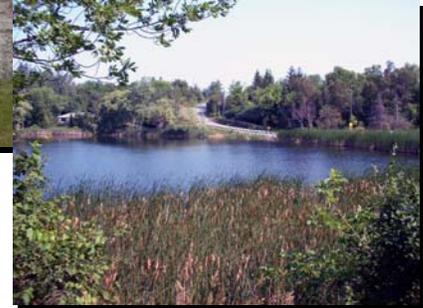
Coastal Wetland

This alternative involves the development of a coastal wetland that would also require wave protection through construction of a breakwater.
