Applewood Creek Channel Restoration – St. James Avenue to Lakeshore Road East

Detailed Design Brief

A design brief submitted by:
Aquafor Beech Ltd.

August, 2019

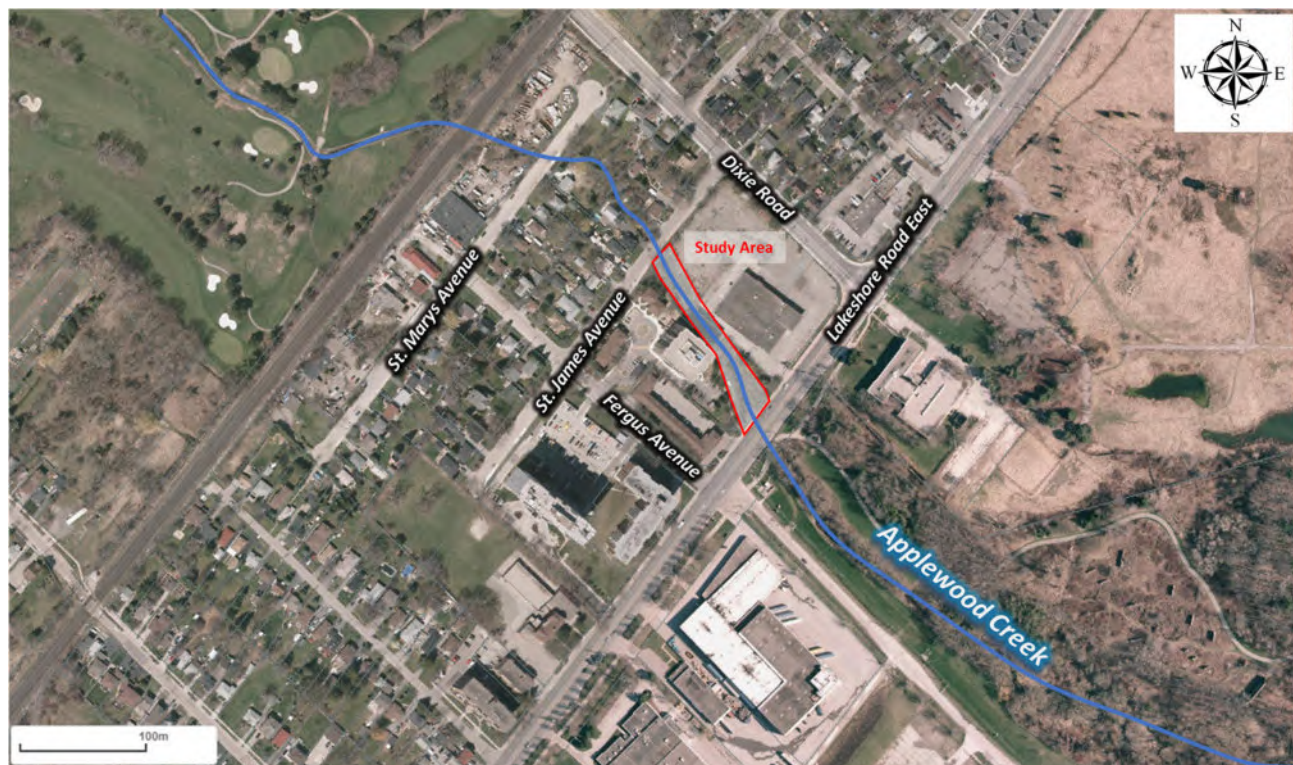
Figure 1-1. Applewood Creek Study Area – St. James Avenue to Lakeshore Road East

Aquafor Beech Limited (Aquafor), in cooperation with Cole Engineering providing Water Resources and Toronto Inspection providing geotechnical expertise, were retained to address the recent issues with regards to the Applewood Creek channel, extending from St. James Avenue to Lakeshore Road East, as illustrated in Figure 1-1.

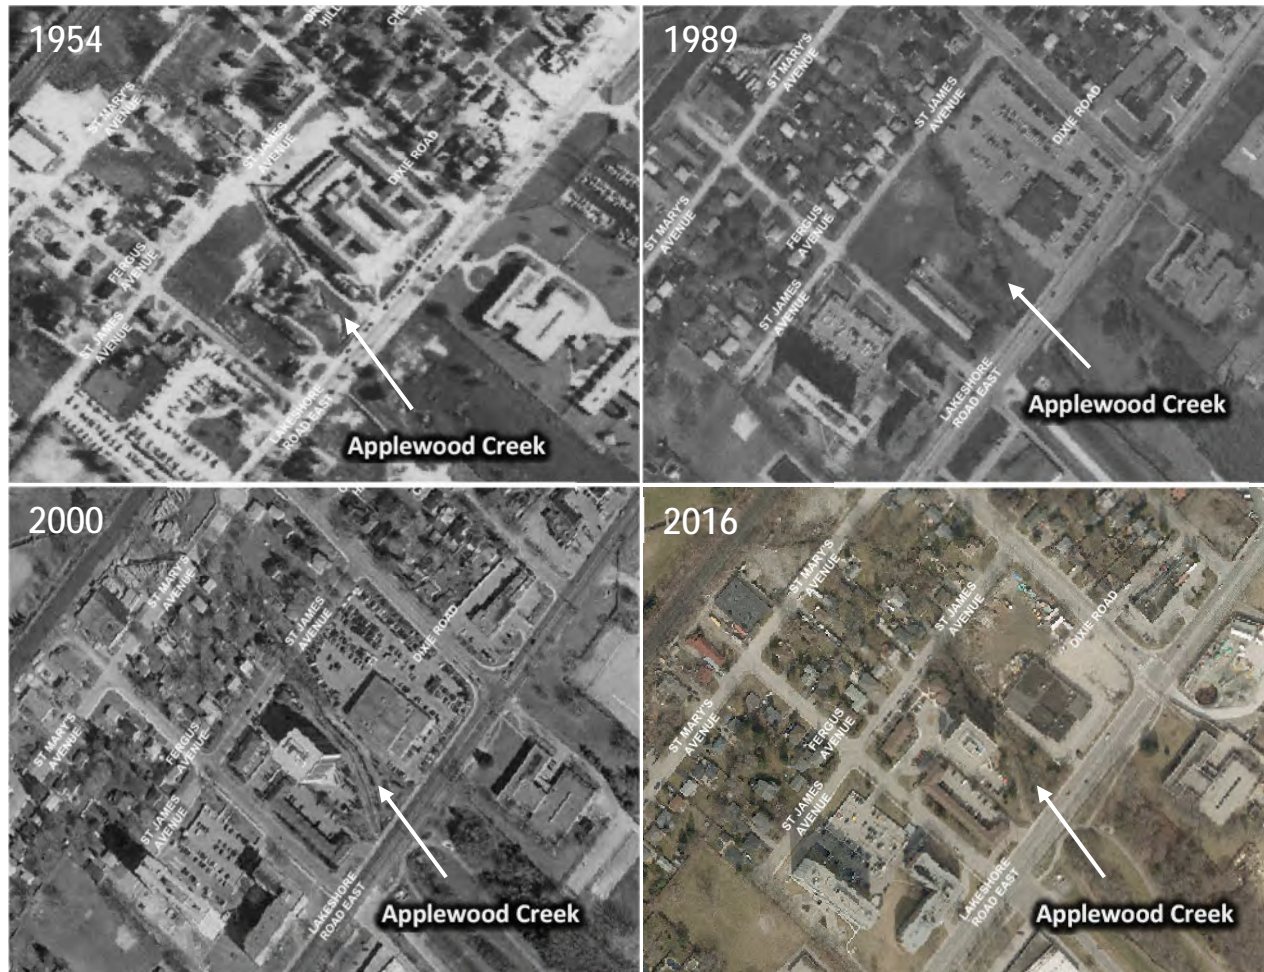
Figure 2-1. Historical Aerial Imagery of Applewood Creek from 1954 to 2016

A geomorphic investigation was completed to provide insight into the existing condition of Applewood Creek within the study area. An investigation into the historical changes in the creek corridor provides insight and understanding of the existing conditions. A series of historic aerial photographs from 1954 to 2016 were compared to provide perspective and context to the age of surrounding urbanization and channel adjustment. The aerial photographs were retrieved from the City of Mississauga's e-Maps, which is shown in Figure 2-1.

The photo comparison shows urban development over that period, resulting in Applewood Creek being channelized and hardened. Figure 2-1 suggest that channel upstream Lakeshore Road East which extends to St. James Avenue was straightened prior to 1954. The large building completely encapsulated with a crossing in the middle of the creek on the eastern side of the creek. The large building was removed in 1989 and the property adjacent to the east contained a completely impervious land parcel with abandoned building. The crossing may have been removed as seen in the aerial photo from 1954. The gabion baskets were placed in the upper portion of the channel between 1989 and 2000. The building on the Applewood Creek's eastern adjacent property may have been replaced or renovated as the size of the building appears larger than the aerial photograph of 1989. The planform is being developed with vegetation on the gabion lining along the banks of the creek in 2016. On the downstream of the study area, additional armourstone is installed.

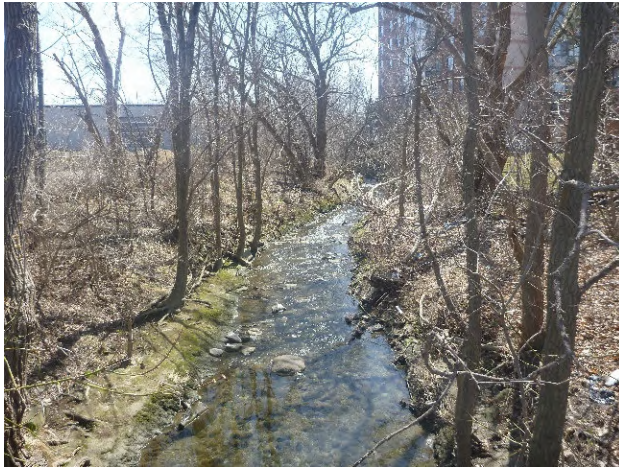
Figure 2-2. Looking downstream from the top of the culvert at Applewood Creek Crossing and St. James Avenue

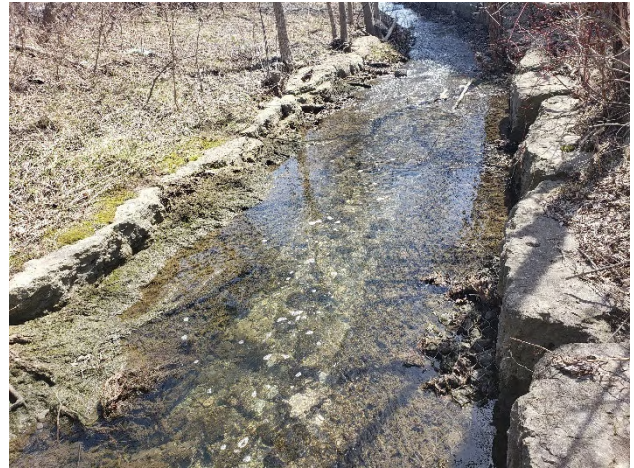
Figure 2-3. Looking downstream. Established willow roots on the side of the creek bed.

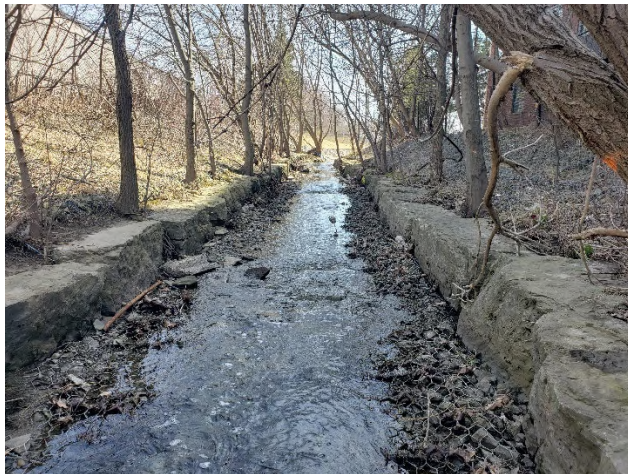
Figure 2-4. Looking downstream. Combination of armourstone banks and gabion bed

Manitoba maple (*Acer negundo*). Some of the dominant canopy species characteristic of Fresh-Moist Lowland Forest Ecosites (per Lee et al., 1998), such as willow (*Salix sp.*) and green ash (*Fraxinus pennsylvanica*), are present on occasion within the woodland, but are no means dominant. Tree cutting has thinned the canopy and, judging by the presence of spray-painted markings on many trees within the corridor, is likely to continue; further reducing canopy coverage. Furthermore, another deviation from the NAS description above is that within the creek corridor between St. James Avenue and Lakeshore Road East, the ground layer vegetation covers between approximately 25-60%. The relative lack of ground vegetation is likely due to the presence of unauthorized trails near St. James Avenue and the fact that most of the valley walls with the creek corridor consist of gabion baskets (see Figure 2-4). South of Lakeshore Road East, the ground layer vegetation coverage is as described in the NAS.

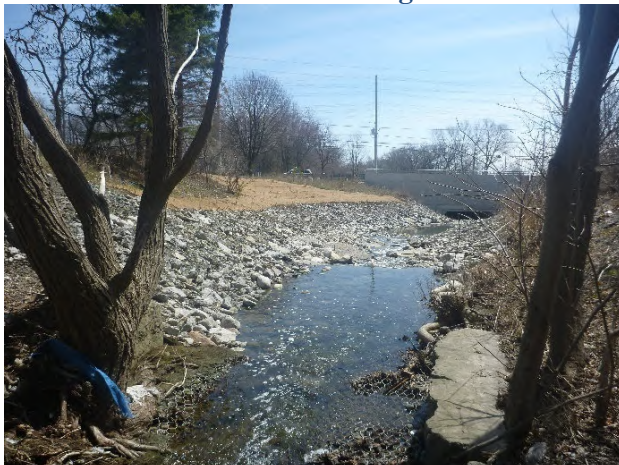
Figure 2-6. Looking downstream from the end of proposed channel restoration

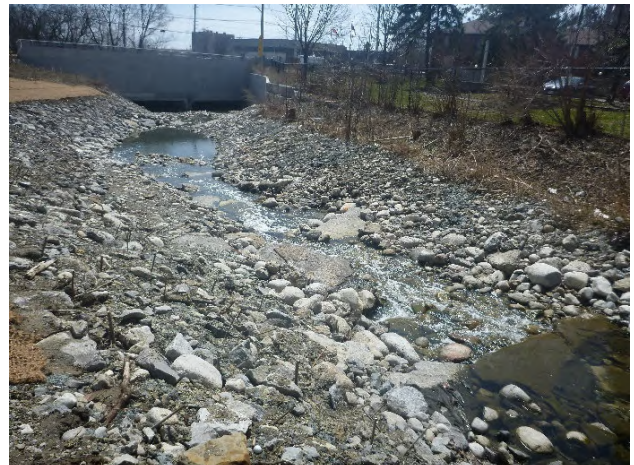
Figure 2-7. Downstream of the study area with a riffle-pool sequence

Applewood Creek conveys flows through the easterly edge of Mississauga, draining an area of approximately 600 hectares composed of residential, commercial, and industrial land use. The watercourse extends for nearly 3 kilometers, draining to Lake Ontario. Loose bed material composed of gabion stone and sediment accumulations. Figure 2-2 through Figure 2-7 provides a site inventory as a photographic illustration of the study area and downstream of the study area. The creek bed and the banks were hardened starting at the culvert crossing of Applewood Creek and St. James Avenue (Figure 2-2) to 72 meters downstream with a gabion basket structure (Figure 2-6). The established willow roots provide grade control in the banks (Figure 2-3). The channel is engineered with a combination of gabion baskets and armourstone lining the bed and banks (Figure 2-4). The meandering planform with engineered riffle-pool sequence follows the rest of the creek (Figure 2-7).

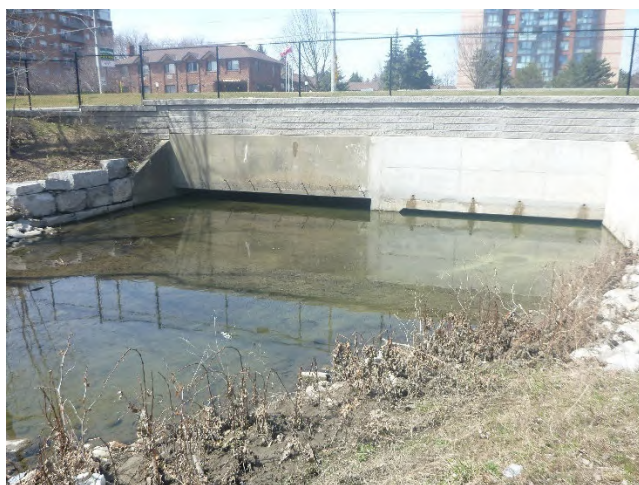
Figure 2-8. Looking upstream towards Applewood Creek and Lakeshore Road East. Aggraded sediment on the downstream of culvert openings

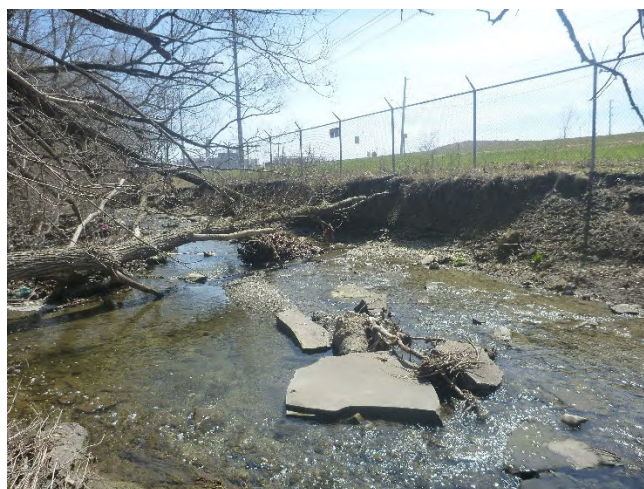
Figure 2-9. Downstream extent of Applewood Creek (south of Lakeshore Road East). Active bank slumping along the fence of Lakeview Wastewater Treatment Plant

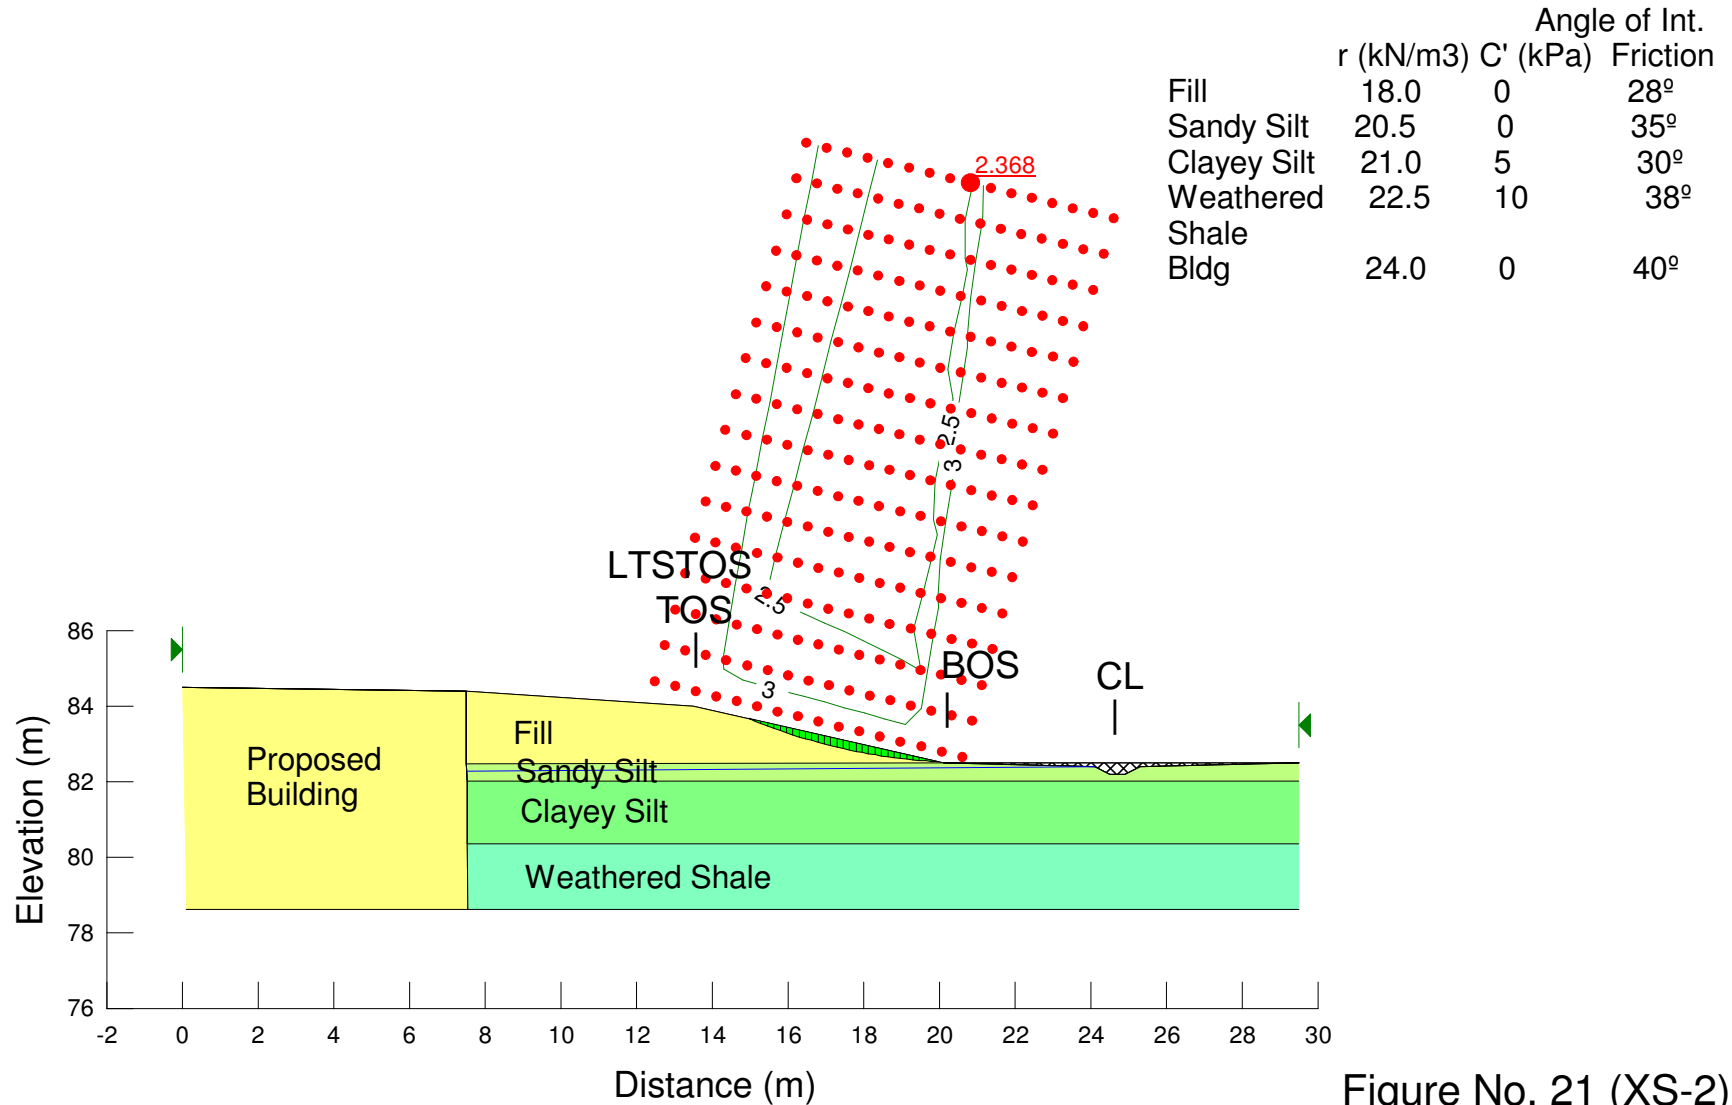
Figure No. 21 (XS-2)

Description: Slope Stability Study 4738-17-G-VAN-A
 Comments: Regional WSE 84.20m
 File Name: 4738 - 1345 Lakeshore Rd E-XS-2(11047).slr
 Analysis Method: Bishop
 Direction of Slip Movement: Left to Right
 Slip Surface Option: Grid and Radius

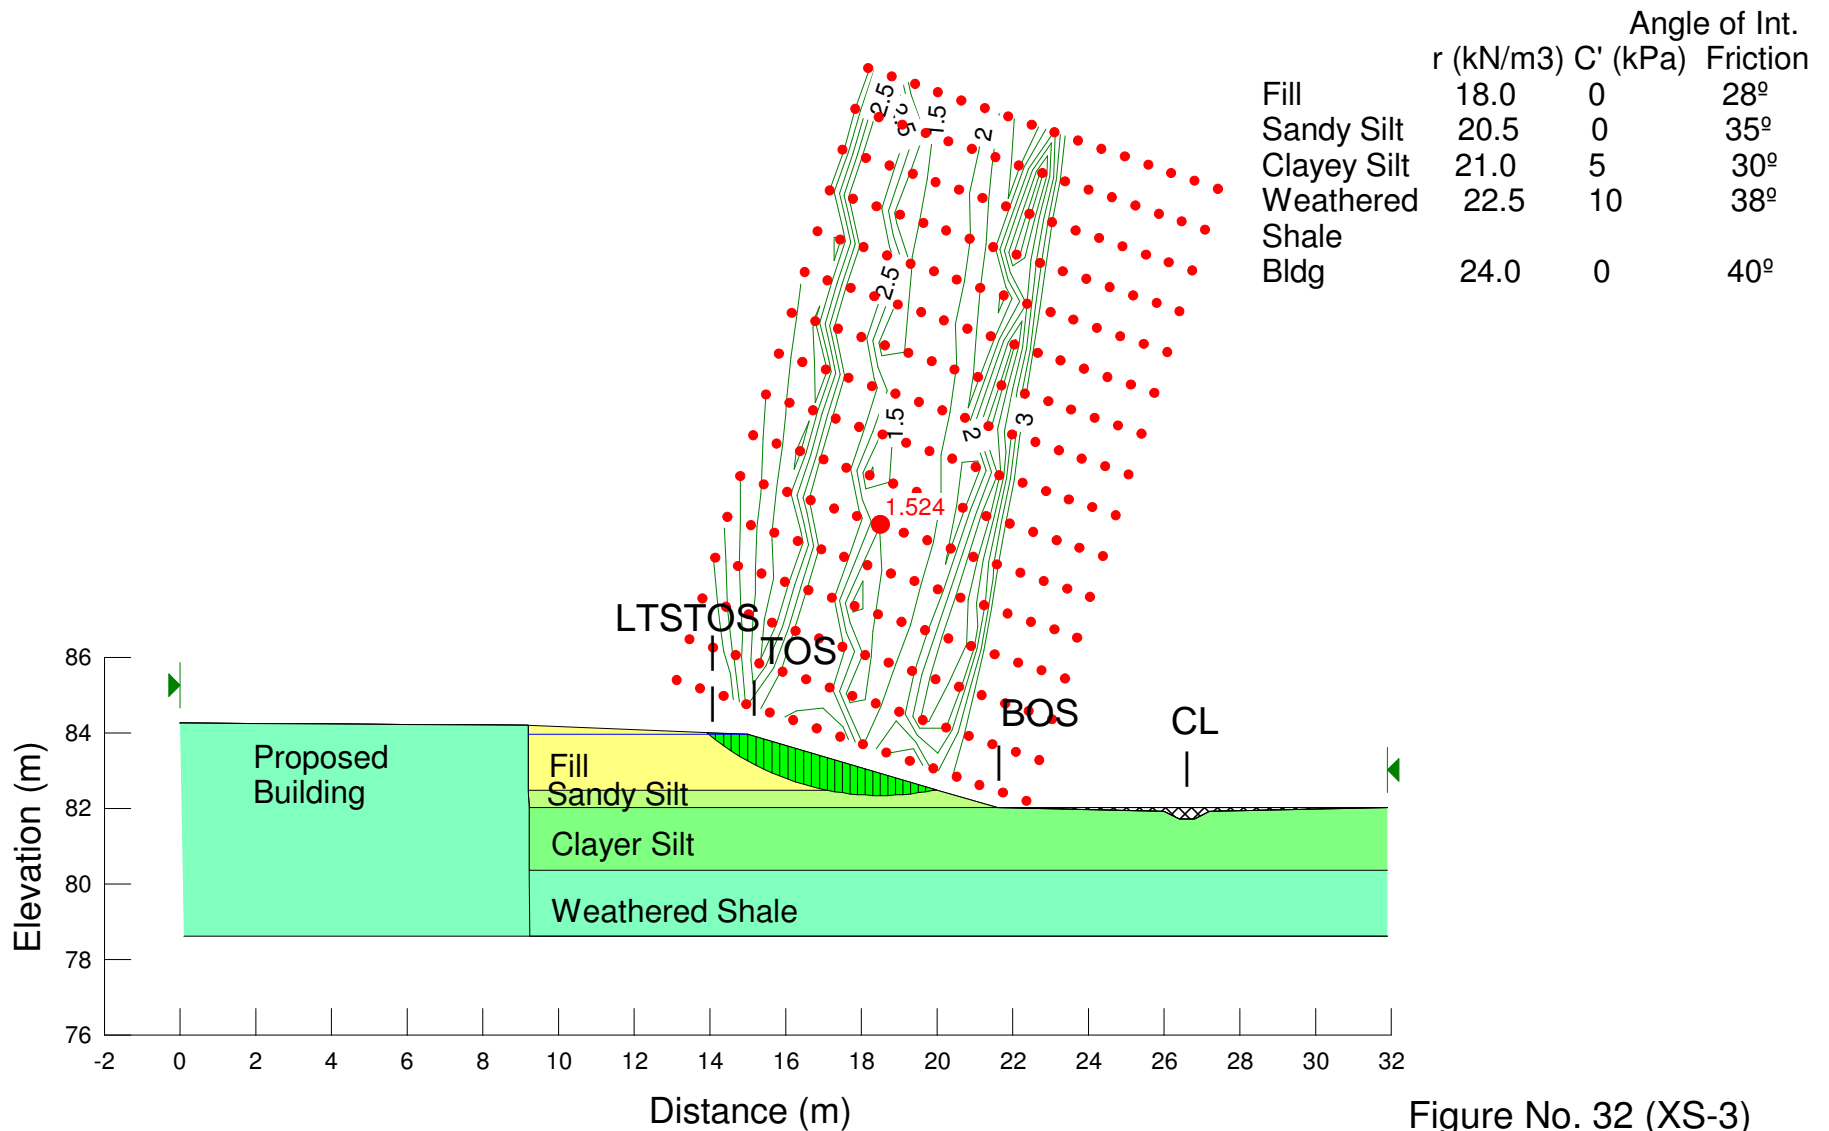
Description: Slope Stability Study 4738-17-G-VAN-A
 Comments: Regional WSE 84.20m
 File Name: 4738 - 1345 Lakeshore Rd E-XS-3(11015).slp
 Analysis Method: Bishop
 Direction of Slip Movement: Left to Right
 Slip Surface Option: Grid and Radius

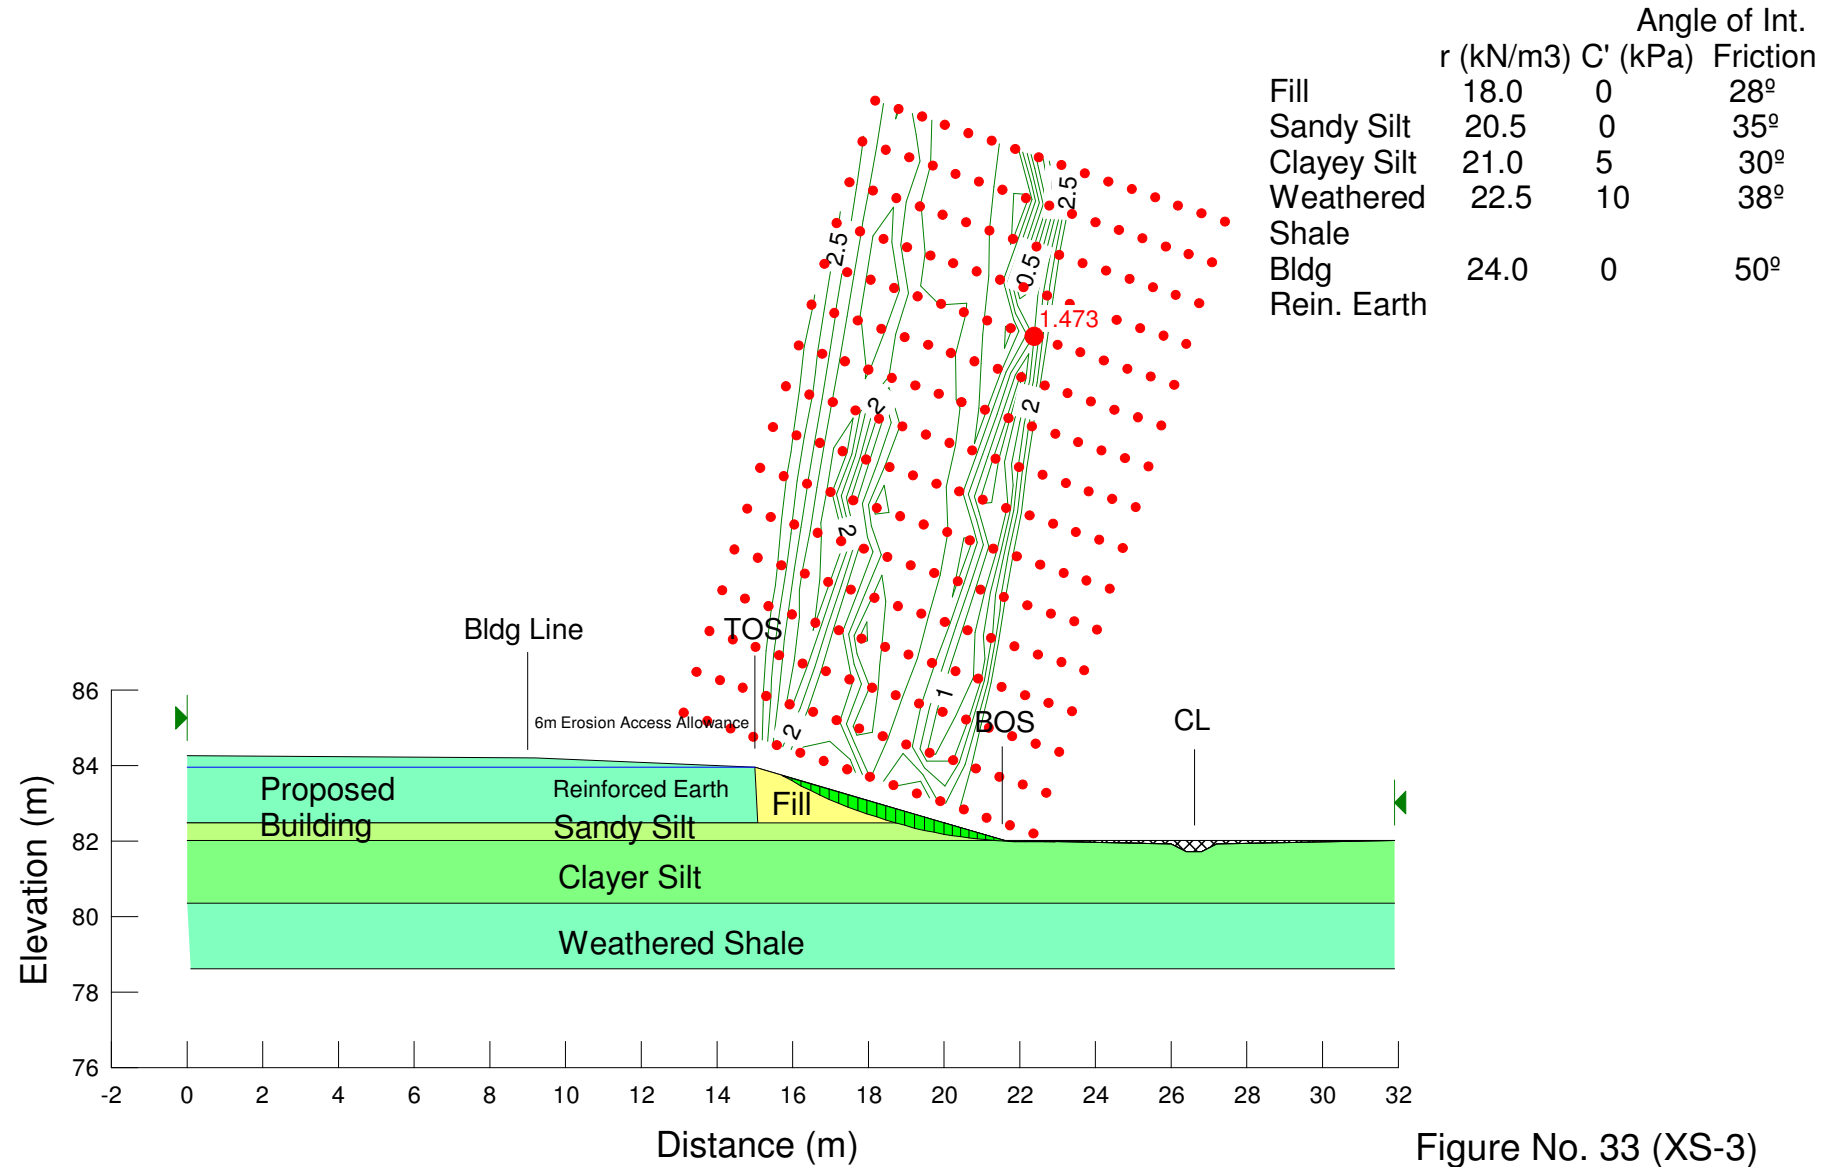
Figure No. 33 (XS-3)

Description: Slope Stability Study 4738-17-G-VAN-A
Comments: Regional WSE 84.00m
File Name: 4738 - 1345 Lakeshore Rd E-XS-3(11015).slp
Analysis Method: Bishop
Direction of Slip Movement: Left to Right
Slip Surface Option: Grid and Radius

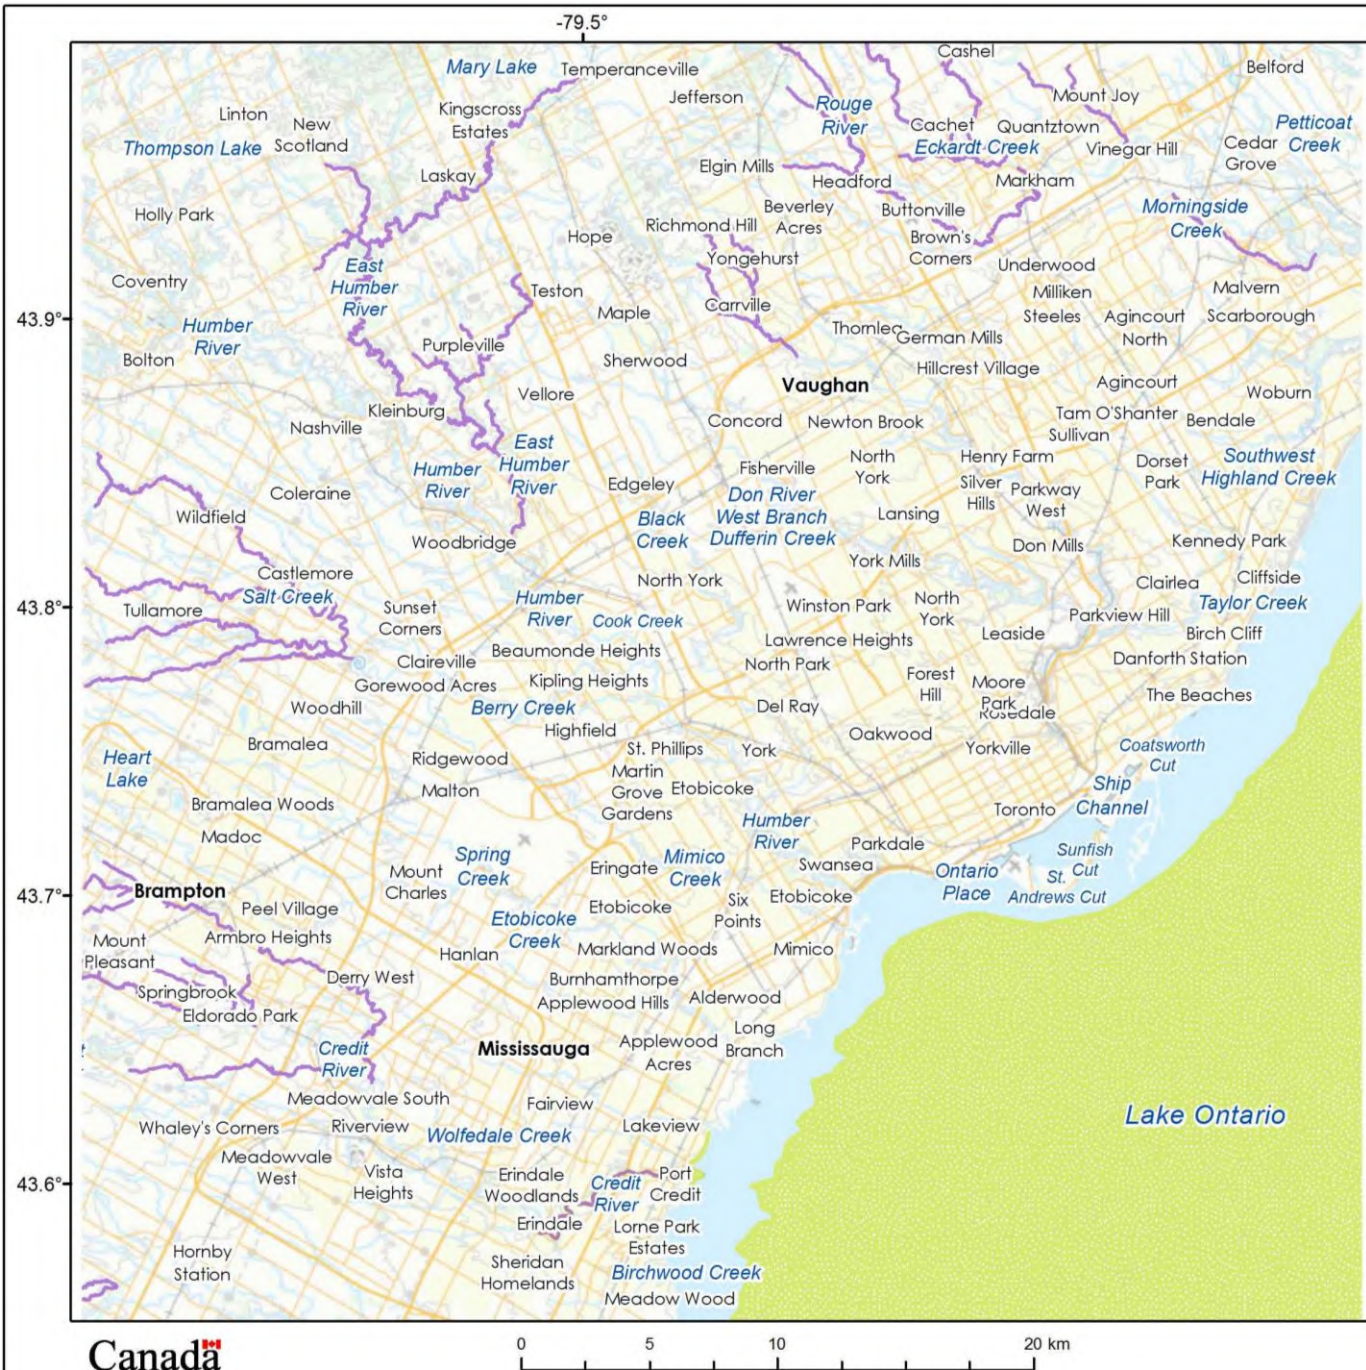
Map 11 of 34

Area within which Critical Habitat is found for one or more aquatic species listed under SARA as:

Area within which one or more species listed under SARA may be found:
