Project Name:
1315 Silver Spear Road
 Starlight Investments
 City of Mississauga

Sheet Title:
Tree Protection Plan

Designed: GM	Drawn: DI	Scale: 1:250	Drawing No.: TP-1
Date of Drawing: August 2017	Job No.: SIS001

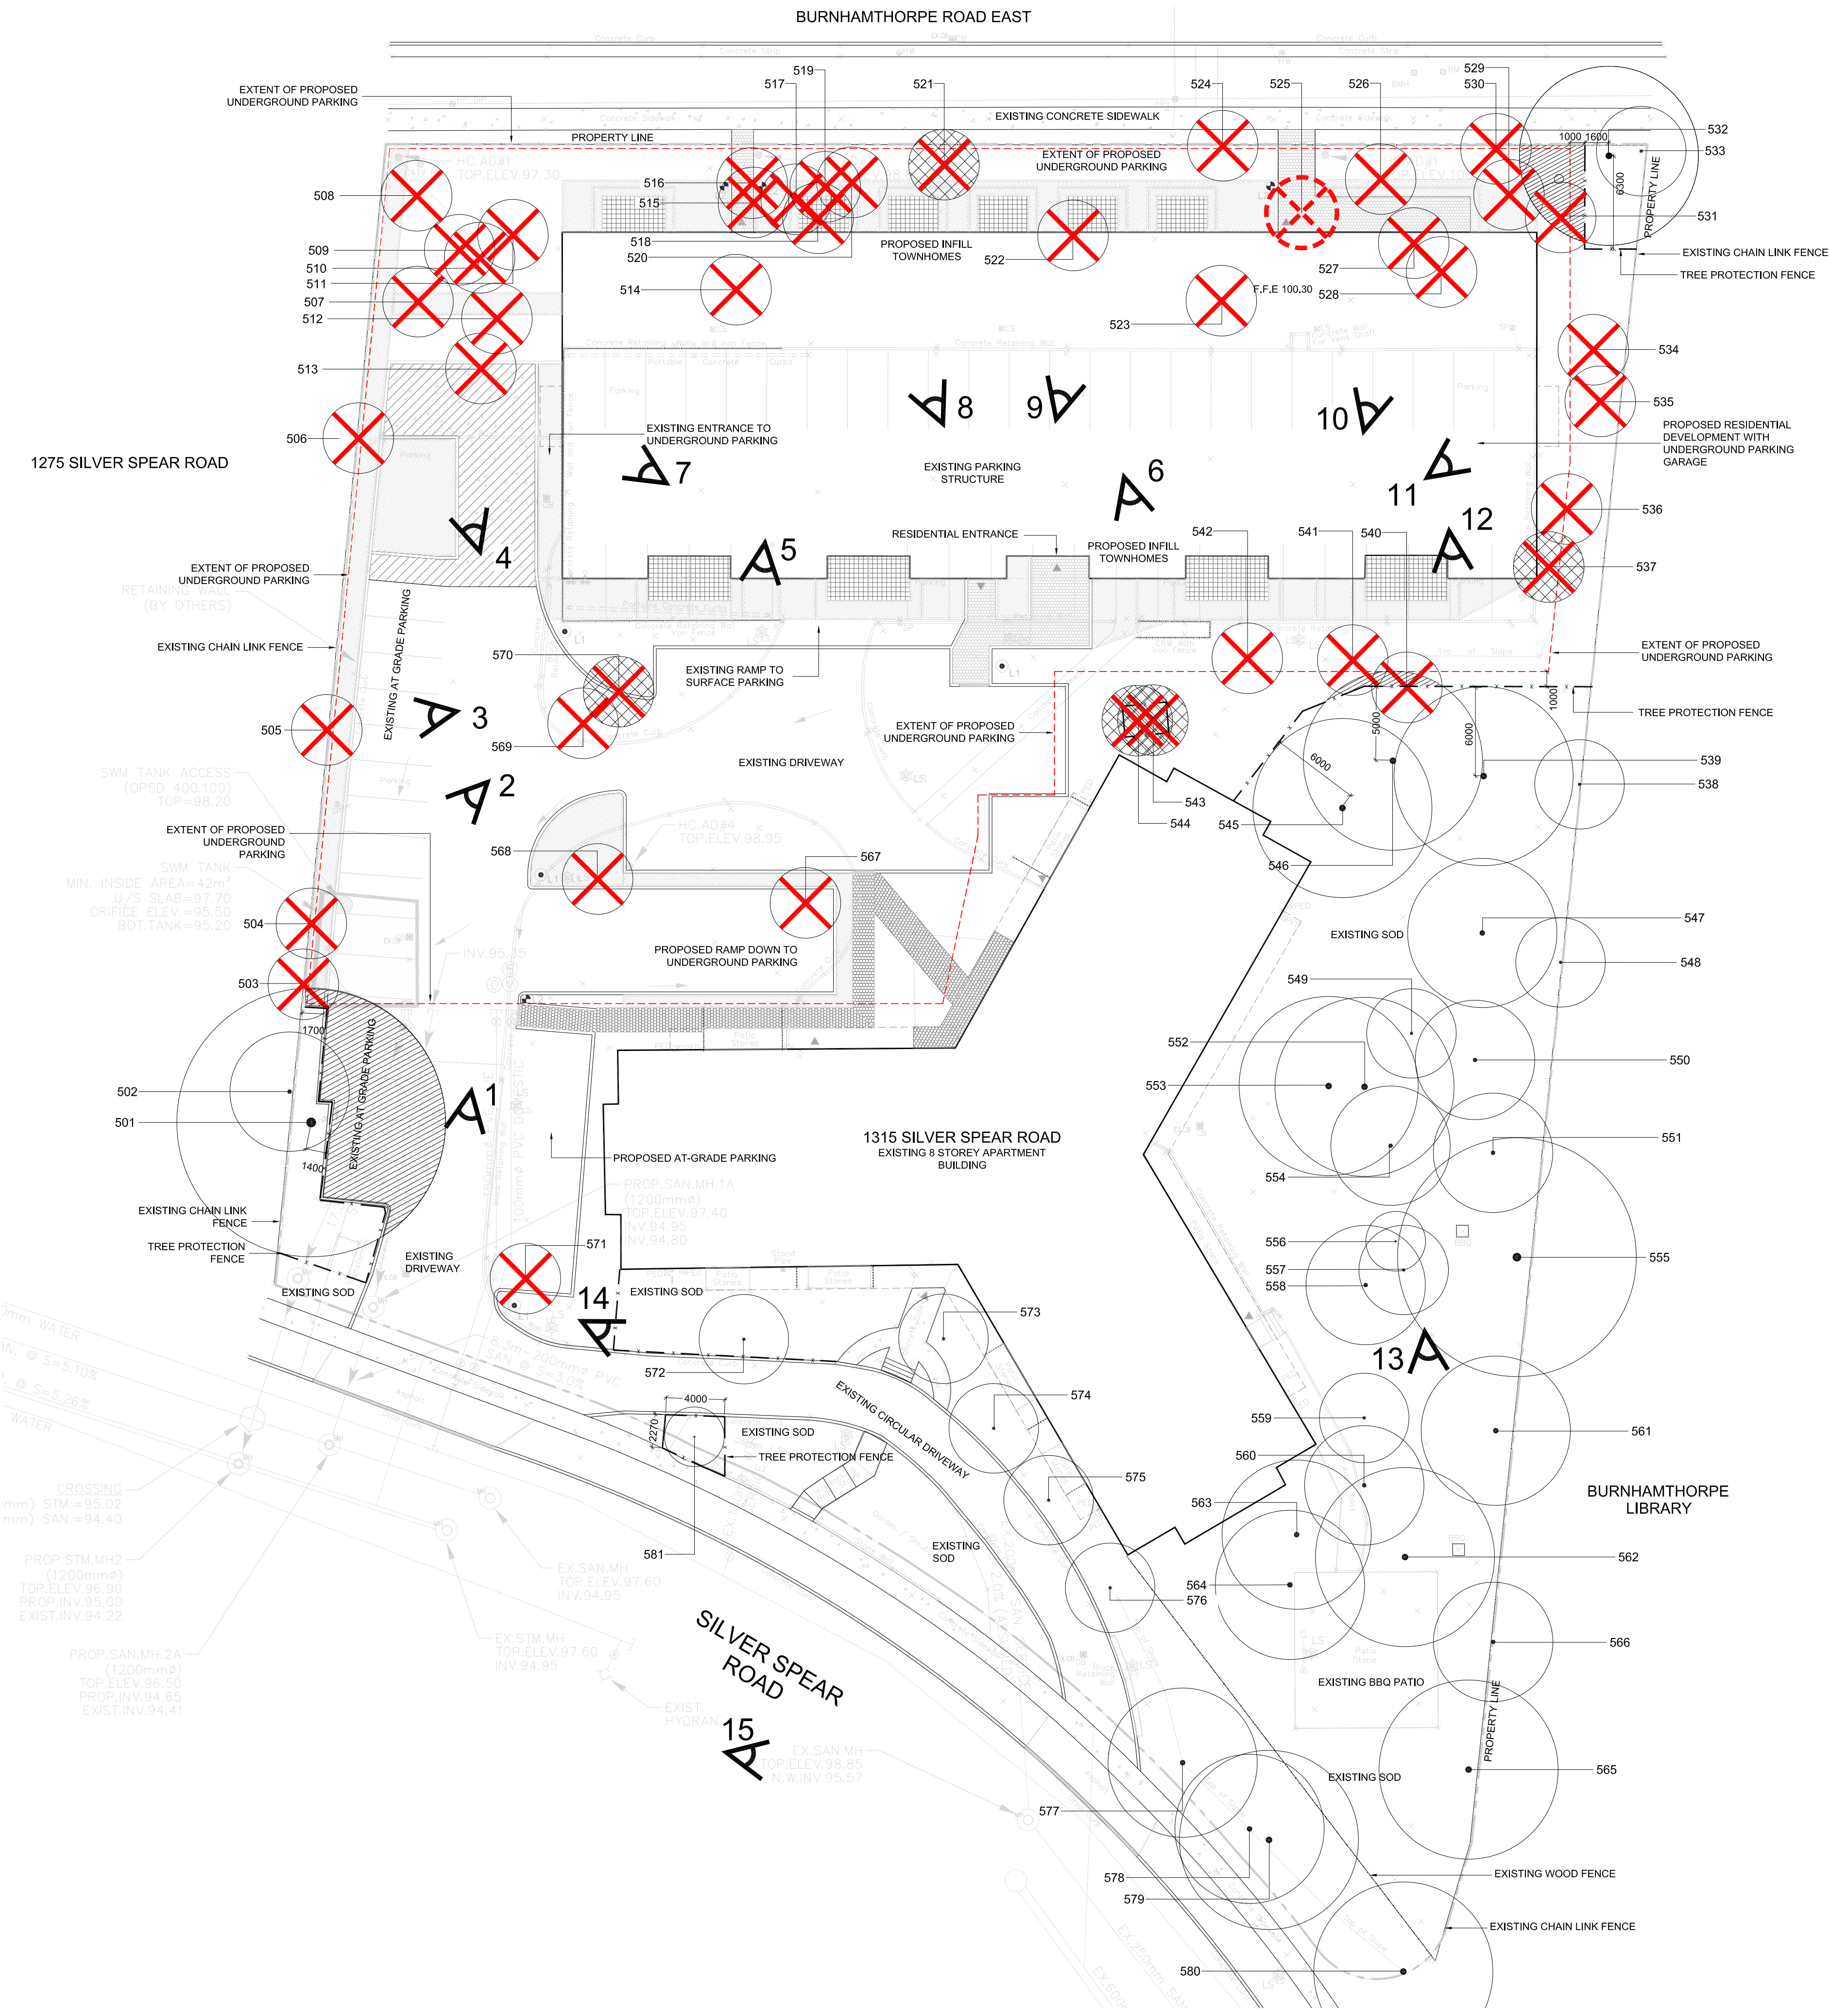
1 TREE PROTECTION PLAN

Regarding the Tree Preservation Plan: The trees reflected in this plan are the result of an inspection as noted on the Arborist Report. The location of tree numbers 504, 506, 524, and 566 are approximate and those locations were not provided in the property survey.
