Project No. 18-519-10

## Geotechnical Suitability of Soil/ground water Proposed Lakeview Development 800 Hydro Road, Mississauga, ON

DS Consultants Ltd. carried out a geotechnical investigation at the subject site in July 2018 (Project No. 18-519-100, report dated December 4, 2019) and drilled forty-five (45) boreholes to depths varying from 1.7 m to 48.3m below the existing grade.

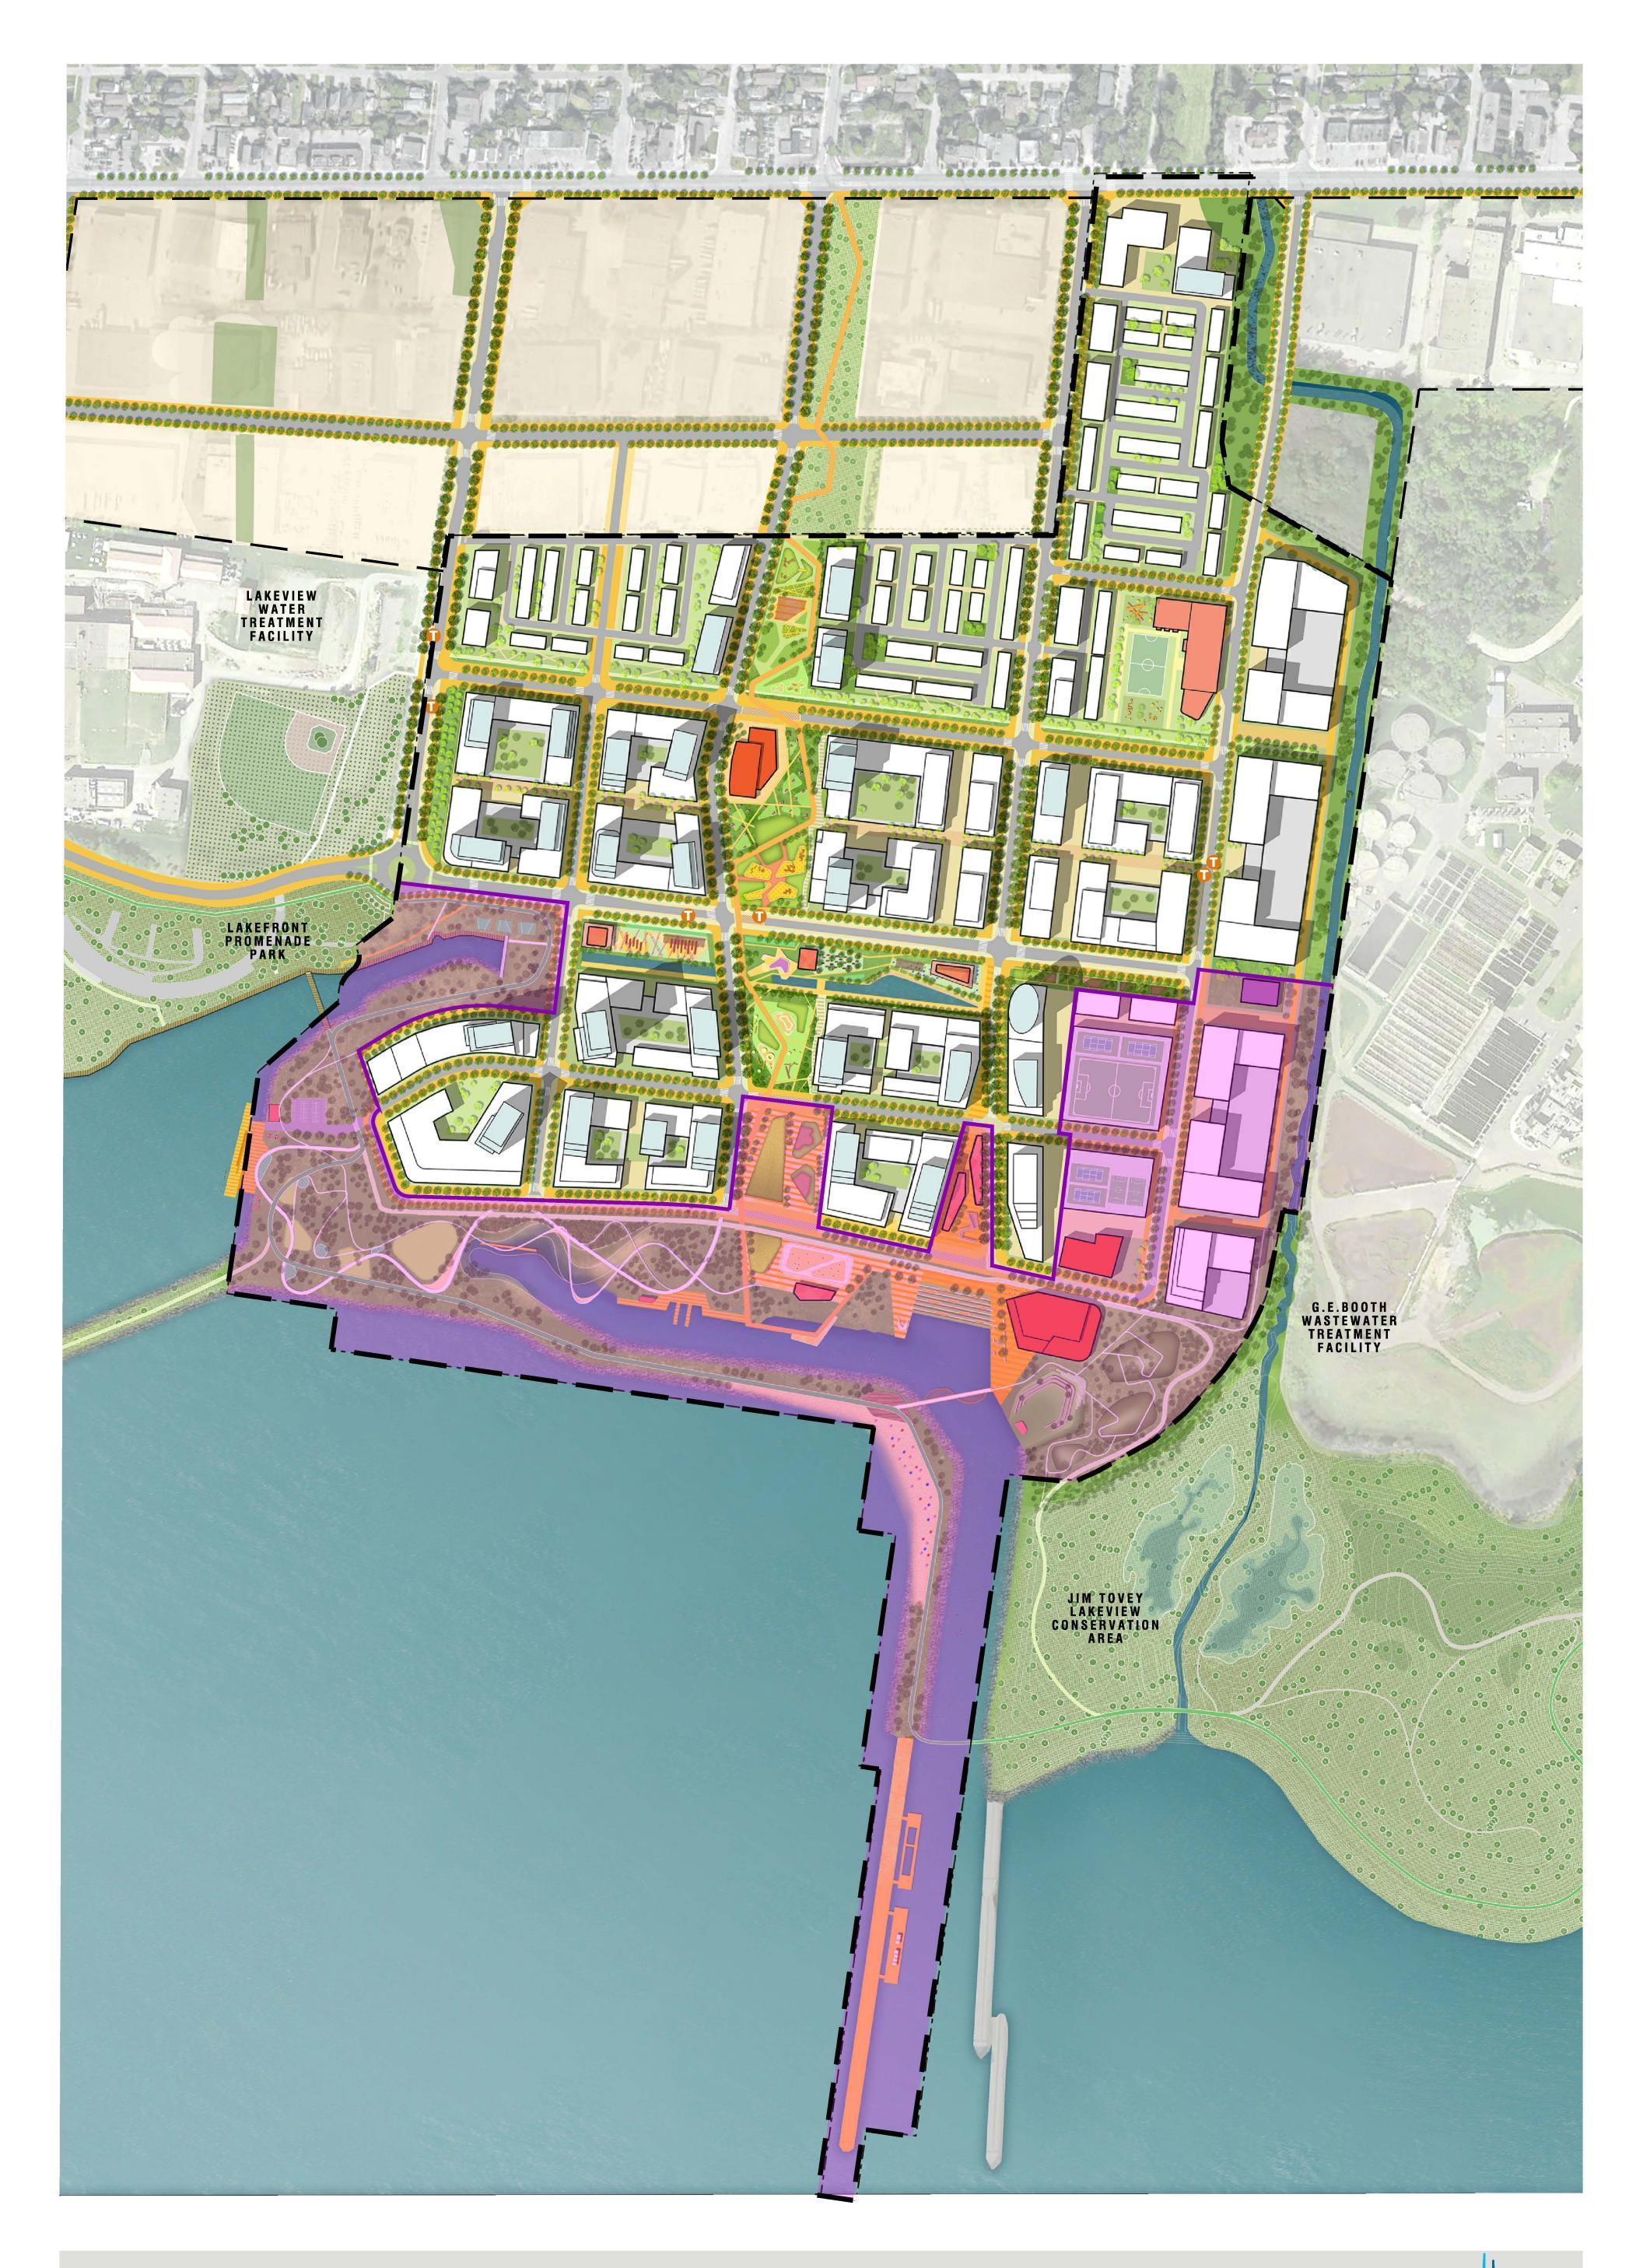
Borehole Location Plan & Borehole Logs

It is understood that there will be a land conveyance to the City, as shown on the attached drawing. Eleven (11) boreholes (BH18-19, BH18-25, and BH18-29 to BH18-37) were drilled within the boundary of the land conveyance. Borehole logs and location plan are attached in Appendix A of this letter.

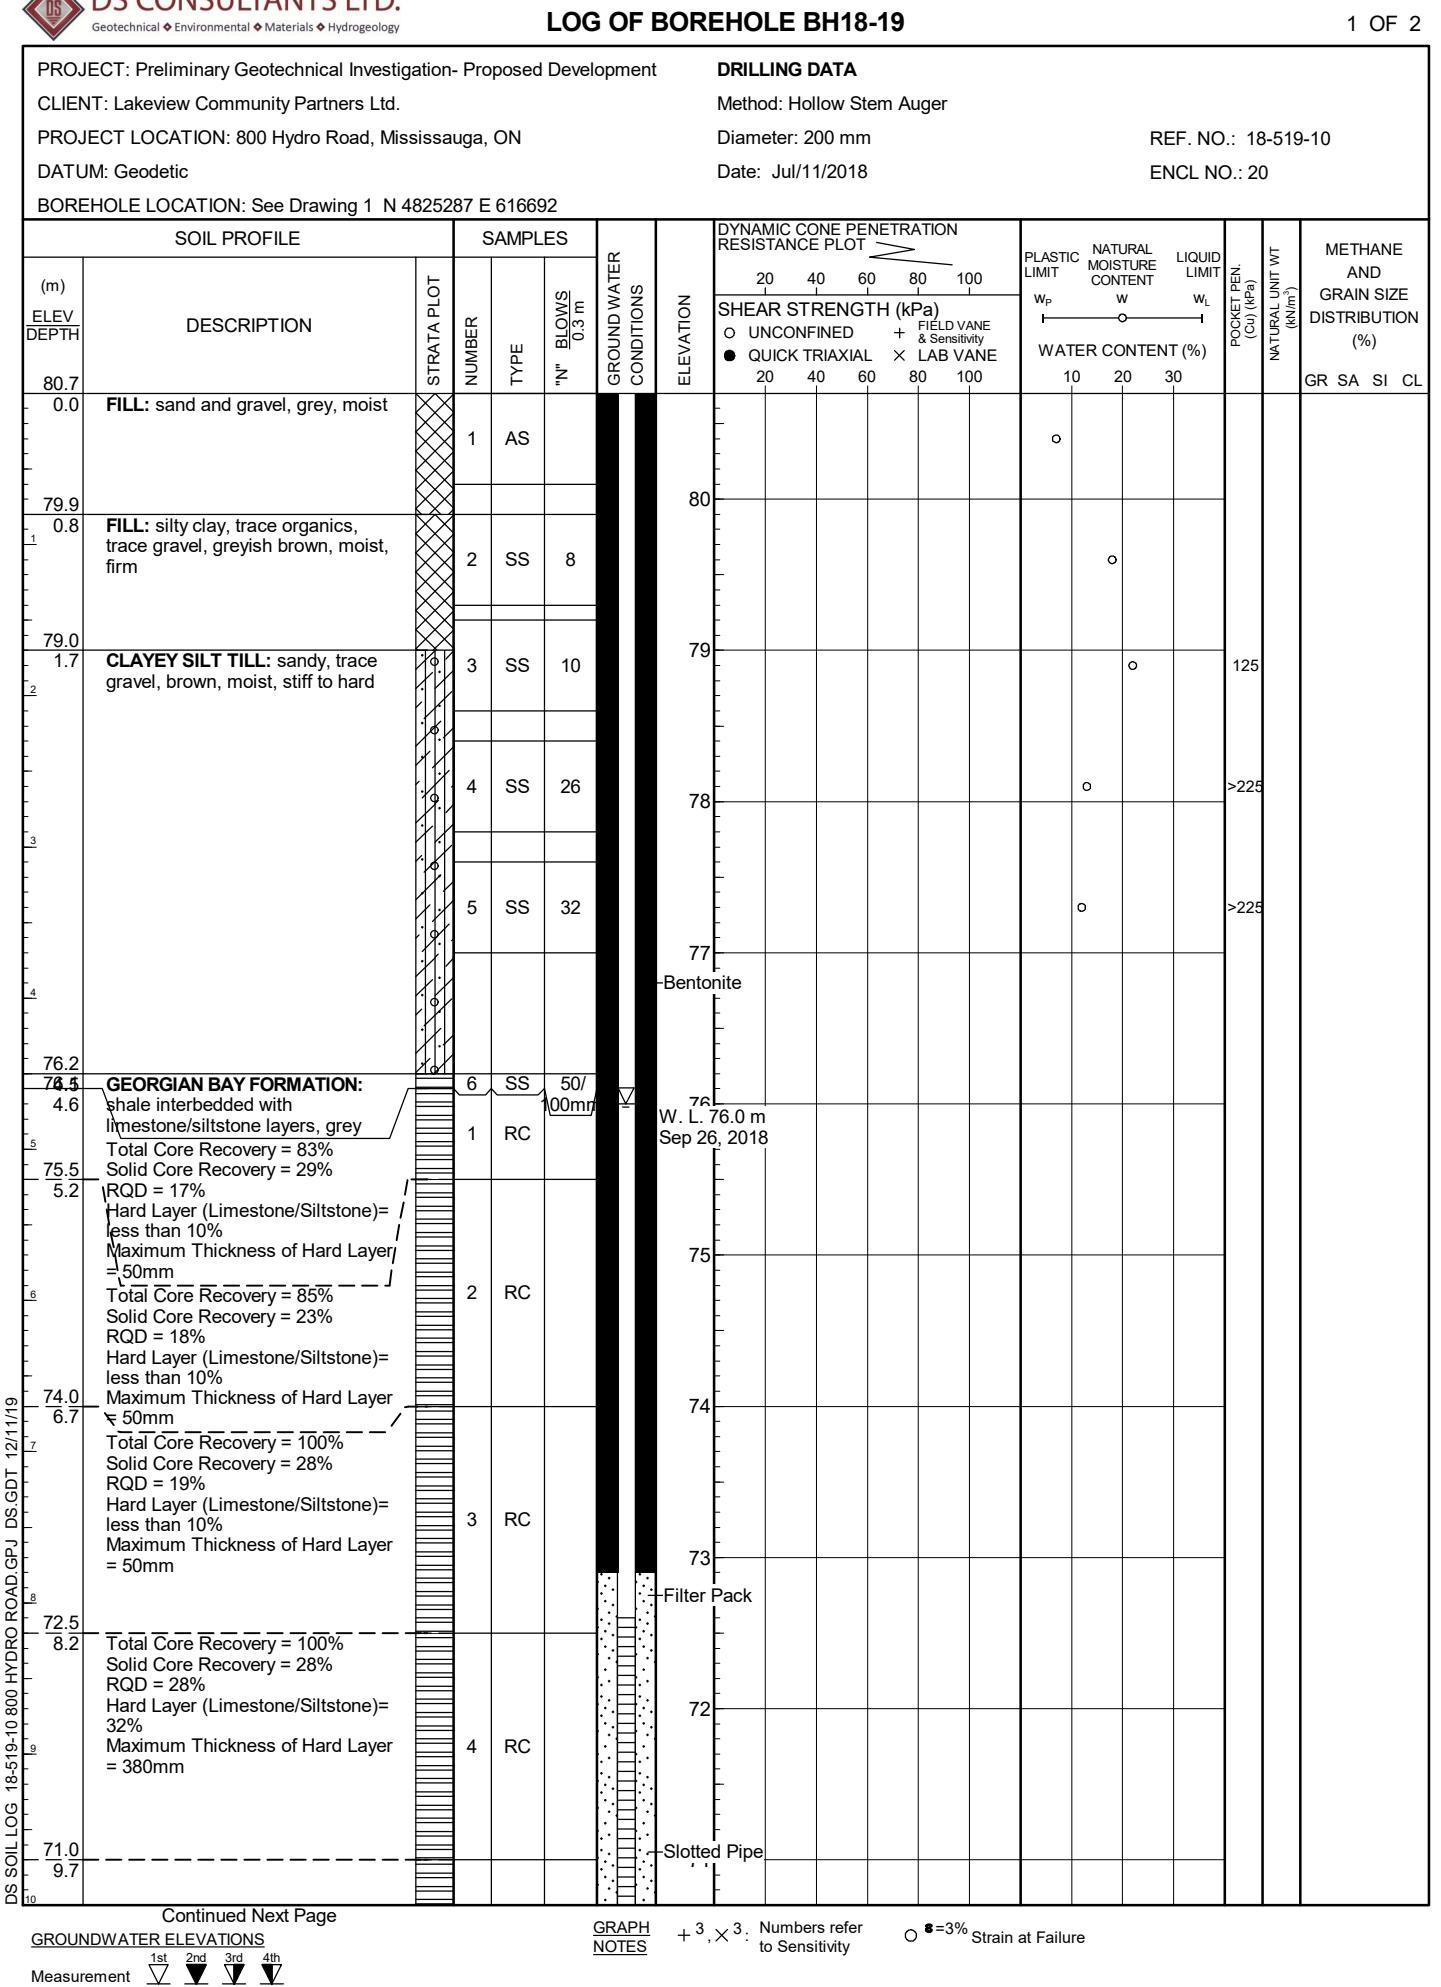
## LOG OF BOREHOLE BH18-19

- - - - 11 - - - - - - - - - - - - - -	Total Core Recovery = 100% Solid Core Recovery = 40% RQD = 30% Hard Layer (Limestone/Siltstone)= 15% Maximum Thickness of Hard Layer = 125mm(Continued)		5	RC			70														
DS SOIL LOG 18-519-10 800 HYDRO ROAD.GPJ DS.GDT 12/11/19	END OF BOREHOLE: Notes: 1) Monitoring well was installed in the borehole upon completion. 2) Water level in the monitoring well at 4.7m on Sept. 26, 2018.

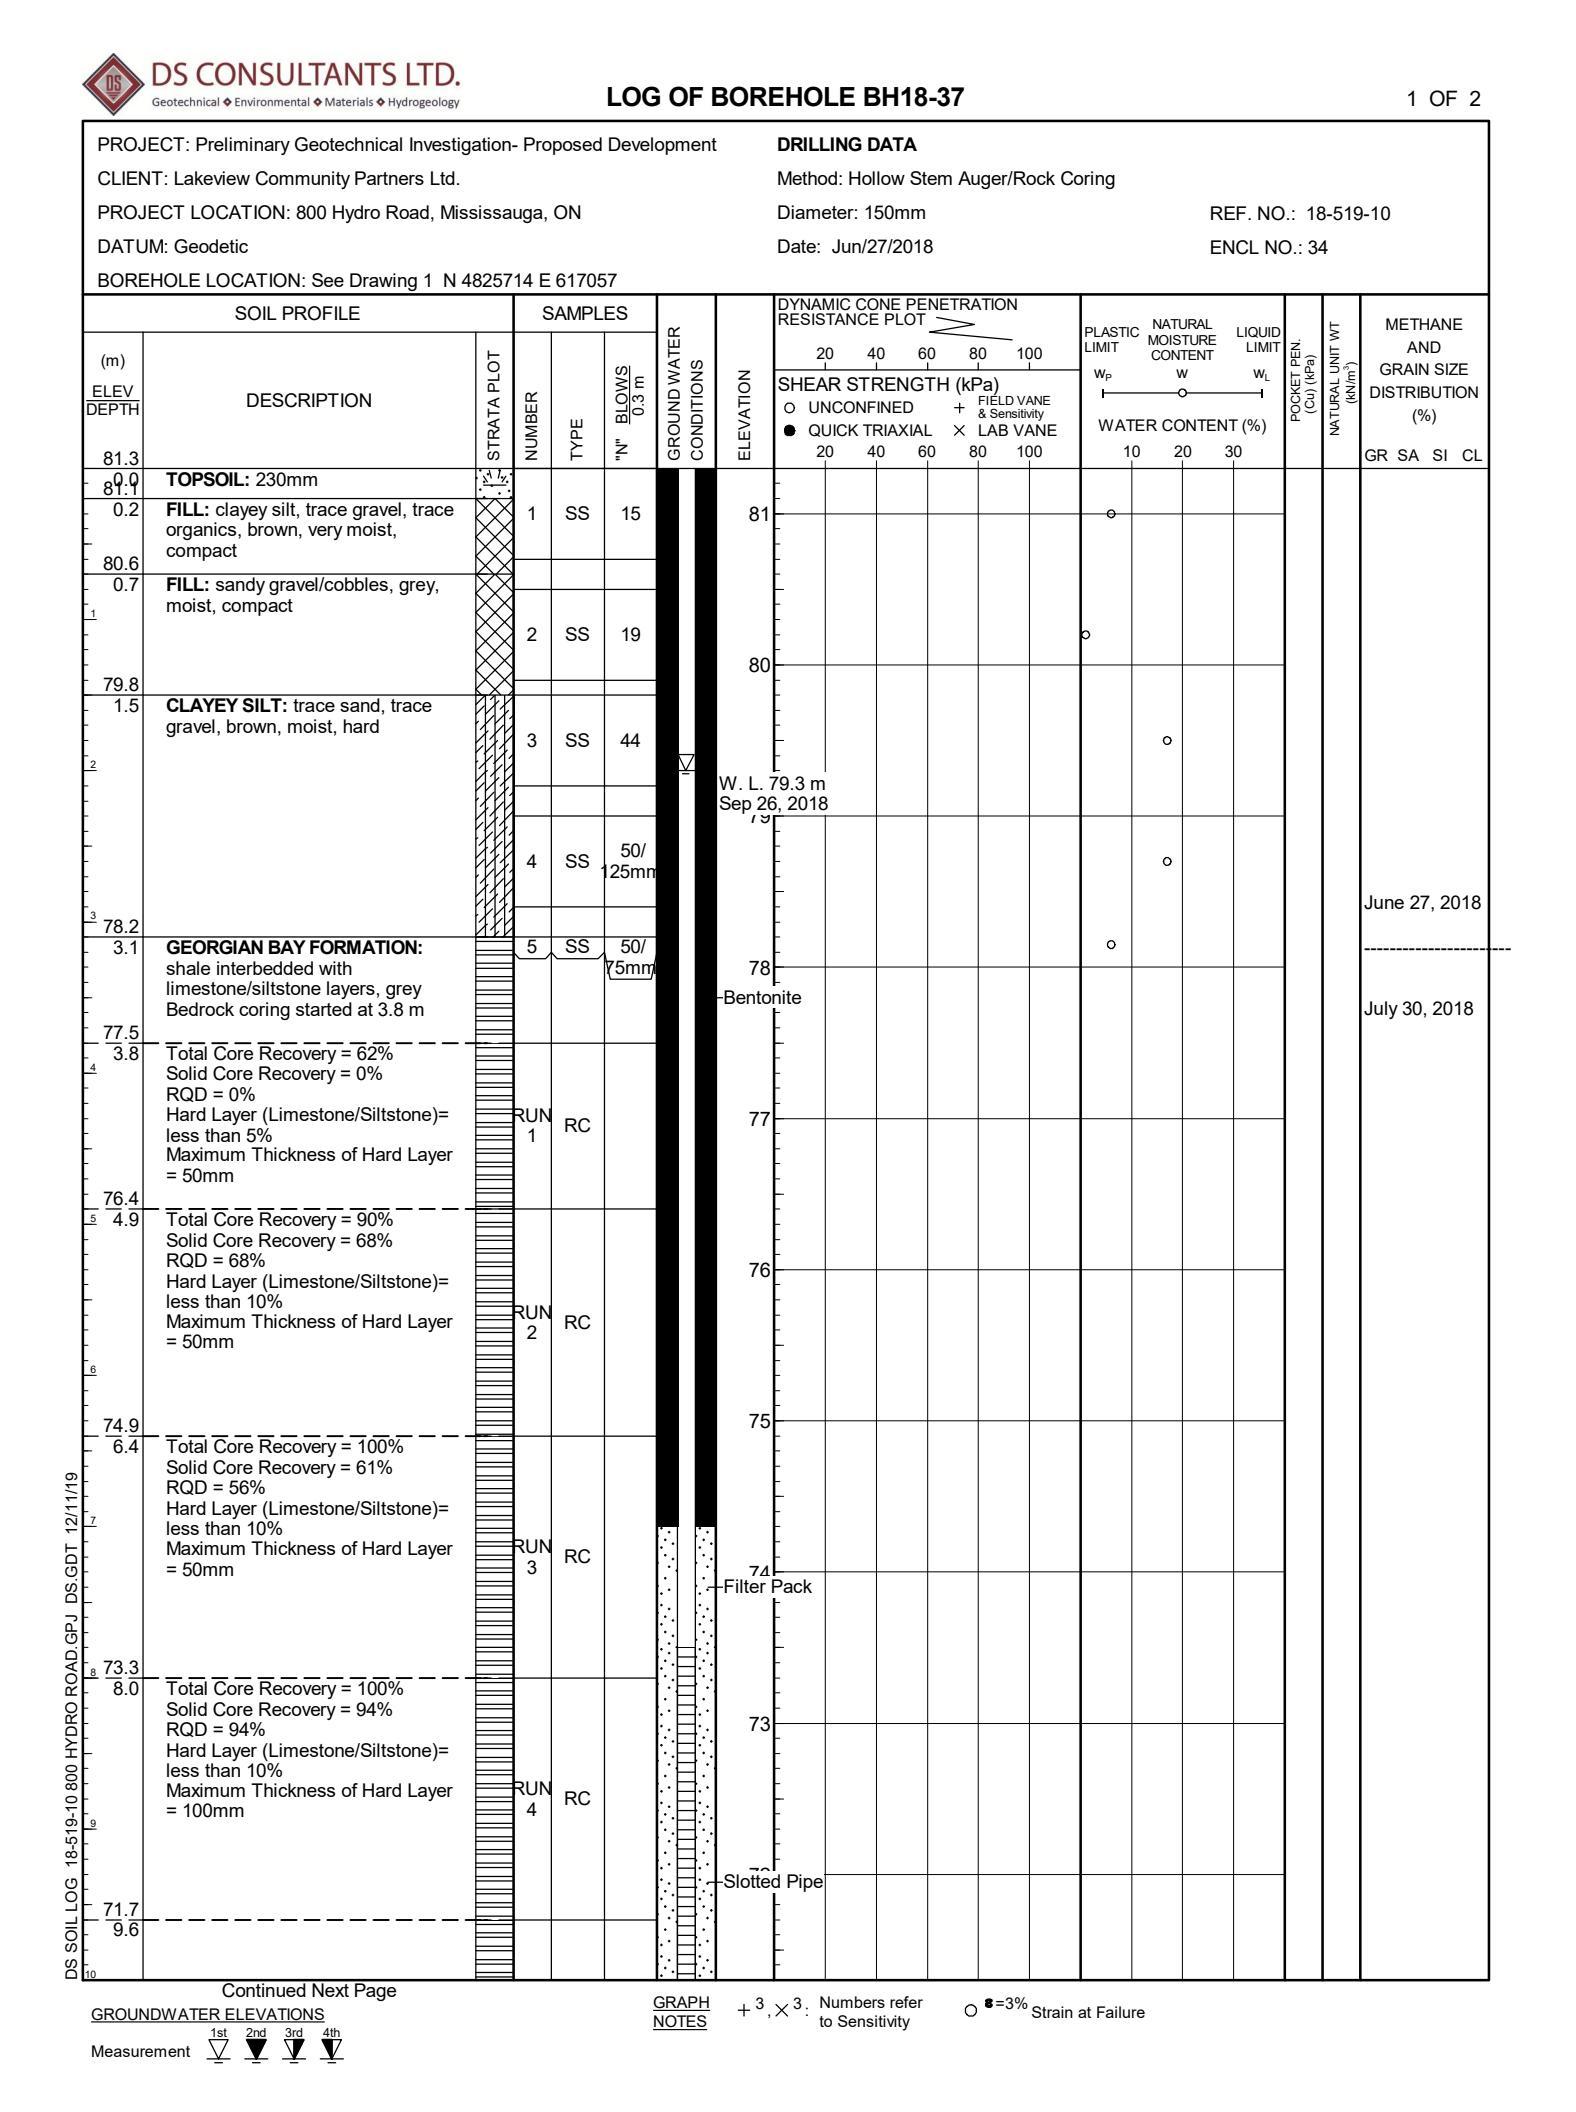
## LOG OF BOREHOLE BH18-37

SOIL PROFILE		S	AMPL	ES	ſſ		DYNA RESIS	MIC CO TANCE	NE PE PLOT		ATION		PI ASTI	C NAT	URAL			Ļ	METHANE
(m) <u>ELEV</u> DEPTH	DESCRIPTION	STRATA PLOT	NUMBER	ТҮРЕ	"N" <u>BLOWS</u>	GROUND WATEI CONDITIONS	ELEVATION	2 SHEA 0 UI • QI 2	0 4 NR STI NCONF JICK TI 0 4	0 6 RENG INED RIAXIAL 0 6	0 8 TH (kF + - × 0 8	Pa) FIELD V. & Sensiti LAB V.	ANE vity ANE 00	UMIT WP WAT		STURE ITENT w o ONTEN 20 3	LIMIT WL T (%)	POCKET PEN. (Cu) (kPa)	NATURAL UNIT V (kN/m <sup>3</sup> )	AND GRAIN SIZE DISTRIBUTION (%) GR SA SI CL
	Total Core Recovery = 100% Solid Core Recovery = 88% RQD = 88% Hard Layer (Limestone/Siltstone)= less than 10% Maximum Thickness of Hard Layer = 100mm(Continued)		RUN 5	RC			71	- - - - -										-		
10.9	END OF BOREHOLE Notes: 1) Monitoring well was installed in the borehole upon completion. 2) Water level in the monitoring well at 2.0m on Sept. 26, 2018.
