Phase Two Environmental Site Assessment

Commercial/Light Industrial Property 51, 57 Tannery Street, and 208 Emby Drive Mississauga, Ontario L5M 1H6

OHE Project No.: 21170-001

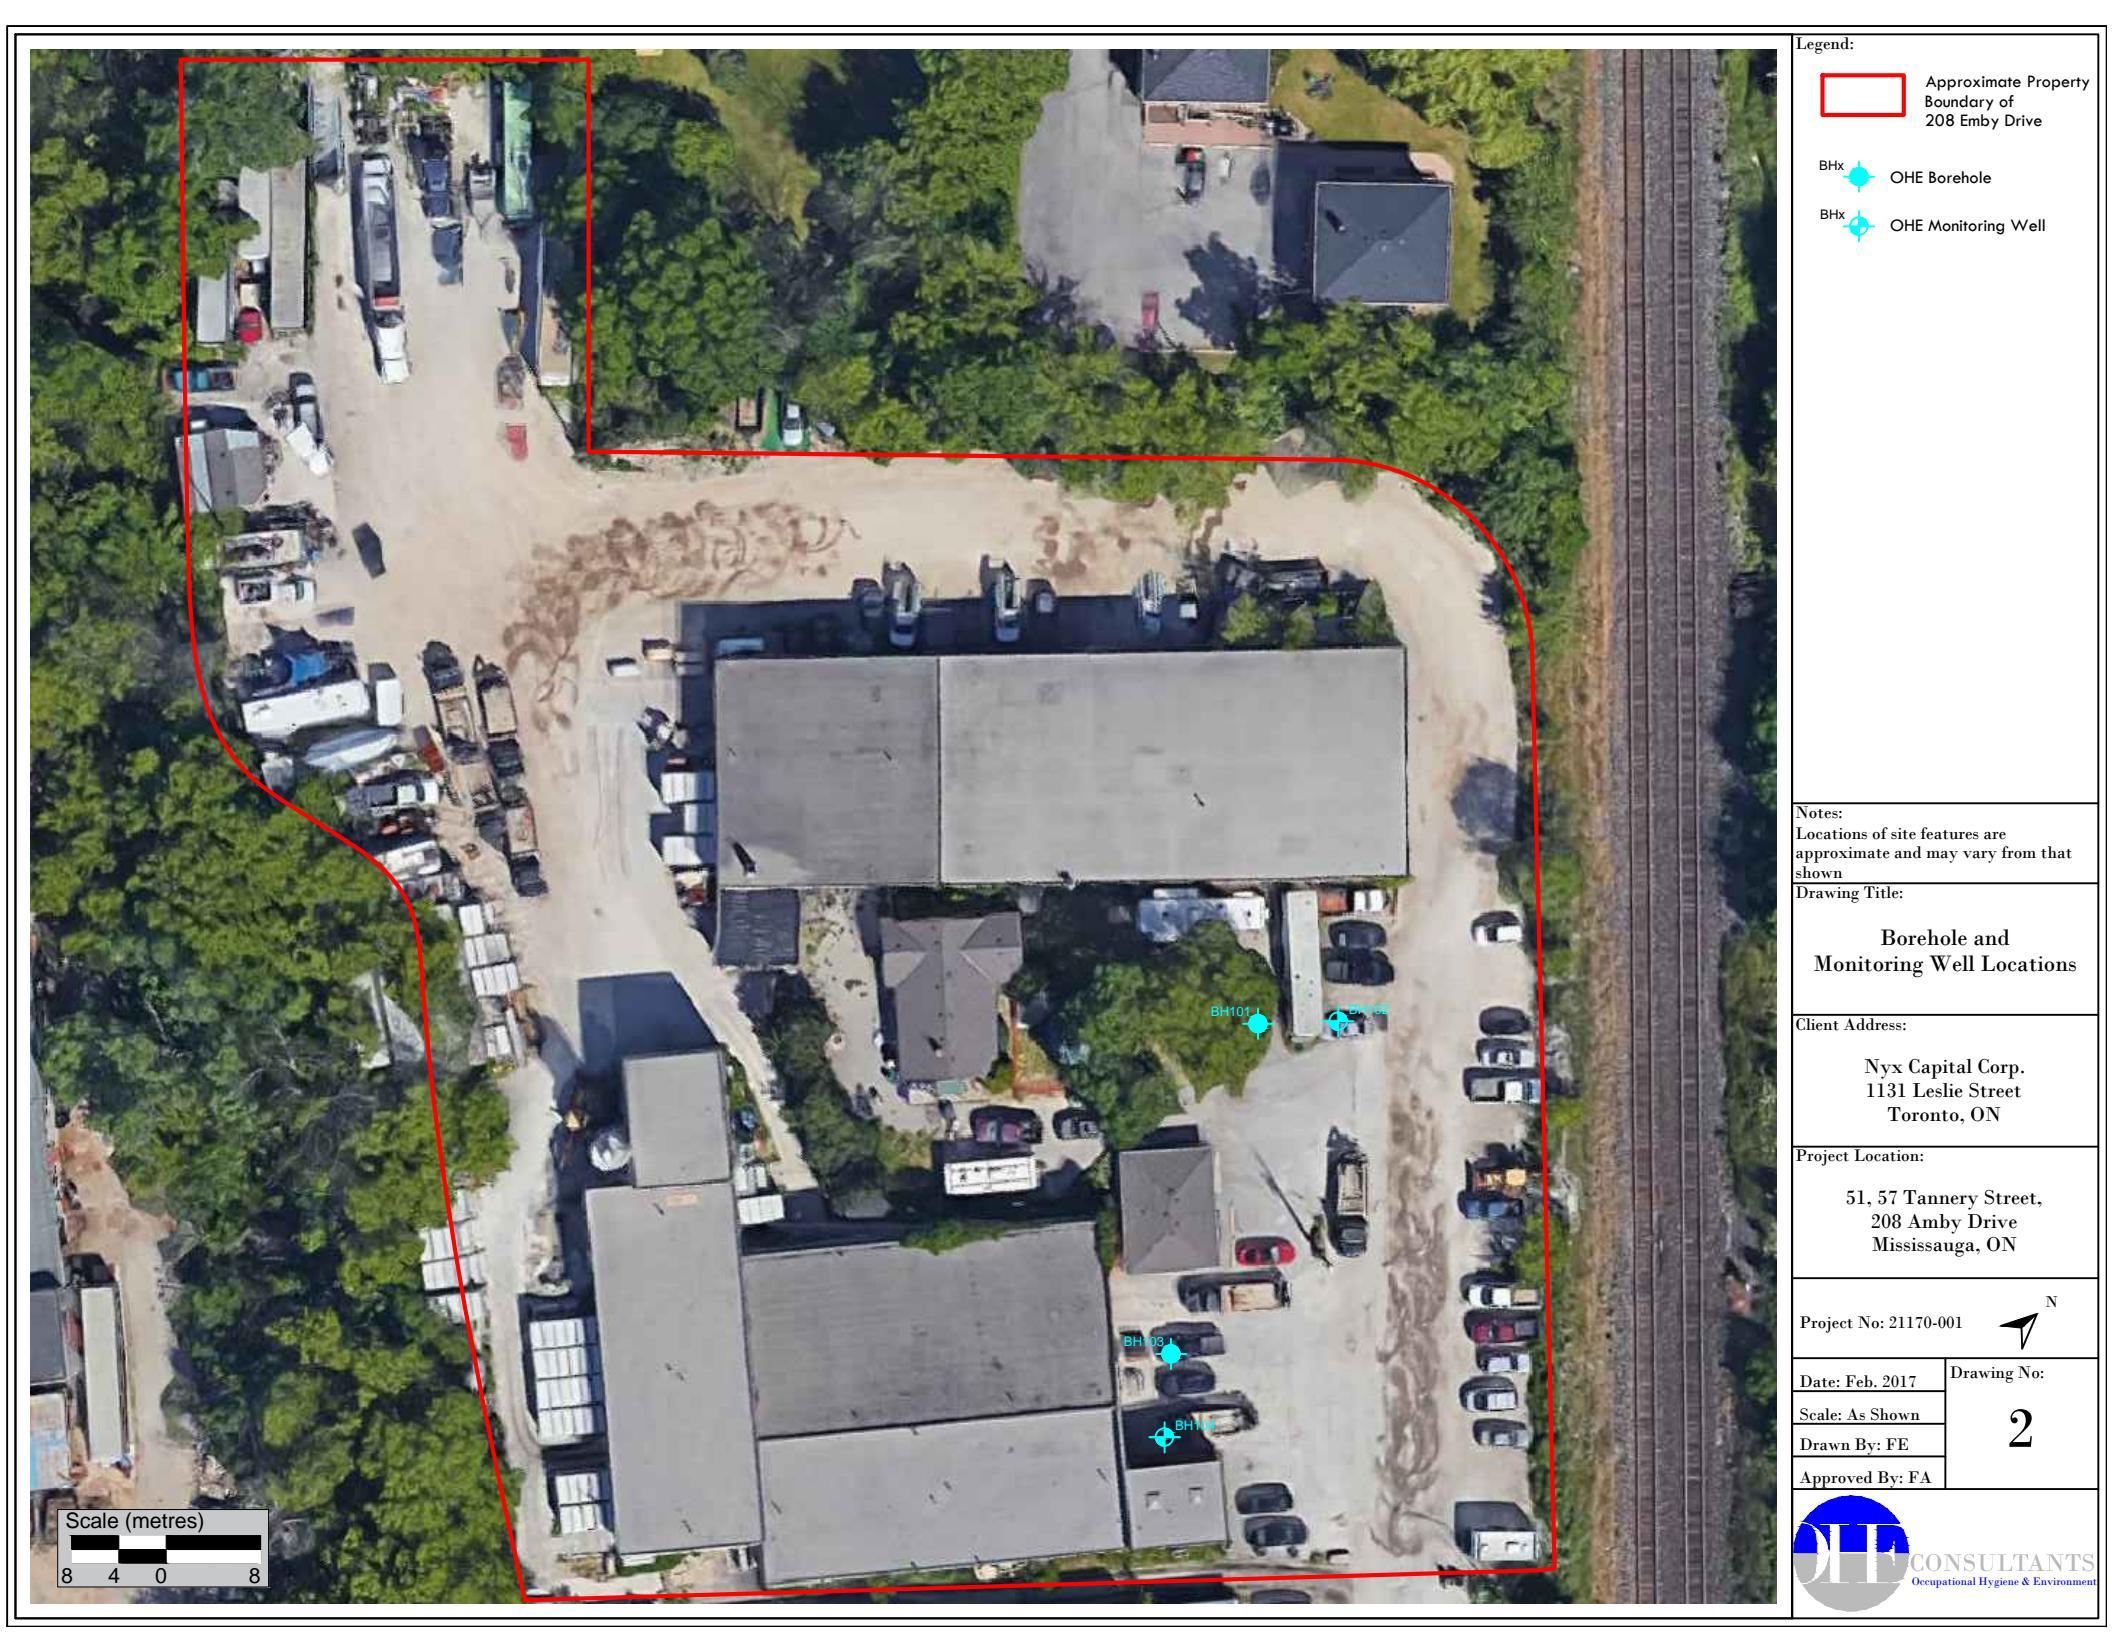
The borehole and monitoring well locations are shown in Drawing 2. Information on subsurface conditions such as stratigraphy, presence/absence of ground water and soil organic headspace vapour concentrations was logged at the time of digging (Borehole Logs are presented in Appendix B).

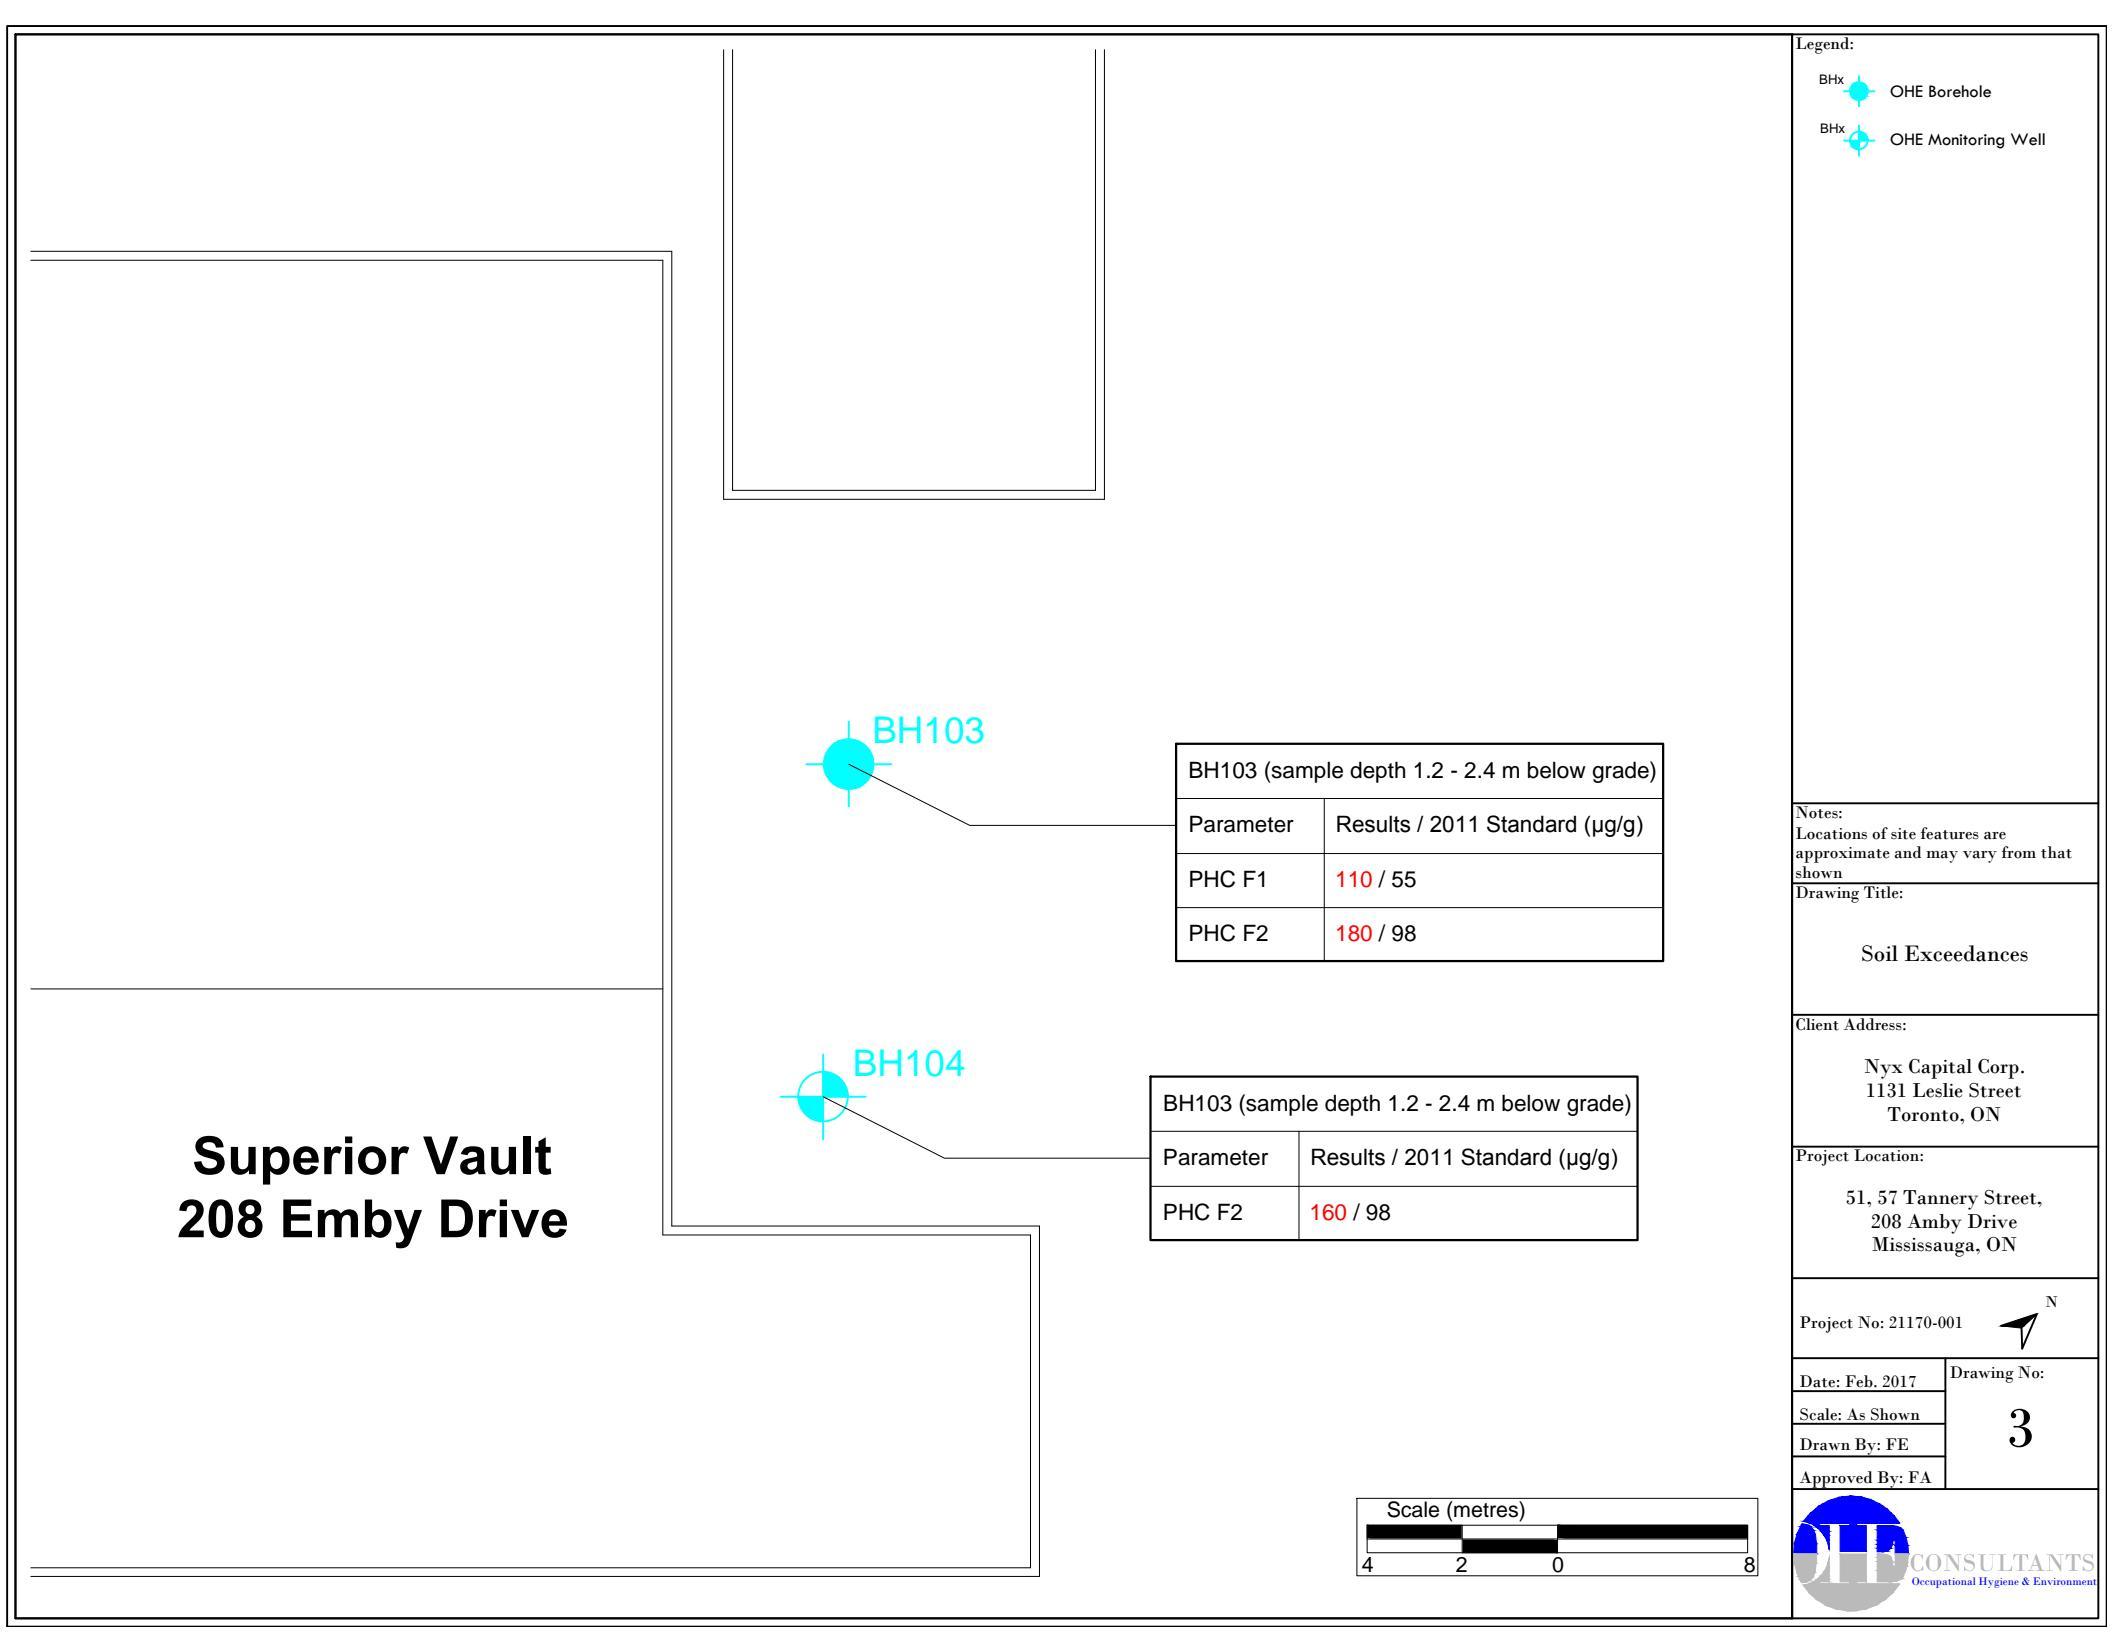
All PHCs and BTEX concentrations in submitted soil samples were found to be below the applicable MOECC Table 3 Standards with the following exceptions:

- BH103:
 - PHCs: PHC fractions F1 and F2.
- BH104:
 - PHCs: PHC fraction F2.

Based on the work completed as part of this Phase Two ESA and the analytical results of the submitted soil and ground water samples, PHCs soil contaminations were identified on the east side of the building occupied by Superior Vault Co. Ltd. (Building H) at 208 Emby Drive. It was not determined if these contamination extended under the building footprint. The source of the above-noted contamination is suspected to be related to historical UST.

The identified PHCs exceedances in soil were assumed to be contained within a proposed excavation area of approximately 10 m long x 8 m wide x 4 m depth, located on the immediate northeast exterior side of Building H (Superior Vault Co. Ltd.). A contractor cost estimate of \$100 per tonne was used to calculate the proposed remediation program, based on the following assumptions:
