Phase One Environmental Site Assessment

600 Lolita Gardens
Mississauga, Ontario
L5A 3K8

620 Lolita Gardens
Mississauga, Ontario
L5A 3K7

SEL Project Number 607918

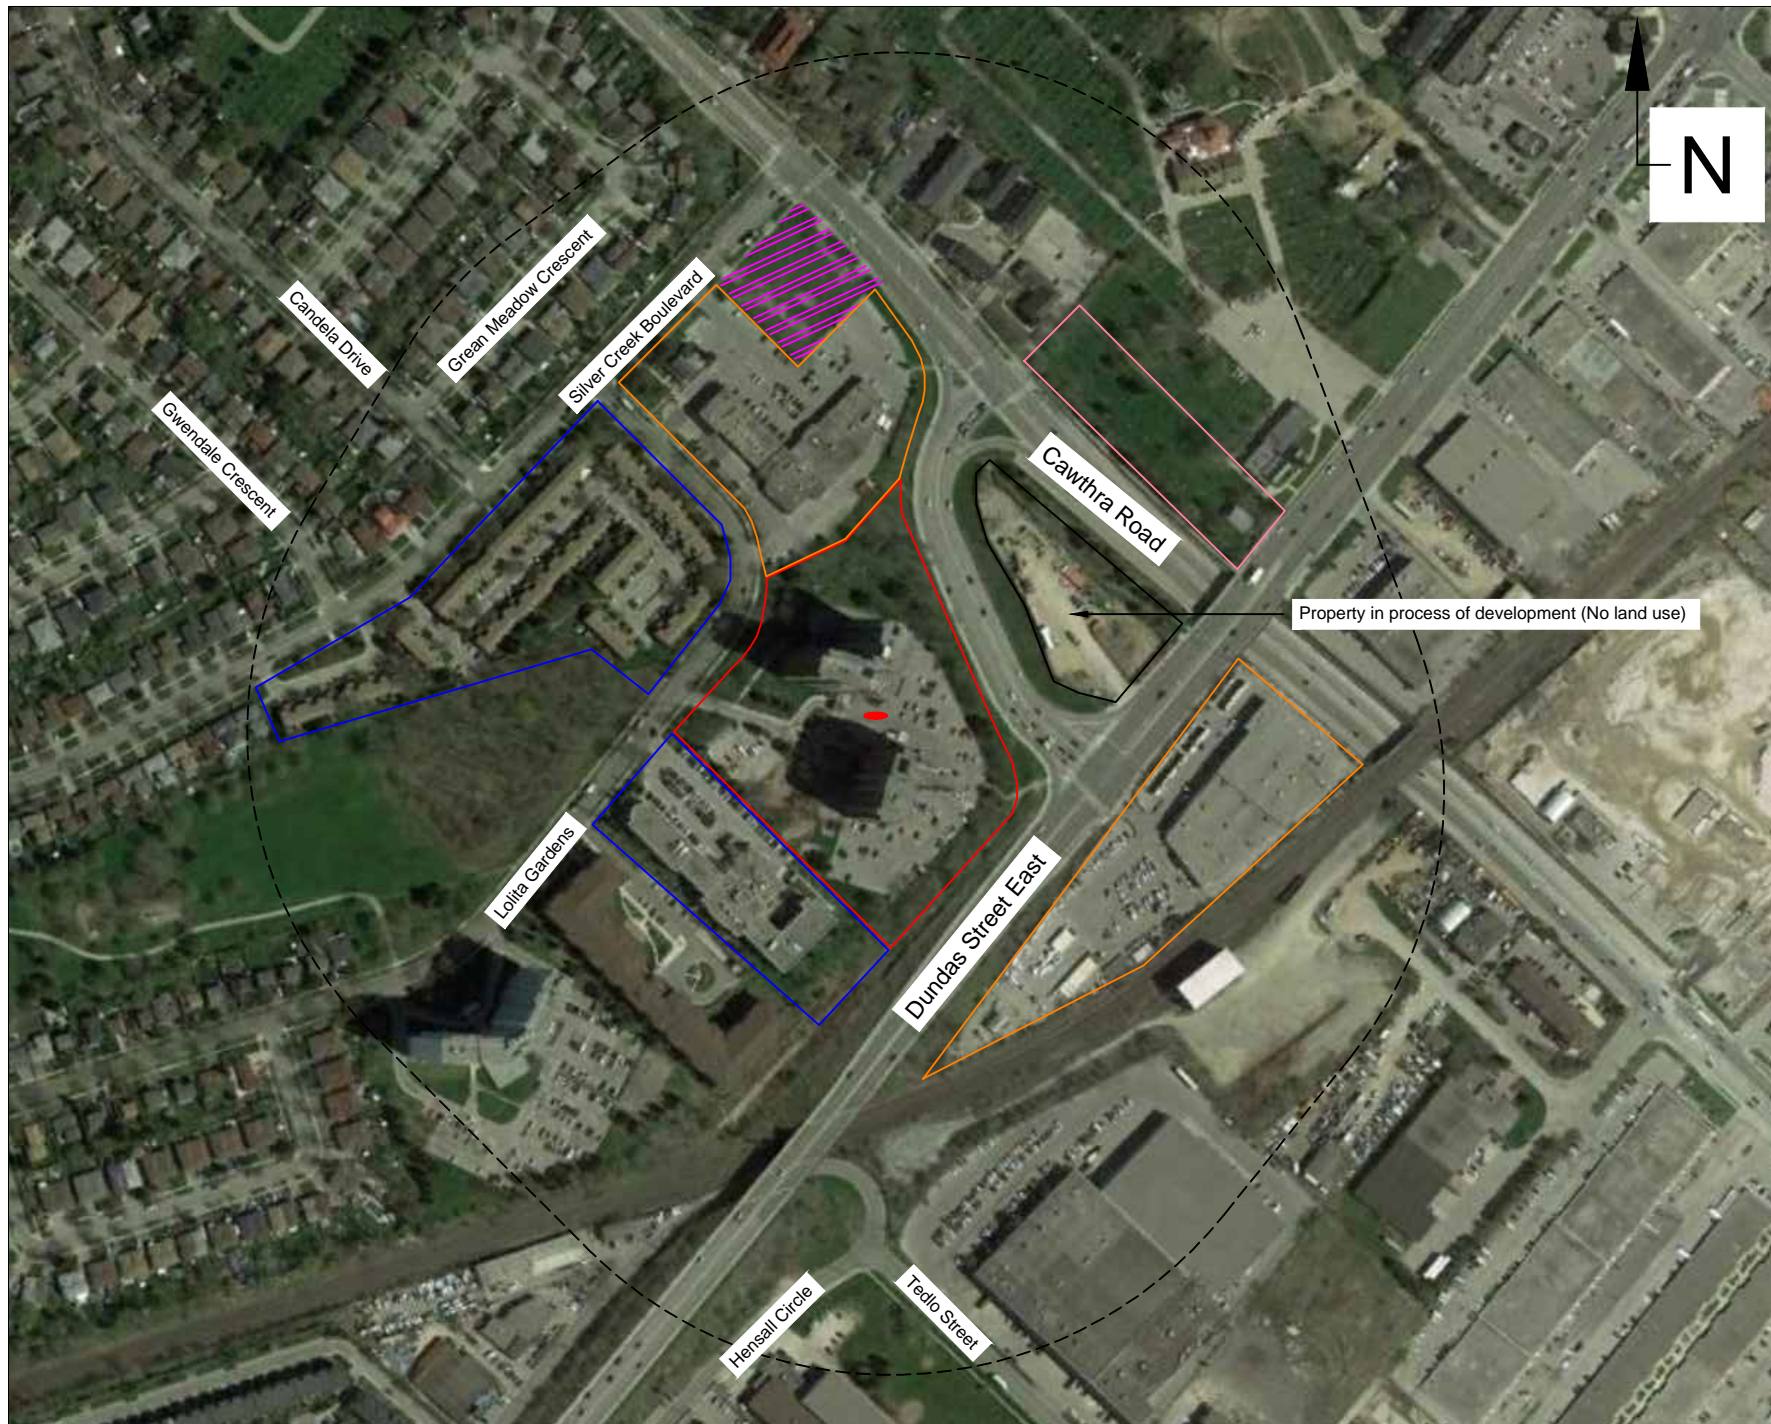
Title:
Figure 2: Phase One
Study Area

-   Approximate
Phase One Study
Area (250m from
Boundary)
-   Approximate Site
Boundary
-

1. Refer to “Figure 2 – Phase One Study Area” as well as “Figure 3 – Site Plan” for reference to the discussion below.
2. i) Figure 2 shows the areas where potentially contaminating activity on or potentially affecting the phase one property had occurred.

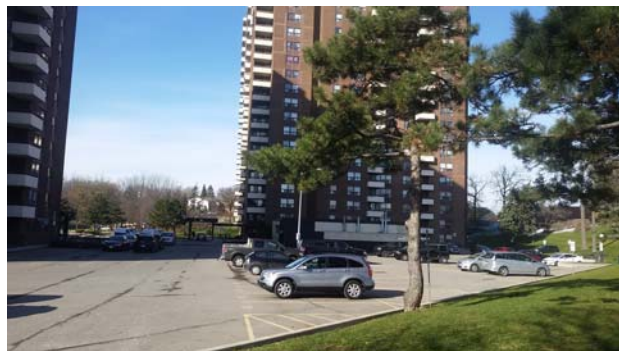
Site Building 1 and 2 were brick multi storey residential buildings with a below grade one level concrete basement. Two apartment units from Site Building 1 (1711 & 209) and two apartment units from Site Building 2 (1206 & 209) were observed at the time of Site reconnaissance which was reportedly representative of each of the buildings apartments. They each appeared to consist of parquet, ceramic and vinyl floor tiles, drywall walls and stucco ceiling. The 1st, 2nd, 18th floors and elevator room of Site Building 1 and the 1st, 2nd, 22nd floors and elevator room of Site Building 2 were heated by baseboard heaters. The rest of the rooms of the buildings were heated from the ceilings.

Photograph 1: View of Site Building 1 (left) and Site Building 2 (right)

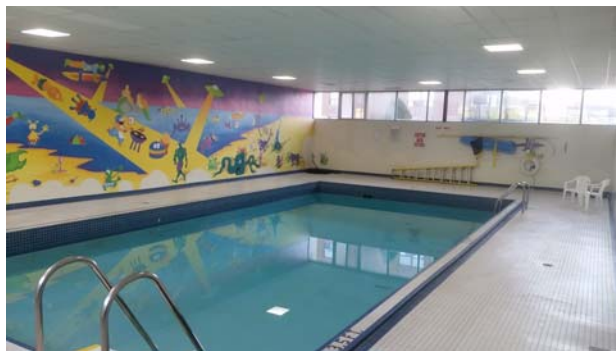
Connected to the east of Site Building 2, between each of the parking garage entrances, was an indoor pool area with male/female change rooms and saunas. The swimming pool heater was observed in one of the parking garage rooms along with tanks of chlorinating liquid and muriatic acid with attached extraction tubing. There were also jugs of chlorinating liquid and muriatic acid being stored in the room for refilling the tanks.

Photograph 2: View of pool building connected to Site Building 2

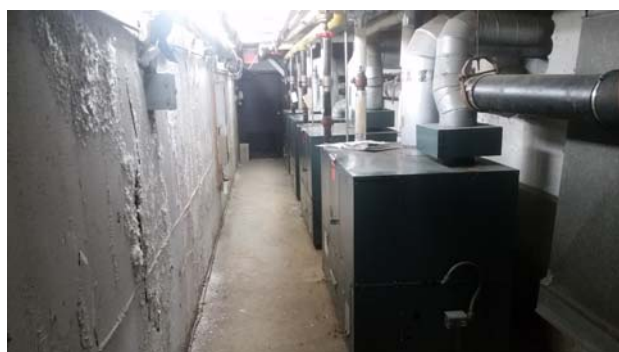
There were four hot water boilers observed to provide heat to the building in a room accessed from the underground parking garage. Four rooftop air conditioning units were observed on the

Photograph 3: View of furnace units for the Site Buildings in underground garage

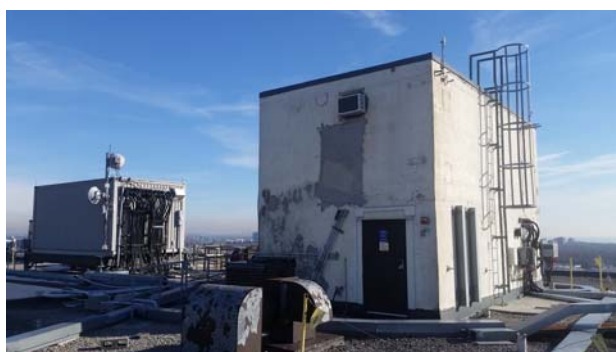
- o The same model of air conditioning unit appeared to be on the elevator shaft room wall of Site Building 2.
 - o There were no labels observed for any of the other air conditioning units observed on the Site, therefore the refrigerant types were unknown.

Photograph 4: View of the elevator shaft room and voltage room on the roof of Site Building 2

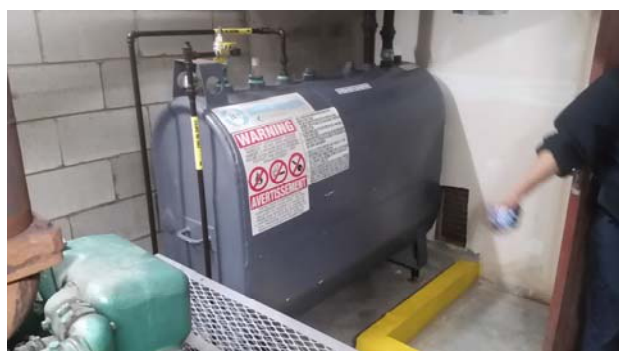
There was one AST observed within the backup generator room in the parking garage. It was a double steel wall (2mm thick each) tank with a 935L capacity used for the above ground storage of fuel oil. It was labelled as having been manufactured in August 2018. The tank appeared to be in good shape without any sign of leaks.

Photograph 5: View of UST in underground garage

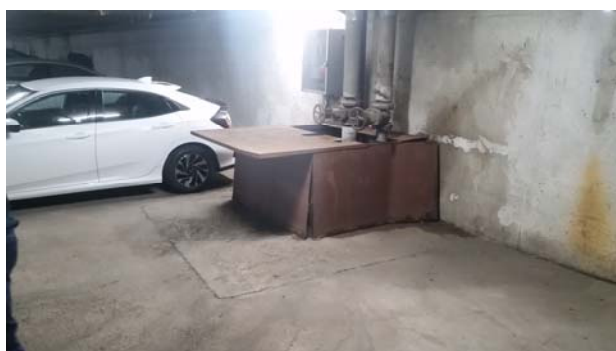
Floor drains were observed throughout the ground level and basement units. Any water entering them was all reportedly directed to a sump observed in the parking garage. Contents of the sump were reported to be regularly discharged into municipal sewer lines.

Photograph 6: View of sump in underground garage
