# Lakeview Village Shoreline Hazard Assessment

Mississauga

February 14 2020 | 13012.101

13012.101

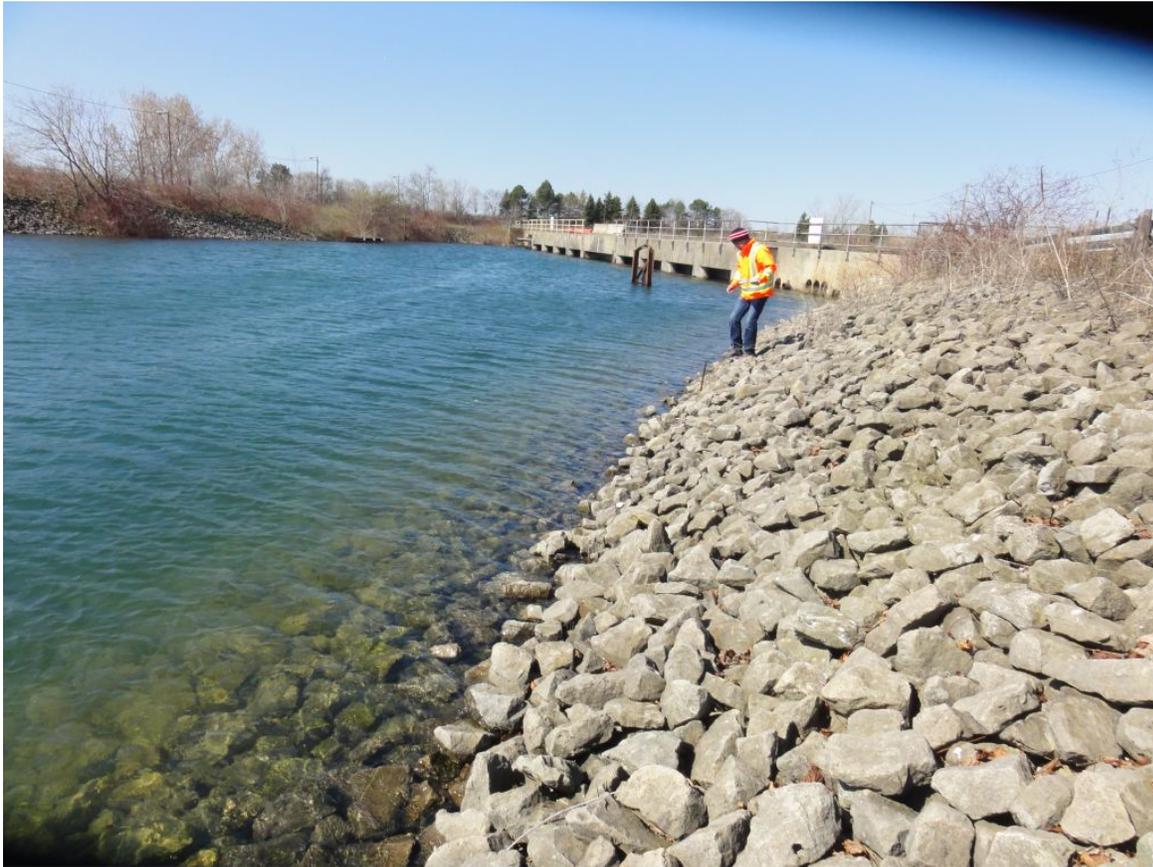
**Figure 2.9: Site reconnaissance of riprap slope protection at Intake Forebay/Channel North**

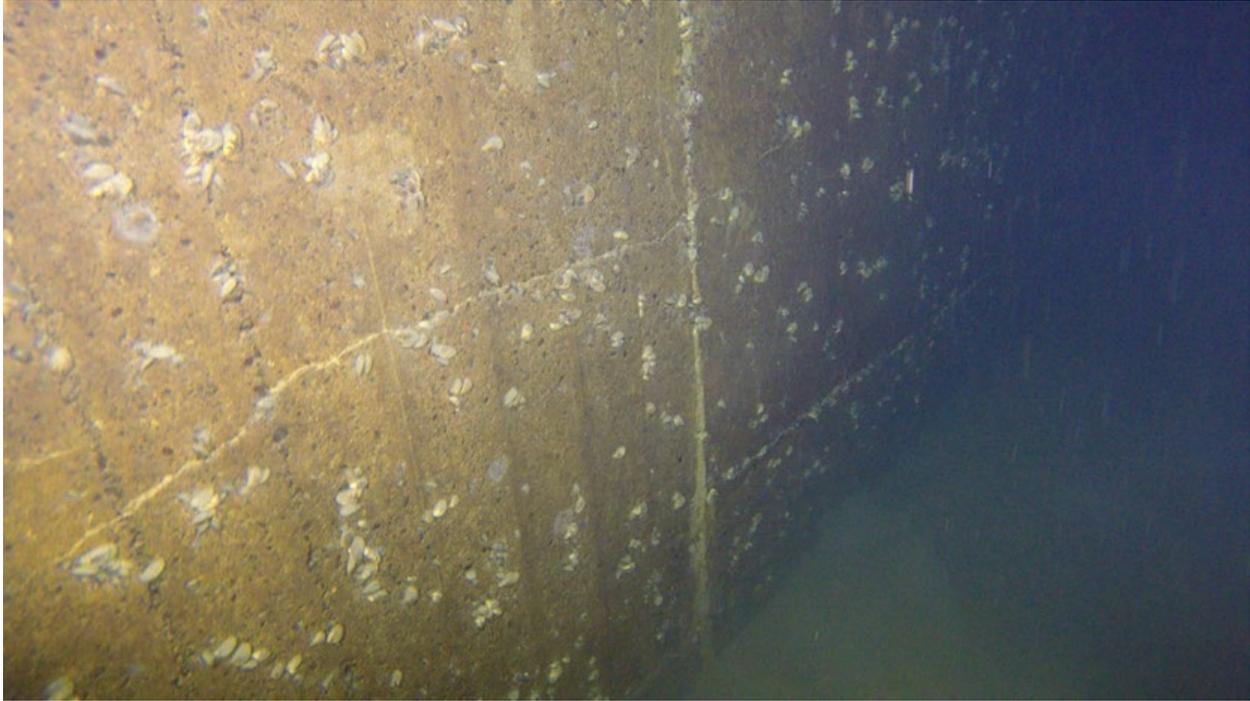
**Figure 2.22: ROV view of interior concrete wall in discharge tunnel**

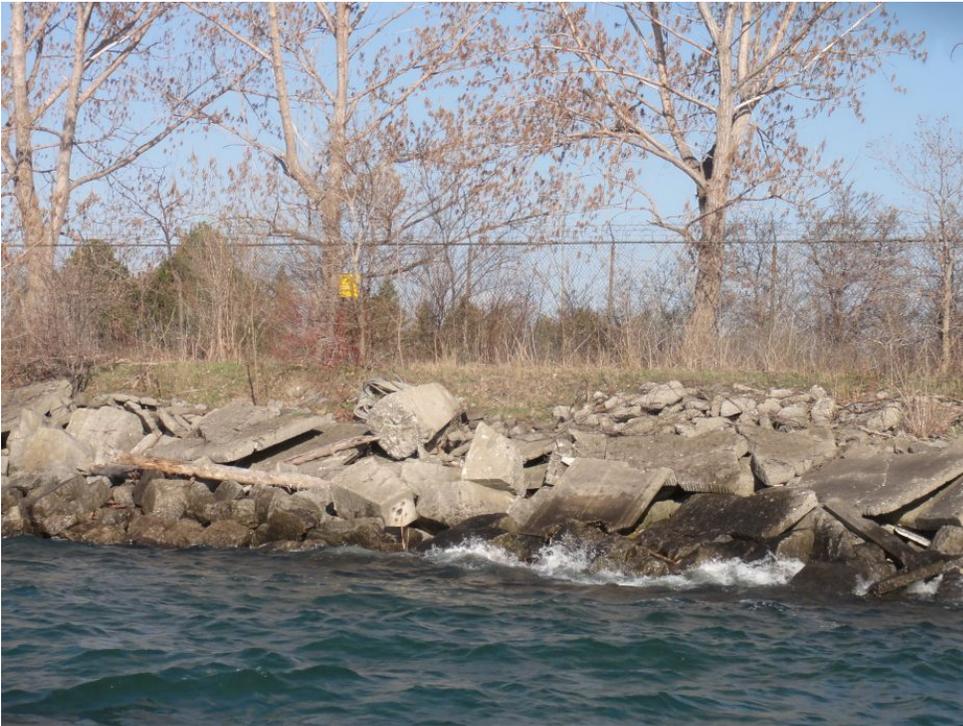
Figure 2.30: Example of concrete rubble slabs on revetment at westerly portion of Outer Shore

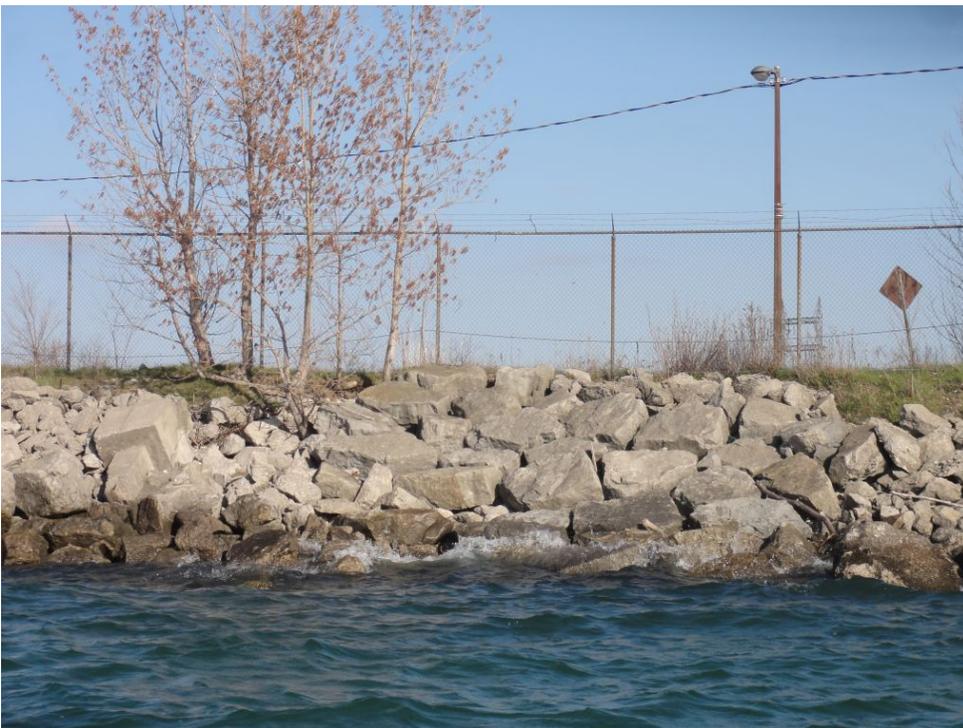
Figure 2.31: Example of additional armour stone on shoreline protection at westerly portion of Outer Shore

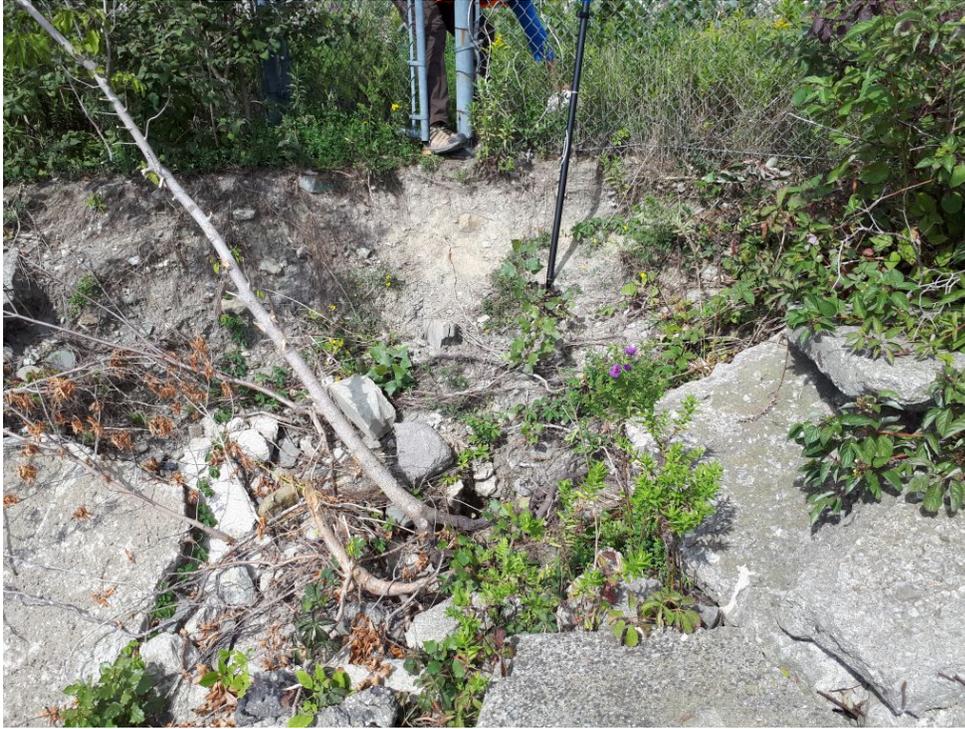
Figure 2.32: Localized wave uprush erosion at top of slope at westerly portion of Outer Shore

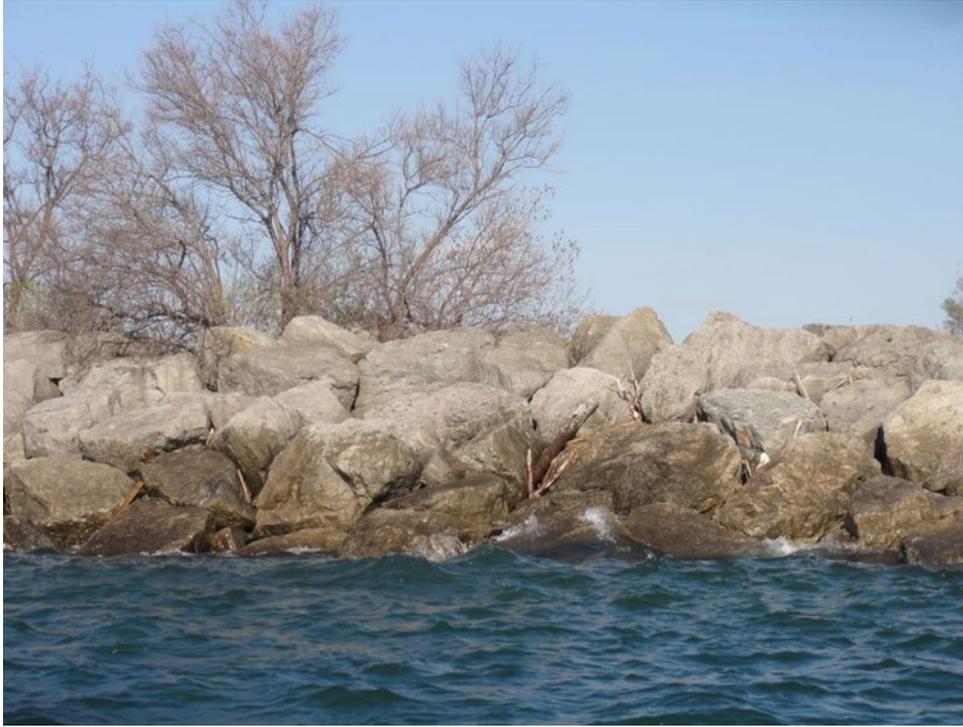
**Figure 2.34: View from water of armour stone protection at Lakefront Promenade Park marina breakwater**

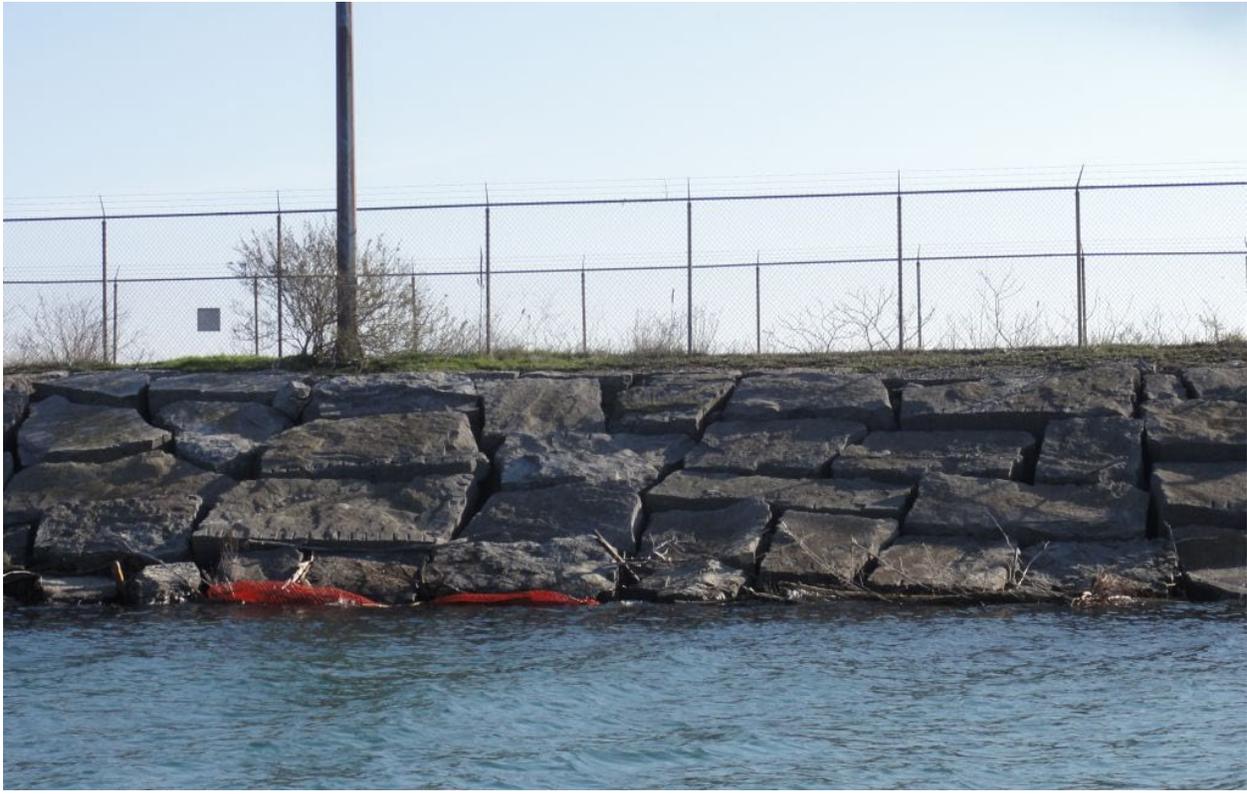
**Figure 2.36: View from water of large, tightly placed armour stone on west side of Western Pier rubble mound mole**

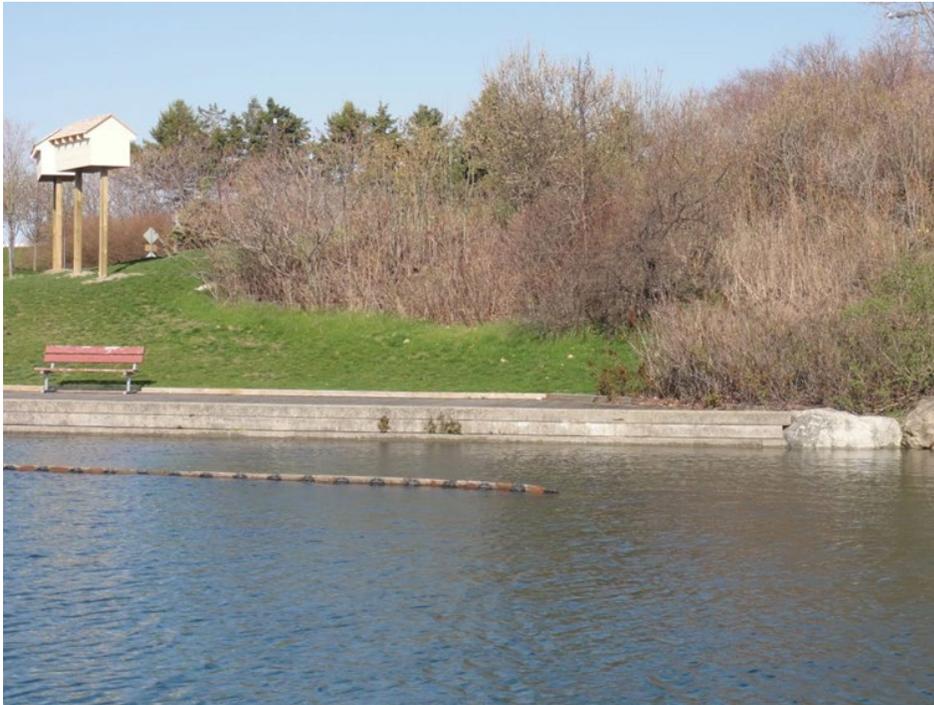
Figure 2.39: LPP marina basin wall adjacent to Discharge Channel West

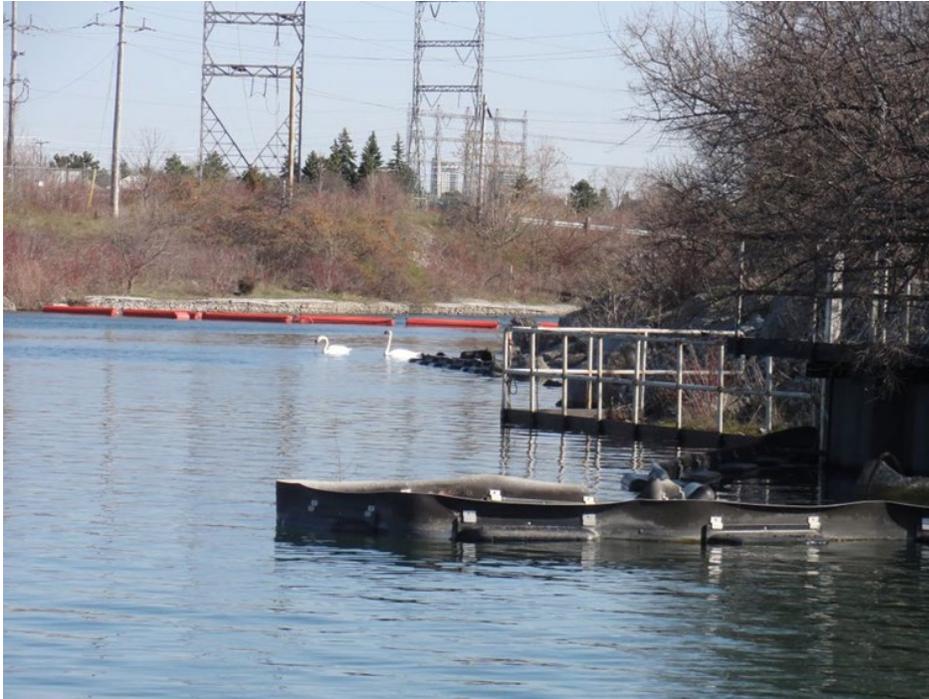
Figure 2.40: Miscellaneous structures at West Shoreline near discharge channel

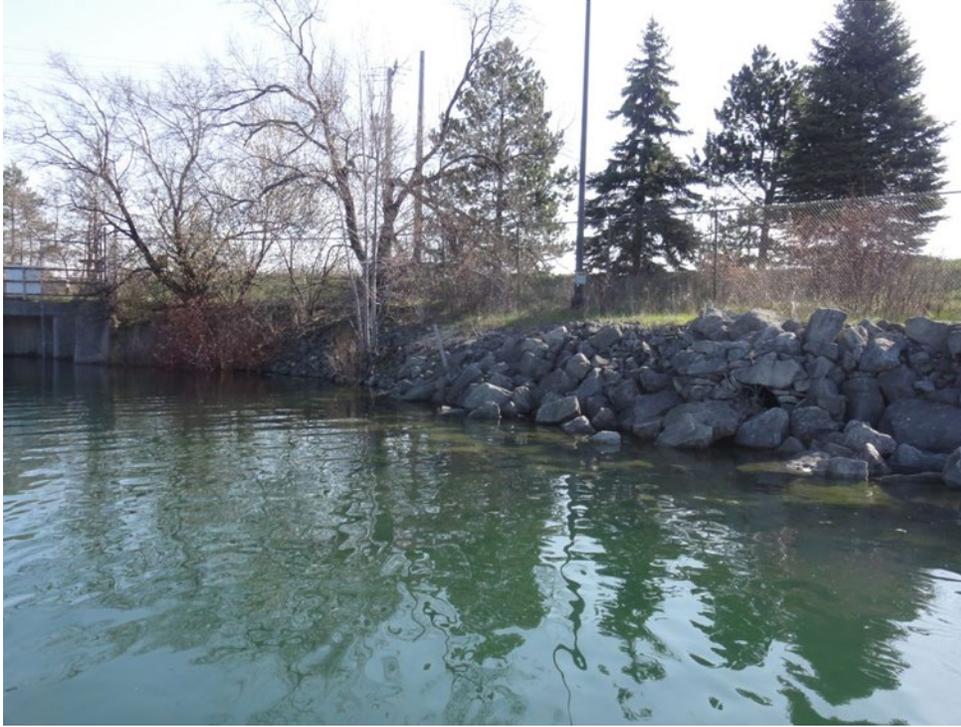
**Figure 2.41: Transition from West Shoreline to Discharge Channel East**

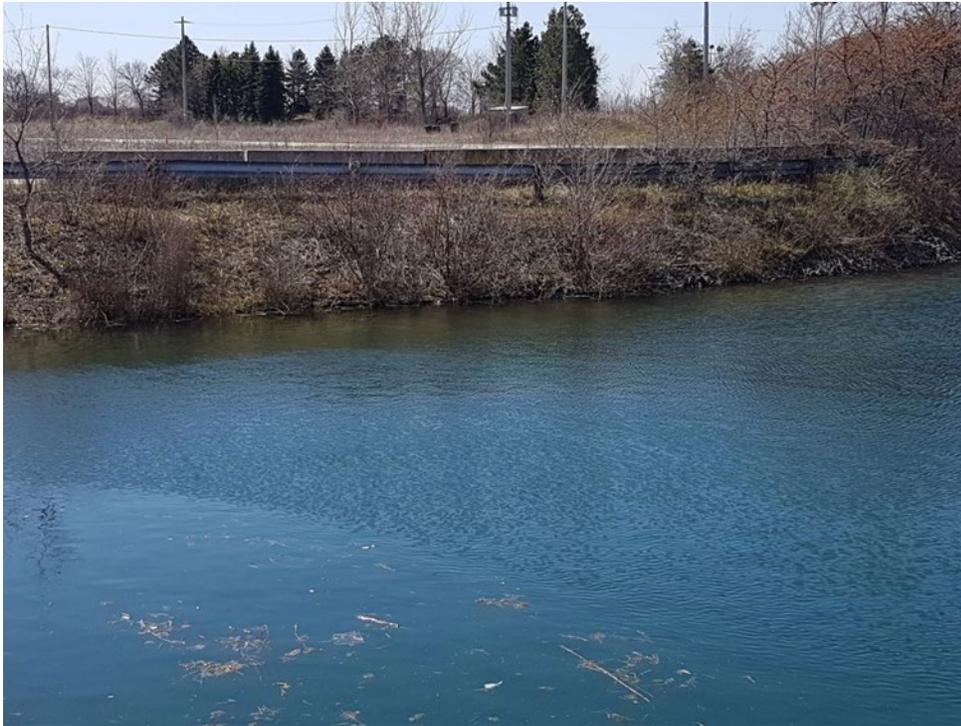
The shoreline protection along the east side consists of a sloping riprap revetment with extensive vegetation established on the slope (Figure 2.43). The top elevation of the stone protection is adequate. From the historical drawings<sup>14</sup>, the toe of the revetment slope is founded on a bedrock bench at elevation 73.9 m (242.5 ft) which has been cut down below the natural bedrock elevation (Figure 2.44). The bedrock bench can be seen in Figure 2.42). As noted, the discharge channel is cut down, from the bench elevation, deeper into the bedrock. The riprap shore protection is not exposed to wave action and there is no longer any flow in the discharge channel. The shore protection is in good condition and can readily be incorporated into the Masterplan for the shoreline in accordance with accepted engineering practice and landscape design. Naturalization features and aquatic habitat elements will be incorporated into the protection works where appropriate. The design life of the new protection will be 60 years.

Figure 2.43: Discharge Channel East –riprap with extensive vegetation

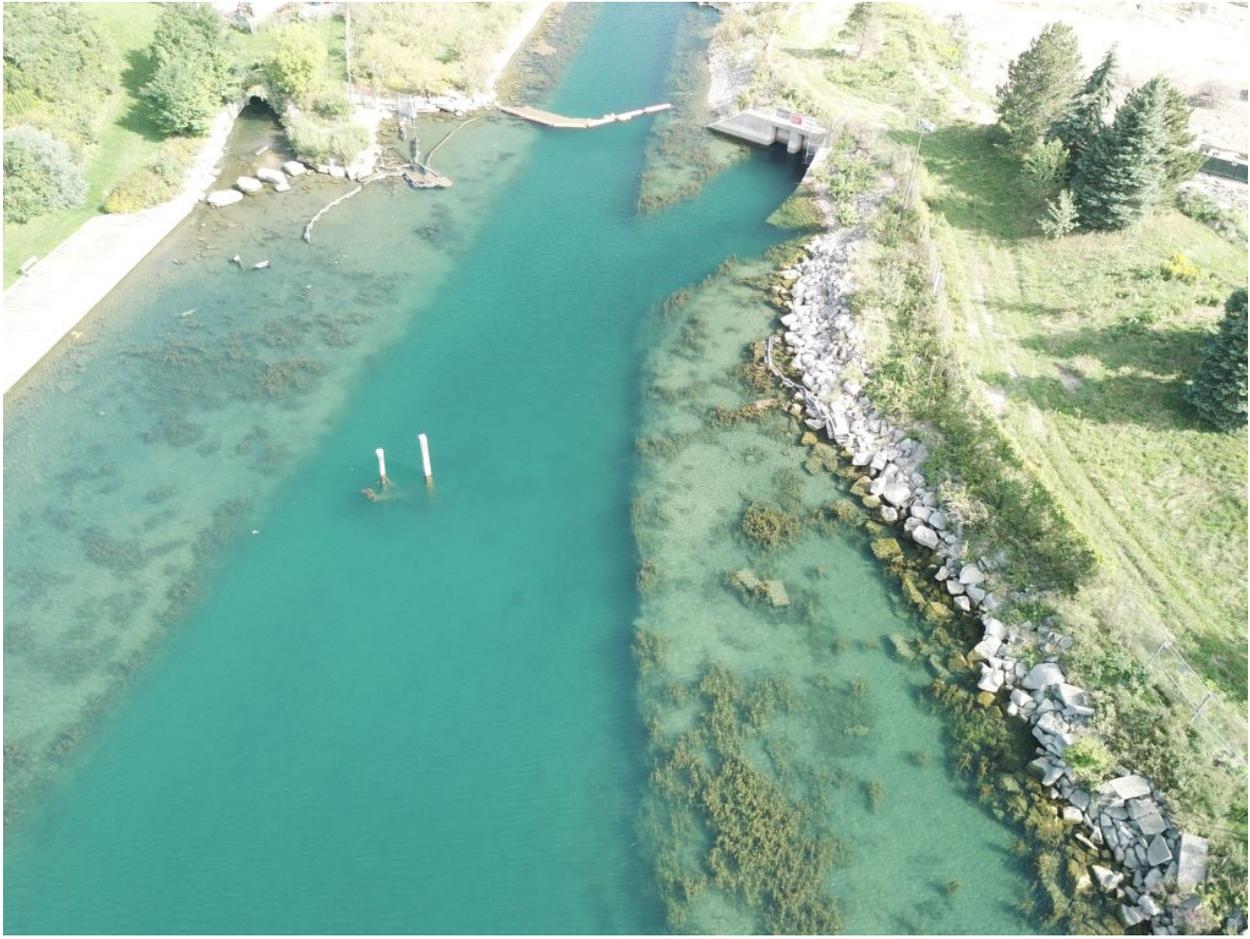
Figure 2.45 shows the concrete headwall for the discharge tunnels from Units 7 and 8. Other miscellaneous structures (e.g., boom dock) at the shore will likely have to be removed for public safety and aesthetics.

Figure 2.45: Discharge Channel East – concrete headwall for Units 7 and 8 (right hand side of photo)

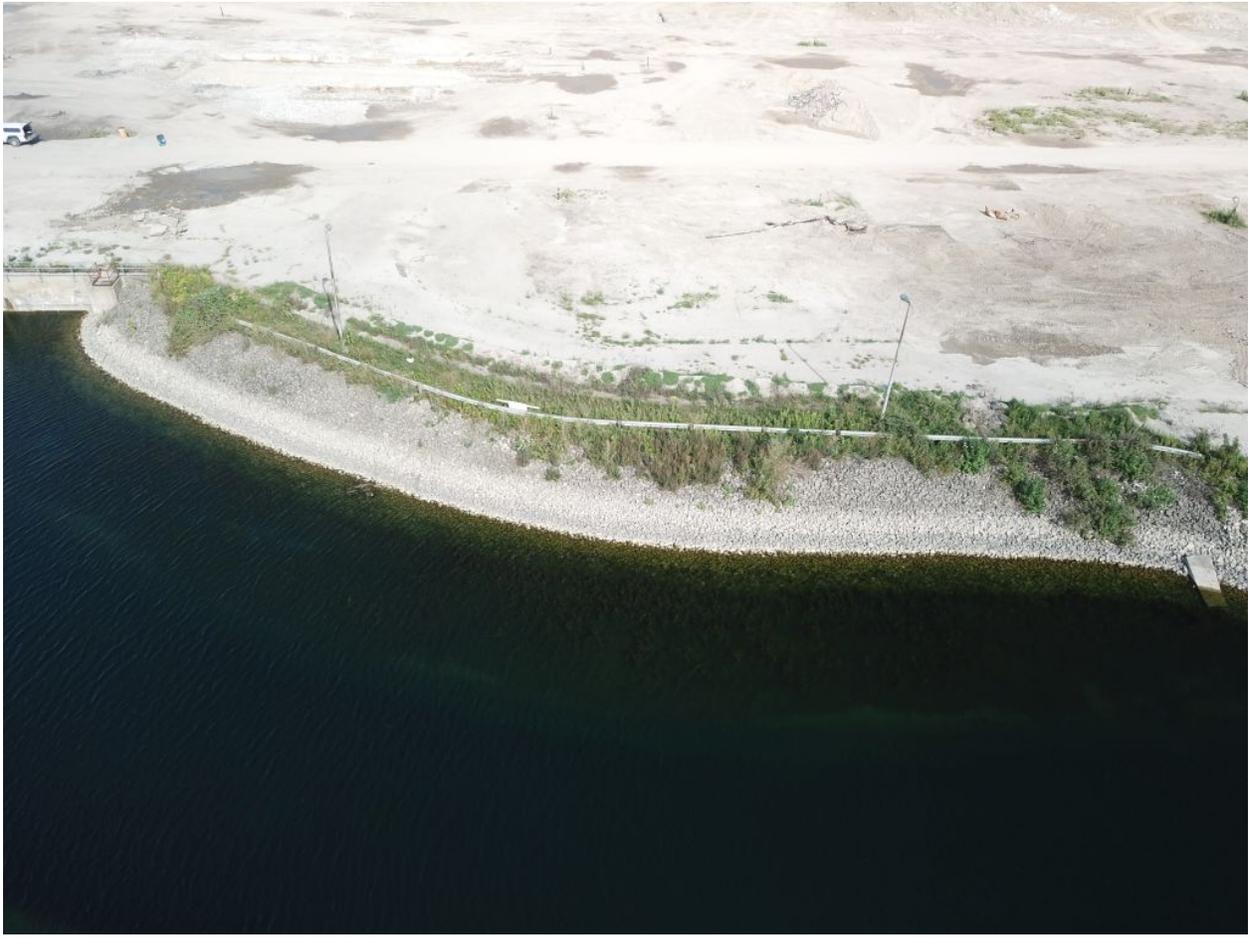
Overall, the riprap shore protection at Inner Forebay North is in good condition and has adequate crest elevation for wave runoff and overtopping protection. The existing protection work will be upgraded and incorporated into the shoreline Masterplan in accordance with accepted engineering practice with a design life of 60 years. Naturalization features and aquatic habitat elements will be incorporated into the protection works where appropriate.

Figure 2.49: Riprap slope protection at west end of Intake Forebay/Channel North (IFN680 to IFN740)

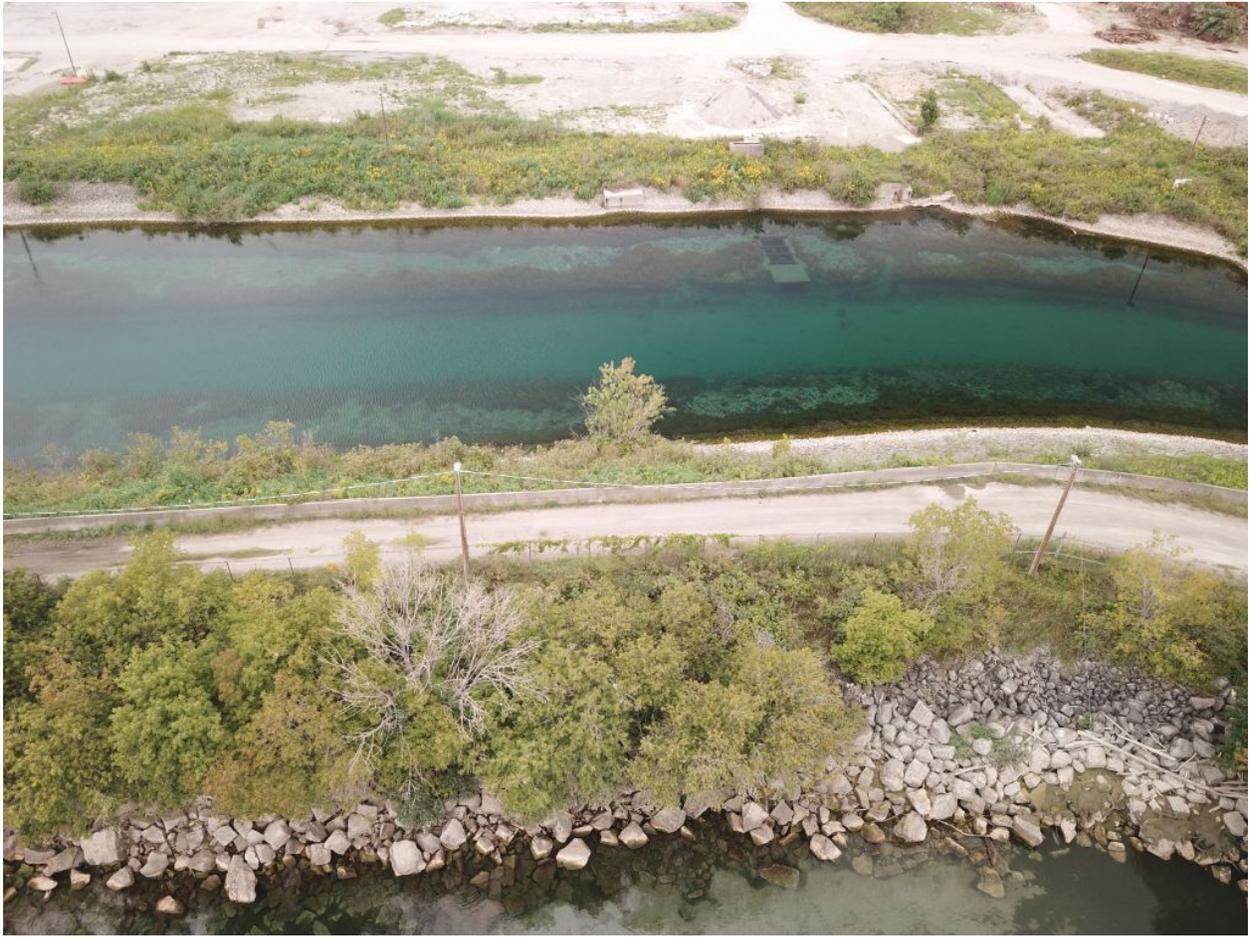
Figure 2.50: Riprap slope protection at east end of Intake Forebay/Channel North (background of photo; Outer Shore in foreground)

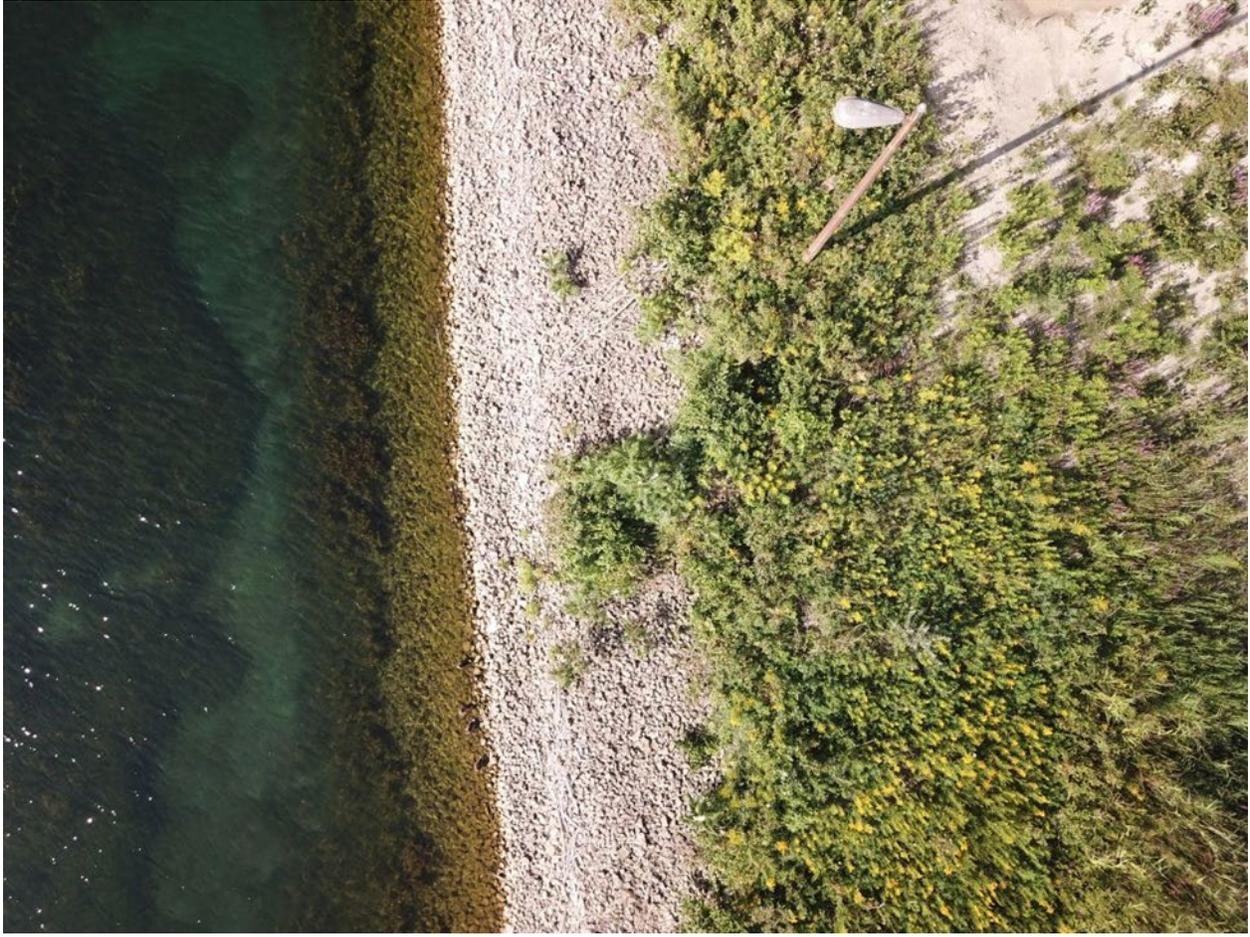
Most of the IFN shoreline is not exposed to lake wave action or potential erosion except near the easterly end where waves travelling northwards between the West and East Piers can reach the shore. Figure 2.52 shows the typical riprap slope protection on the sheltered north side of the intake channel. Figure 2.53 shows the riprap stone size between IFN660 and IFN735. The riprap does vary in size and top elevation at the more exposed location at the easterly end; here the size of the stone protection is larger (Figure 2.54, Figure 2.55 and Figure 2.56).

Figure 2.52: Riprap slope protection at Intake Forebay/Channel North

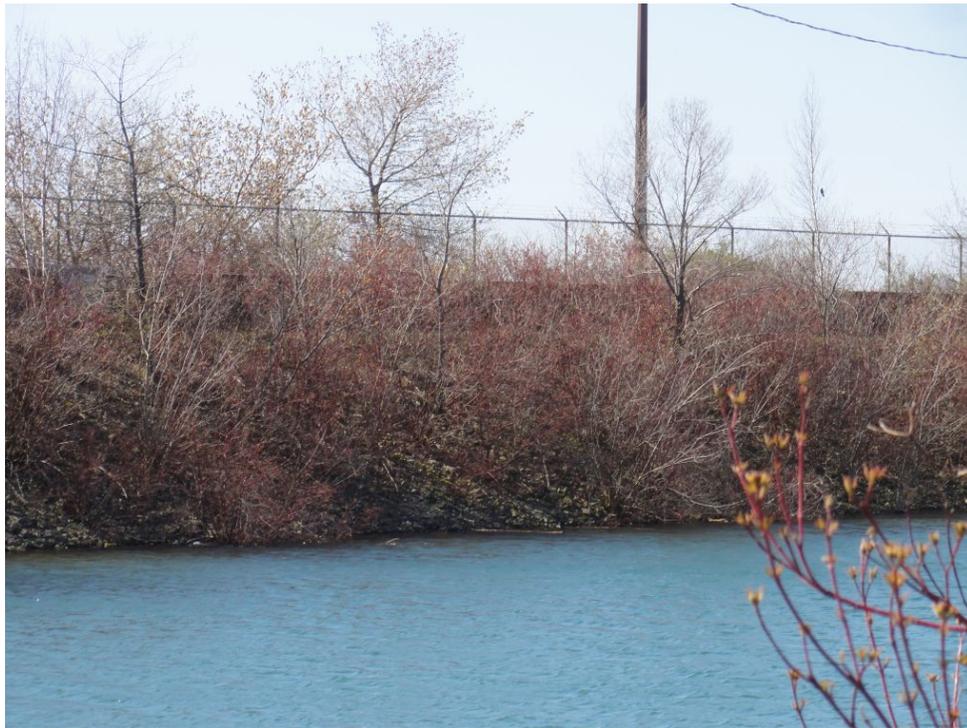
The riprap revetment is in good condition with well-established vegetation (see Figure 2.58 and Figure 2.60). The top elevation of the stone protection is adequate.

Figure 2.60: Example of riprap slope protection with extensive, established vegetation at Intake Forebay/Channel South

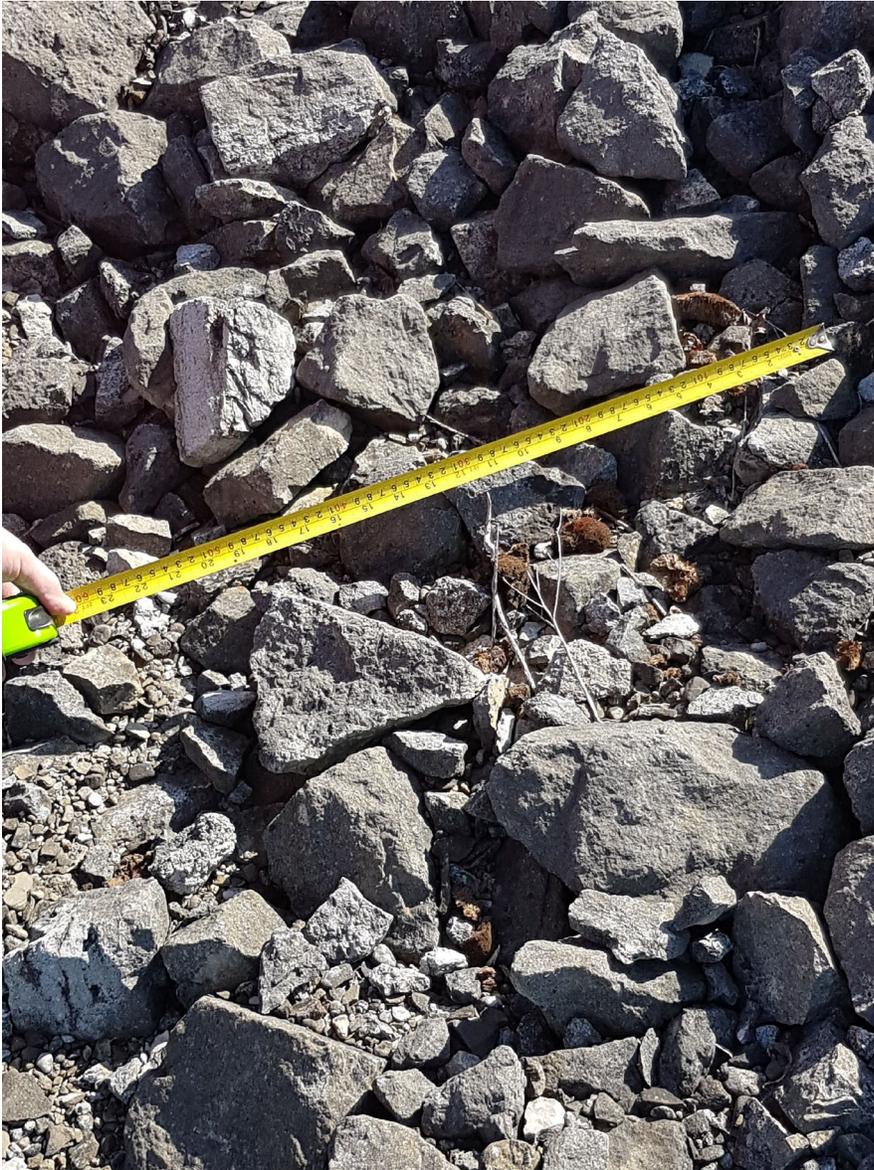
Figure 2.61: Example of riprap stone size at Intake Forebay/Channel South (IFS340)

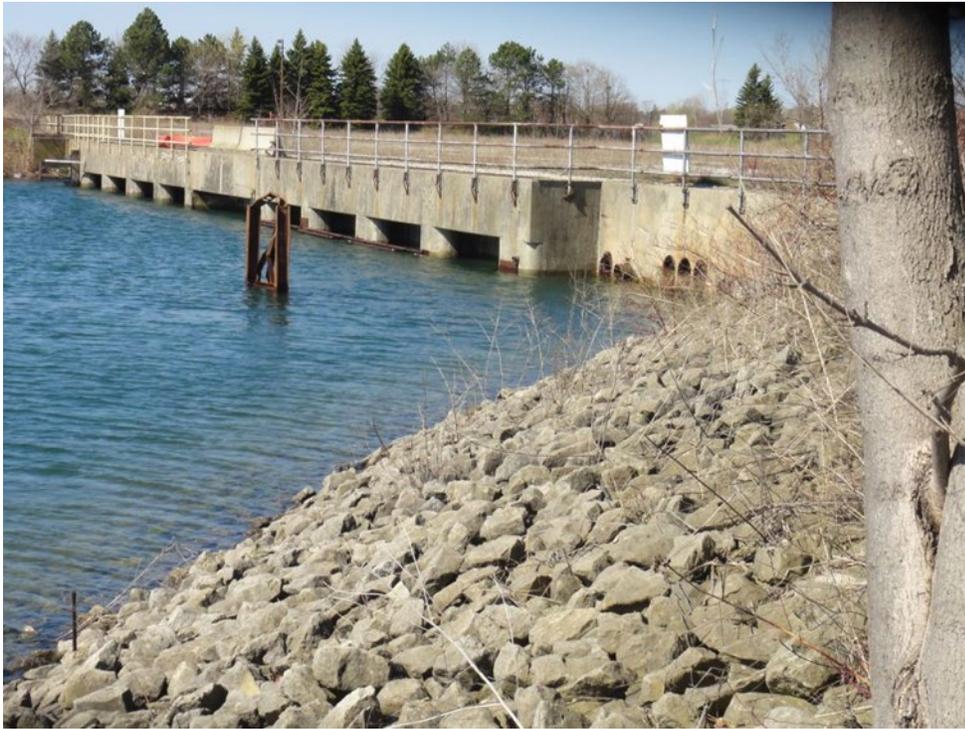
Various isolated concrete and steel structures were observed in the channel (e.g., see Figure 2.17 and Figure 2.64). These structures could pose a hazard to navigation and will be charted and marked with warning buoys or removed.

Figure 2.64: Concrete Pumphouse 3 (for Units 5, 6, 7 & 8) at Intake Forebay/Channel North

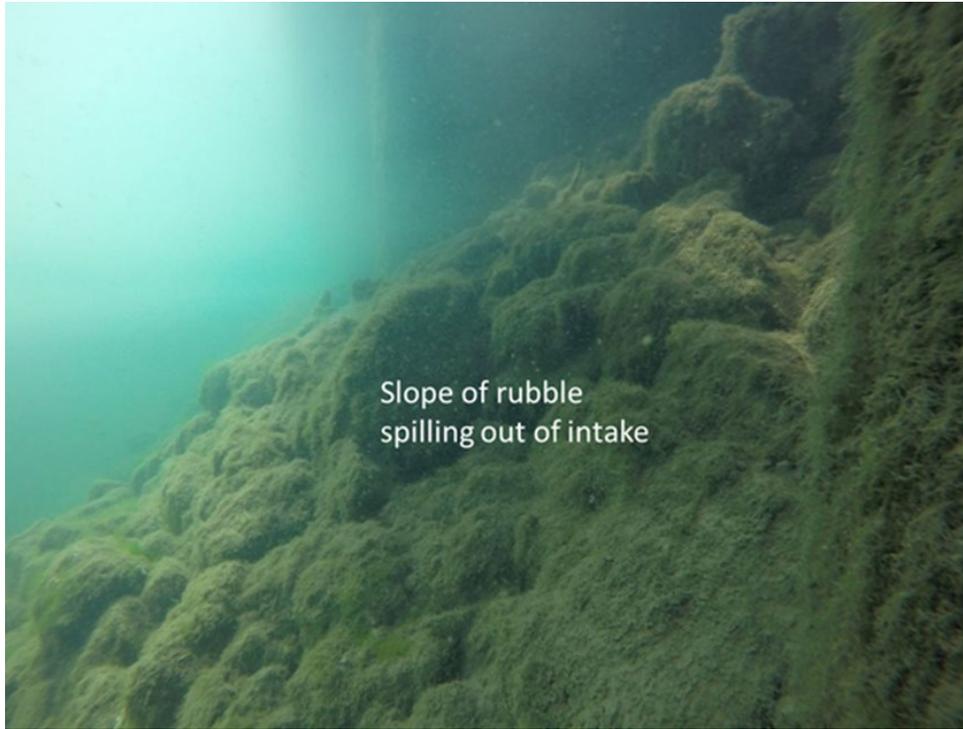
Figure 2.74: Rubble slope spilling out of intake at Pumphouse 3
