## **Report on**

Geotechnical Slope Stability Assessment Serson Creek Lakeview Village, 800 Hydro Road Mississauga, Ontario

**Prepared For:** Lakeview Community Partners Limited

**Project No.** 18-519-102 July 19, 2019

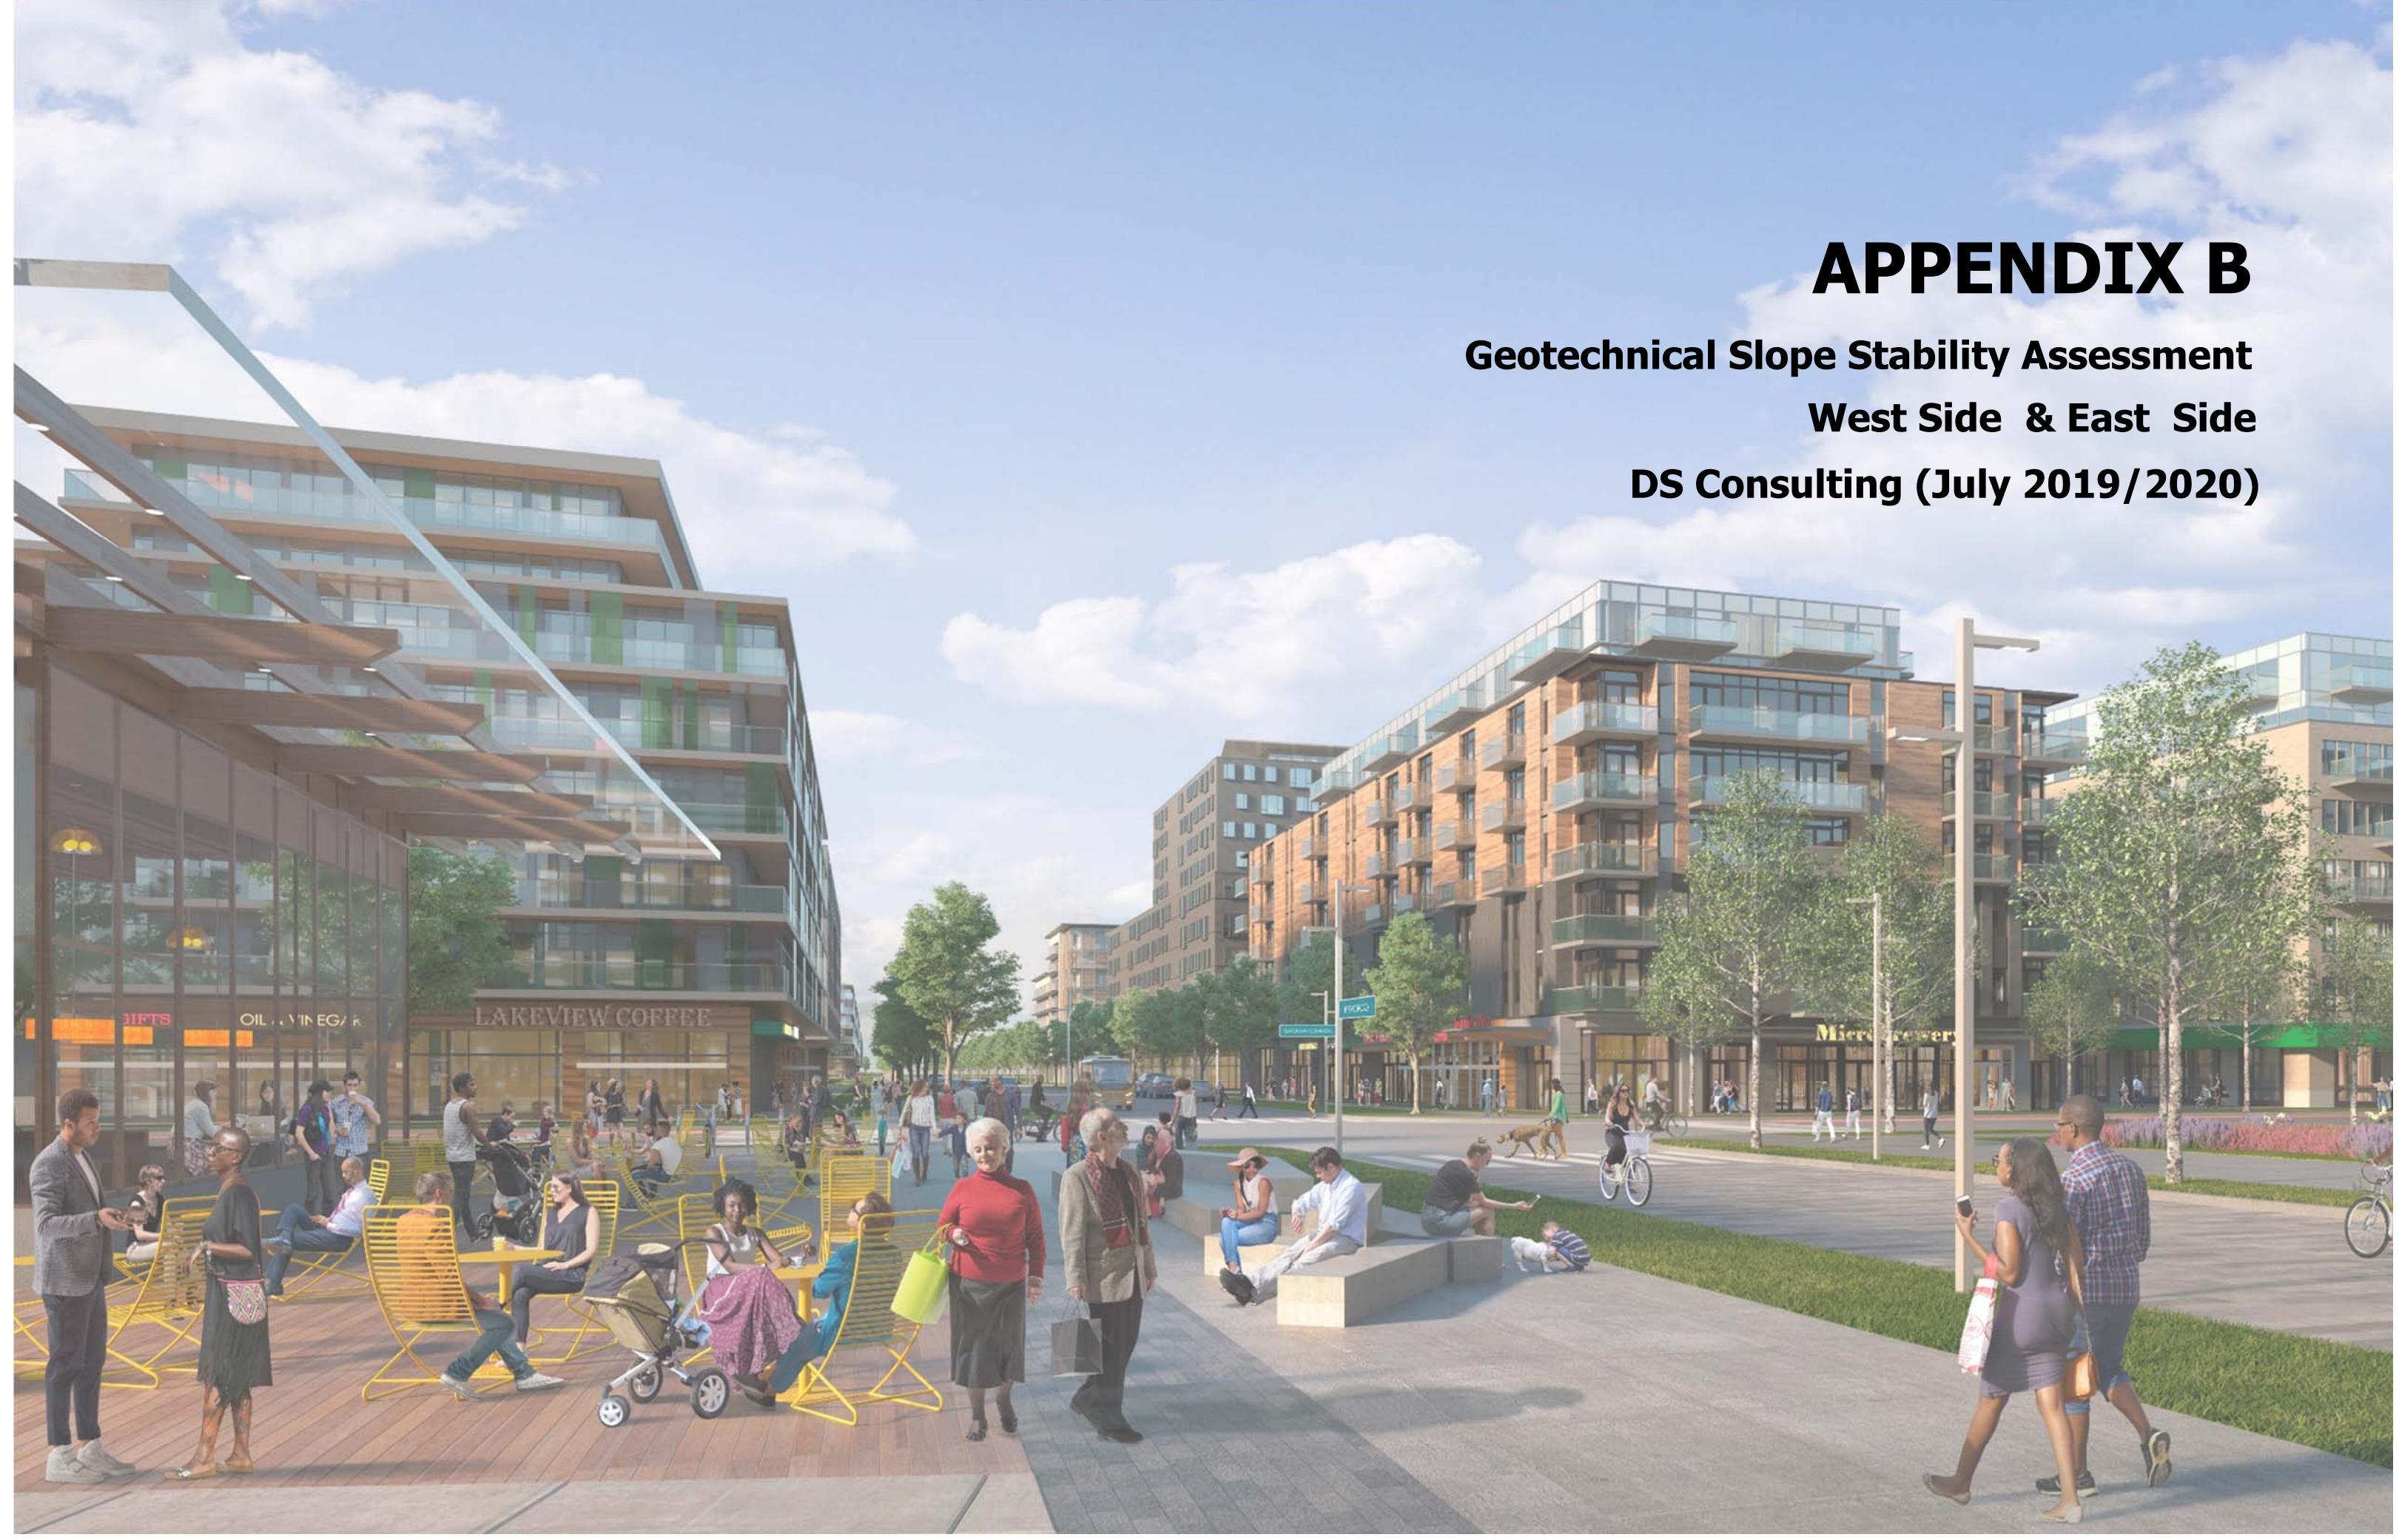
Drawn By:		Date:	
F.Z		S.Y		July 2019
	Project No:		Figure No.	
As Shown		18-519-102		1

Based on the long-term stable top of slope (LTSTOS) at Sections A-A to N-N, and our field observations, the recommended long-term stable top of slope line (Line S10-S11 ... S8-S9) is shown on Figure 1.

The derived the long-term stable top of slope (LTSTOS) line is based on the grade at the time of site survey for the topographic map in Figure 1. Where the grade elevation in the area along the creek slope has changed since the site survey, the location of long-term stable top of slope (LTSTOS) line may need to be adjusted.

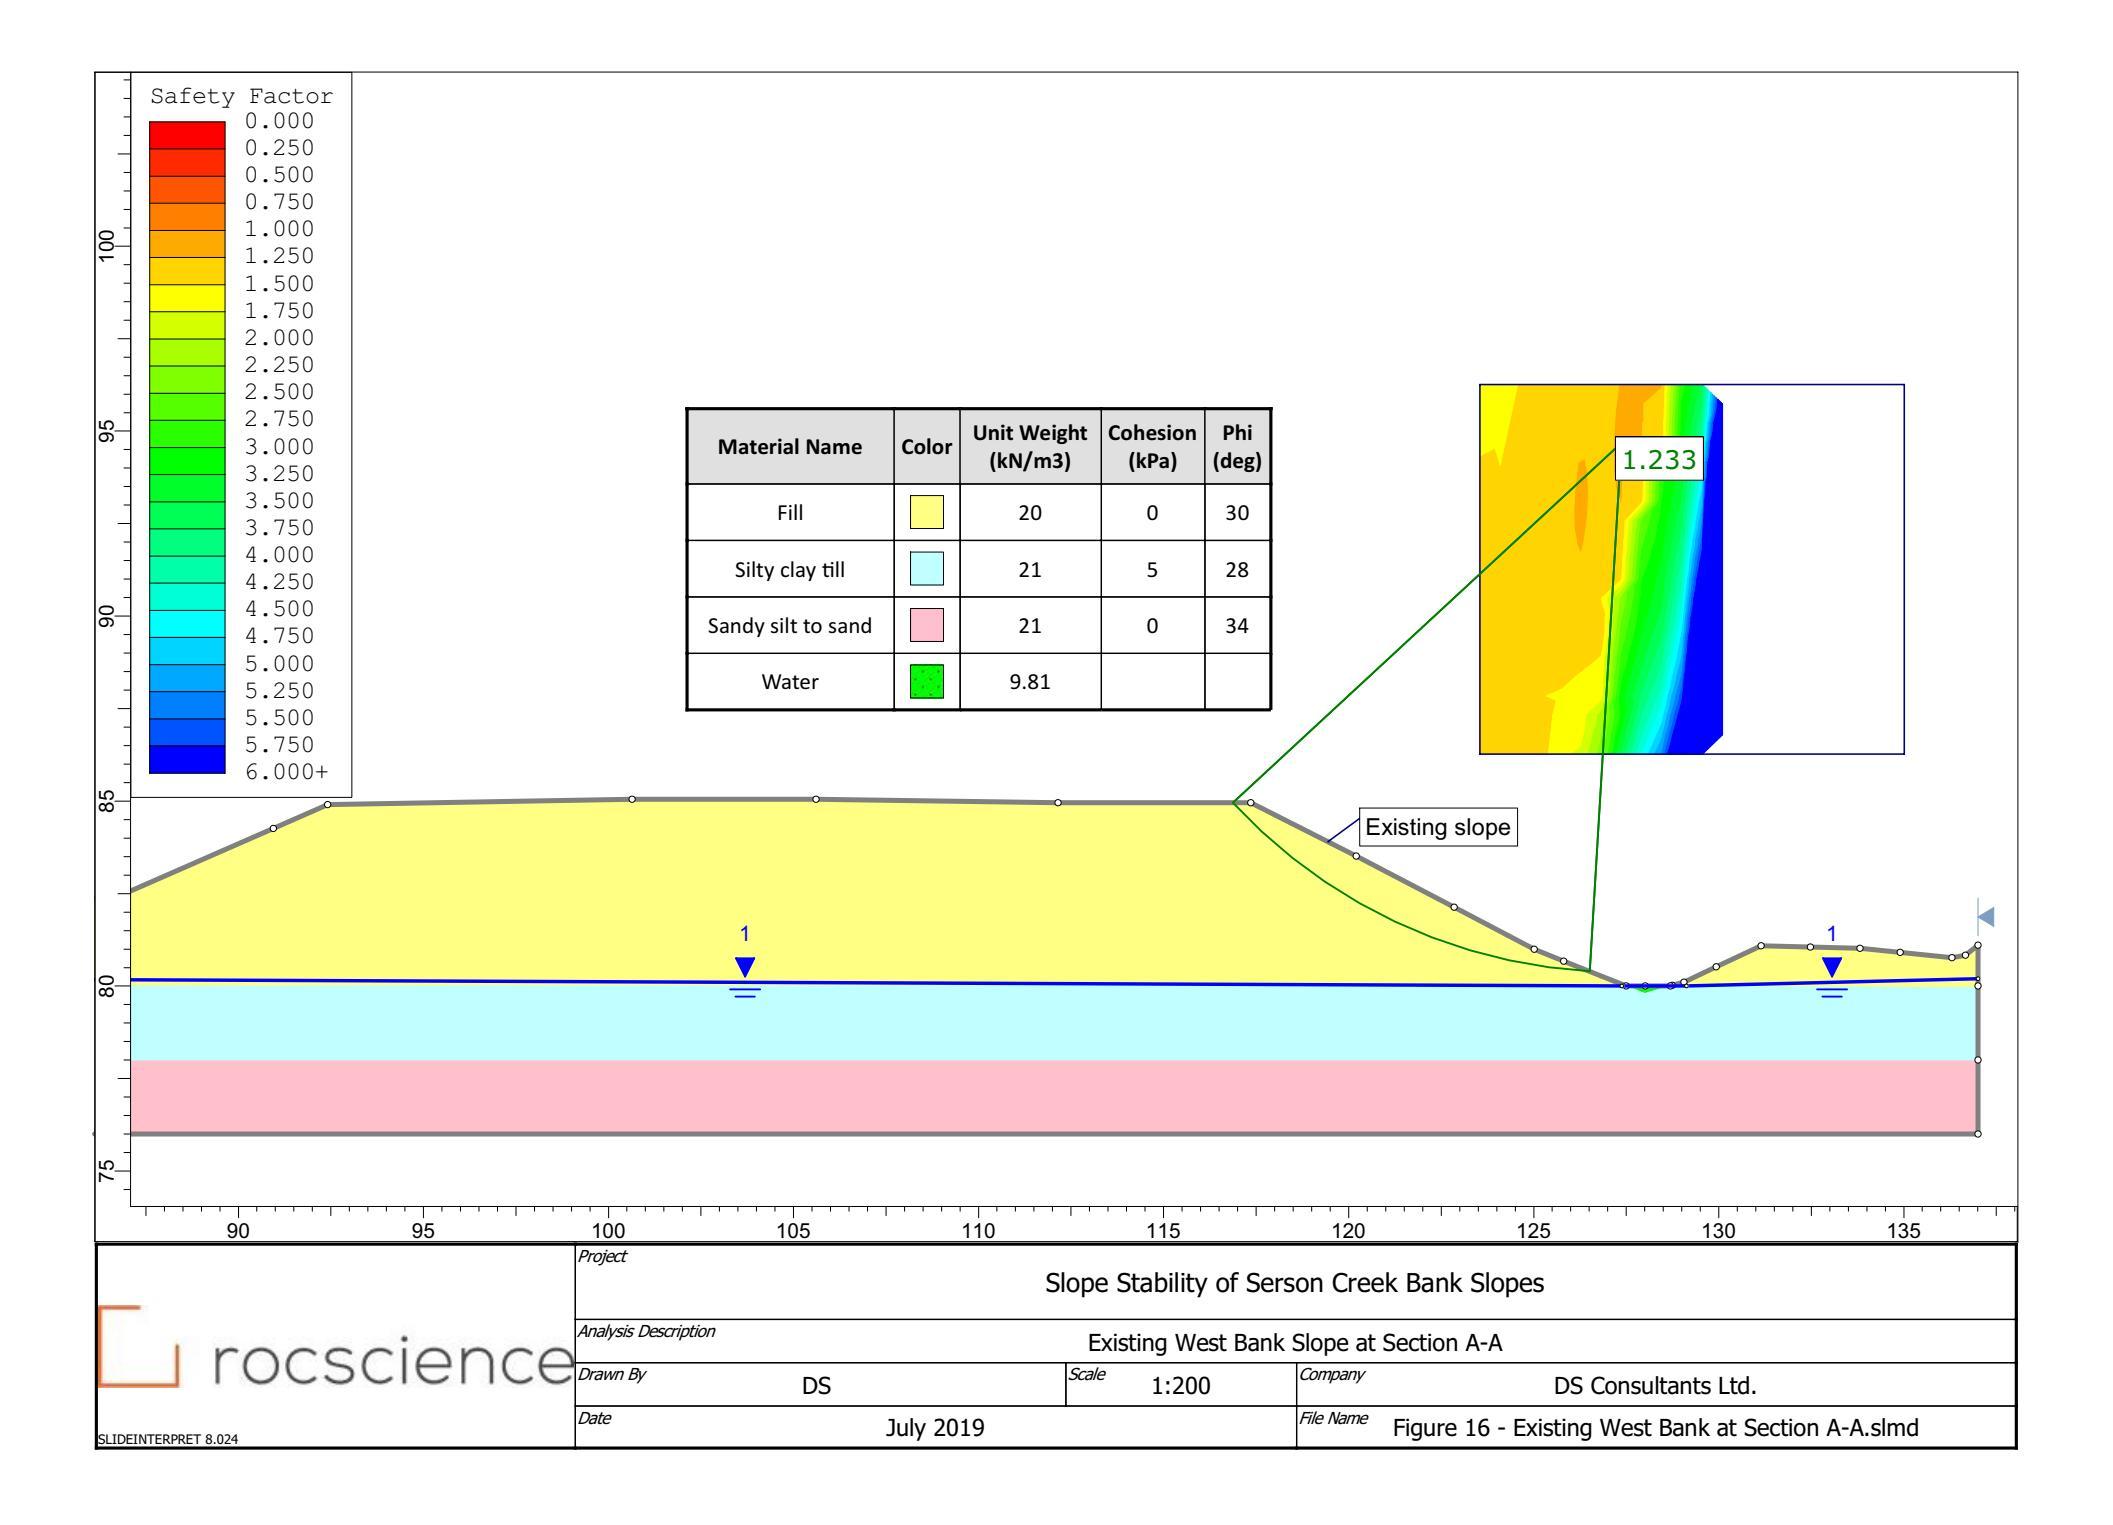
The existing slope profiles at Sections A-A to N-N (see Figure 1 for locations) are presented on Figures 2 to 15. Long-term stability analyses of the existing slopes at three typical Sections A-A, L-L and N-N have been carried out with the computer program SLIDE (Version 8) using the Simplified Bishop method, Simplified Janbu method and GLE/Morgenstern-Price method. The analysis results are presented in Figures 16 to 18 and are summarized on Table 2 below.

Slope Location	Approximate Steepness	Calculated Factor of Safety (FS)	Long-Term Stability	
Section A-A	2H:1V	1.23	FS<1.5. Not stable	
(See Figure 16)				
Section L-L	2 511.11	1 56	ES>1 5 Stable	
(See Figure 17)	2.311.17	1.50	13-1.5, Stable	
Section N-N	2 24.11	1 4 2	FC <1 F Not Stable	
(See Figure 18)		1.45

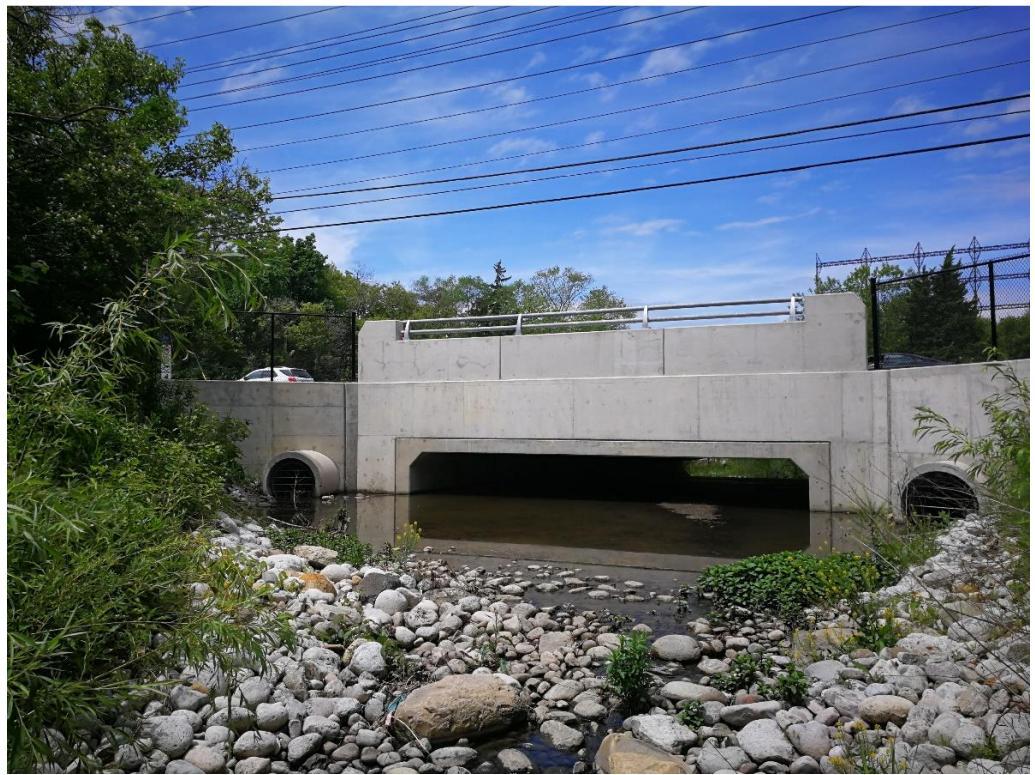
Photo B1: Creek and Concrete Culvert at Lakeshore Blvd (looking north - upstream)

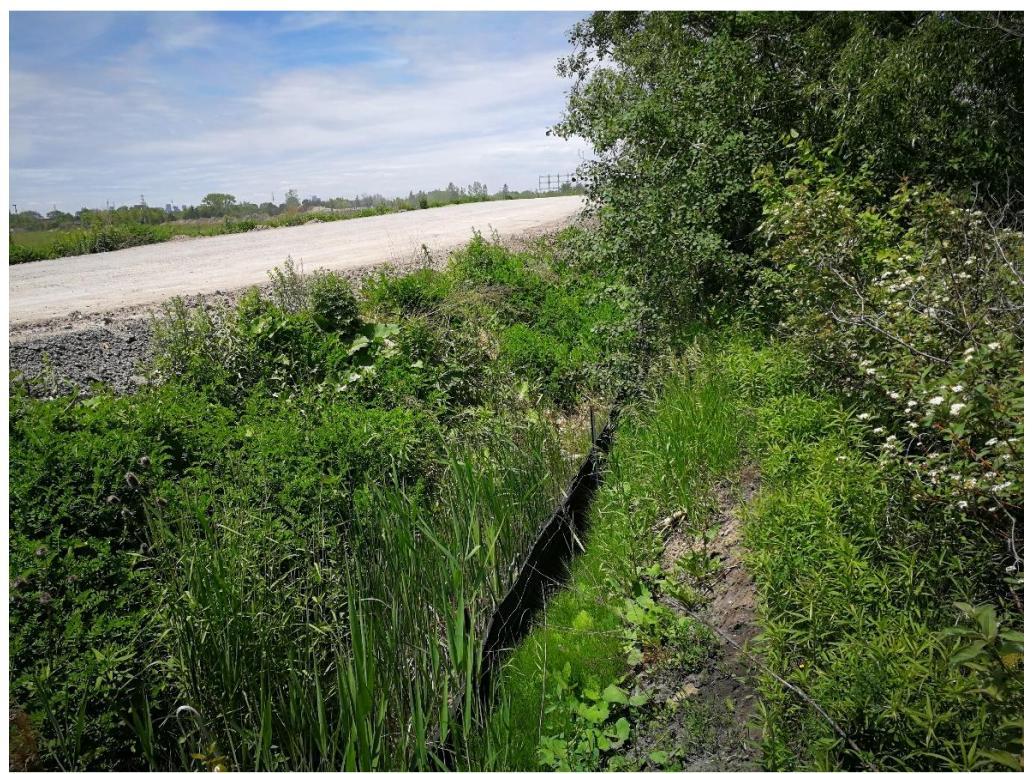
Photo B18: Ditch between Creek and Road at south part of Reach S2 area (looing north - upstream)

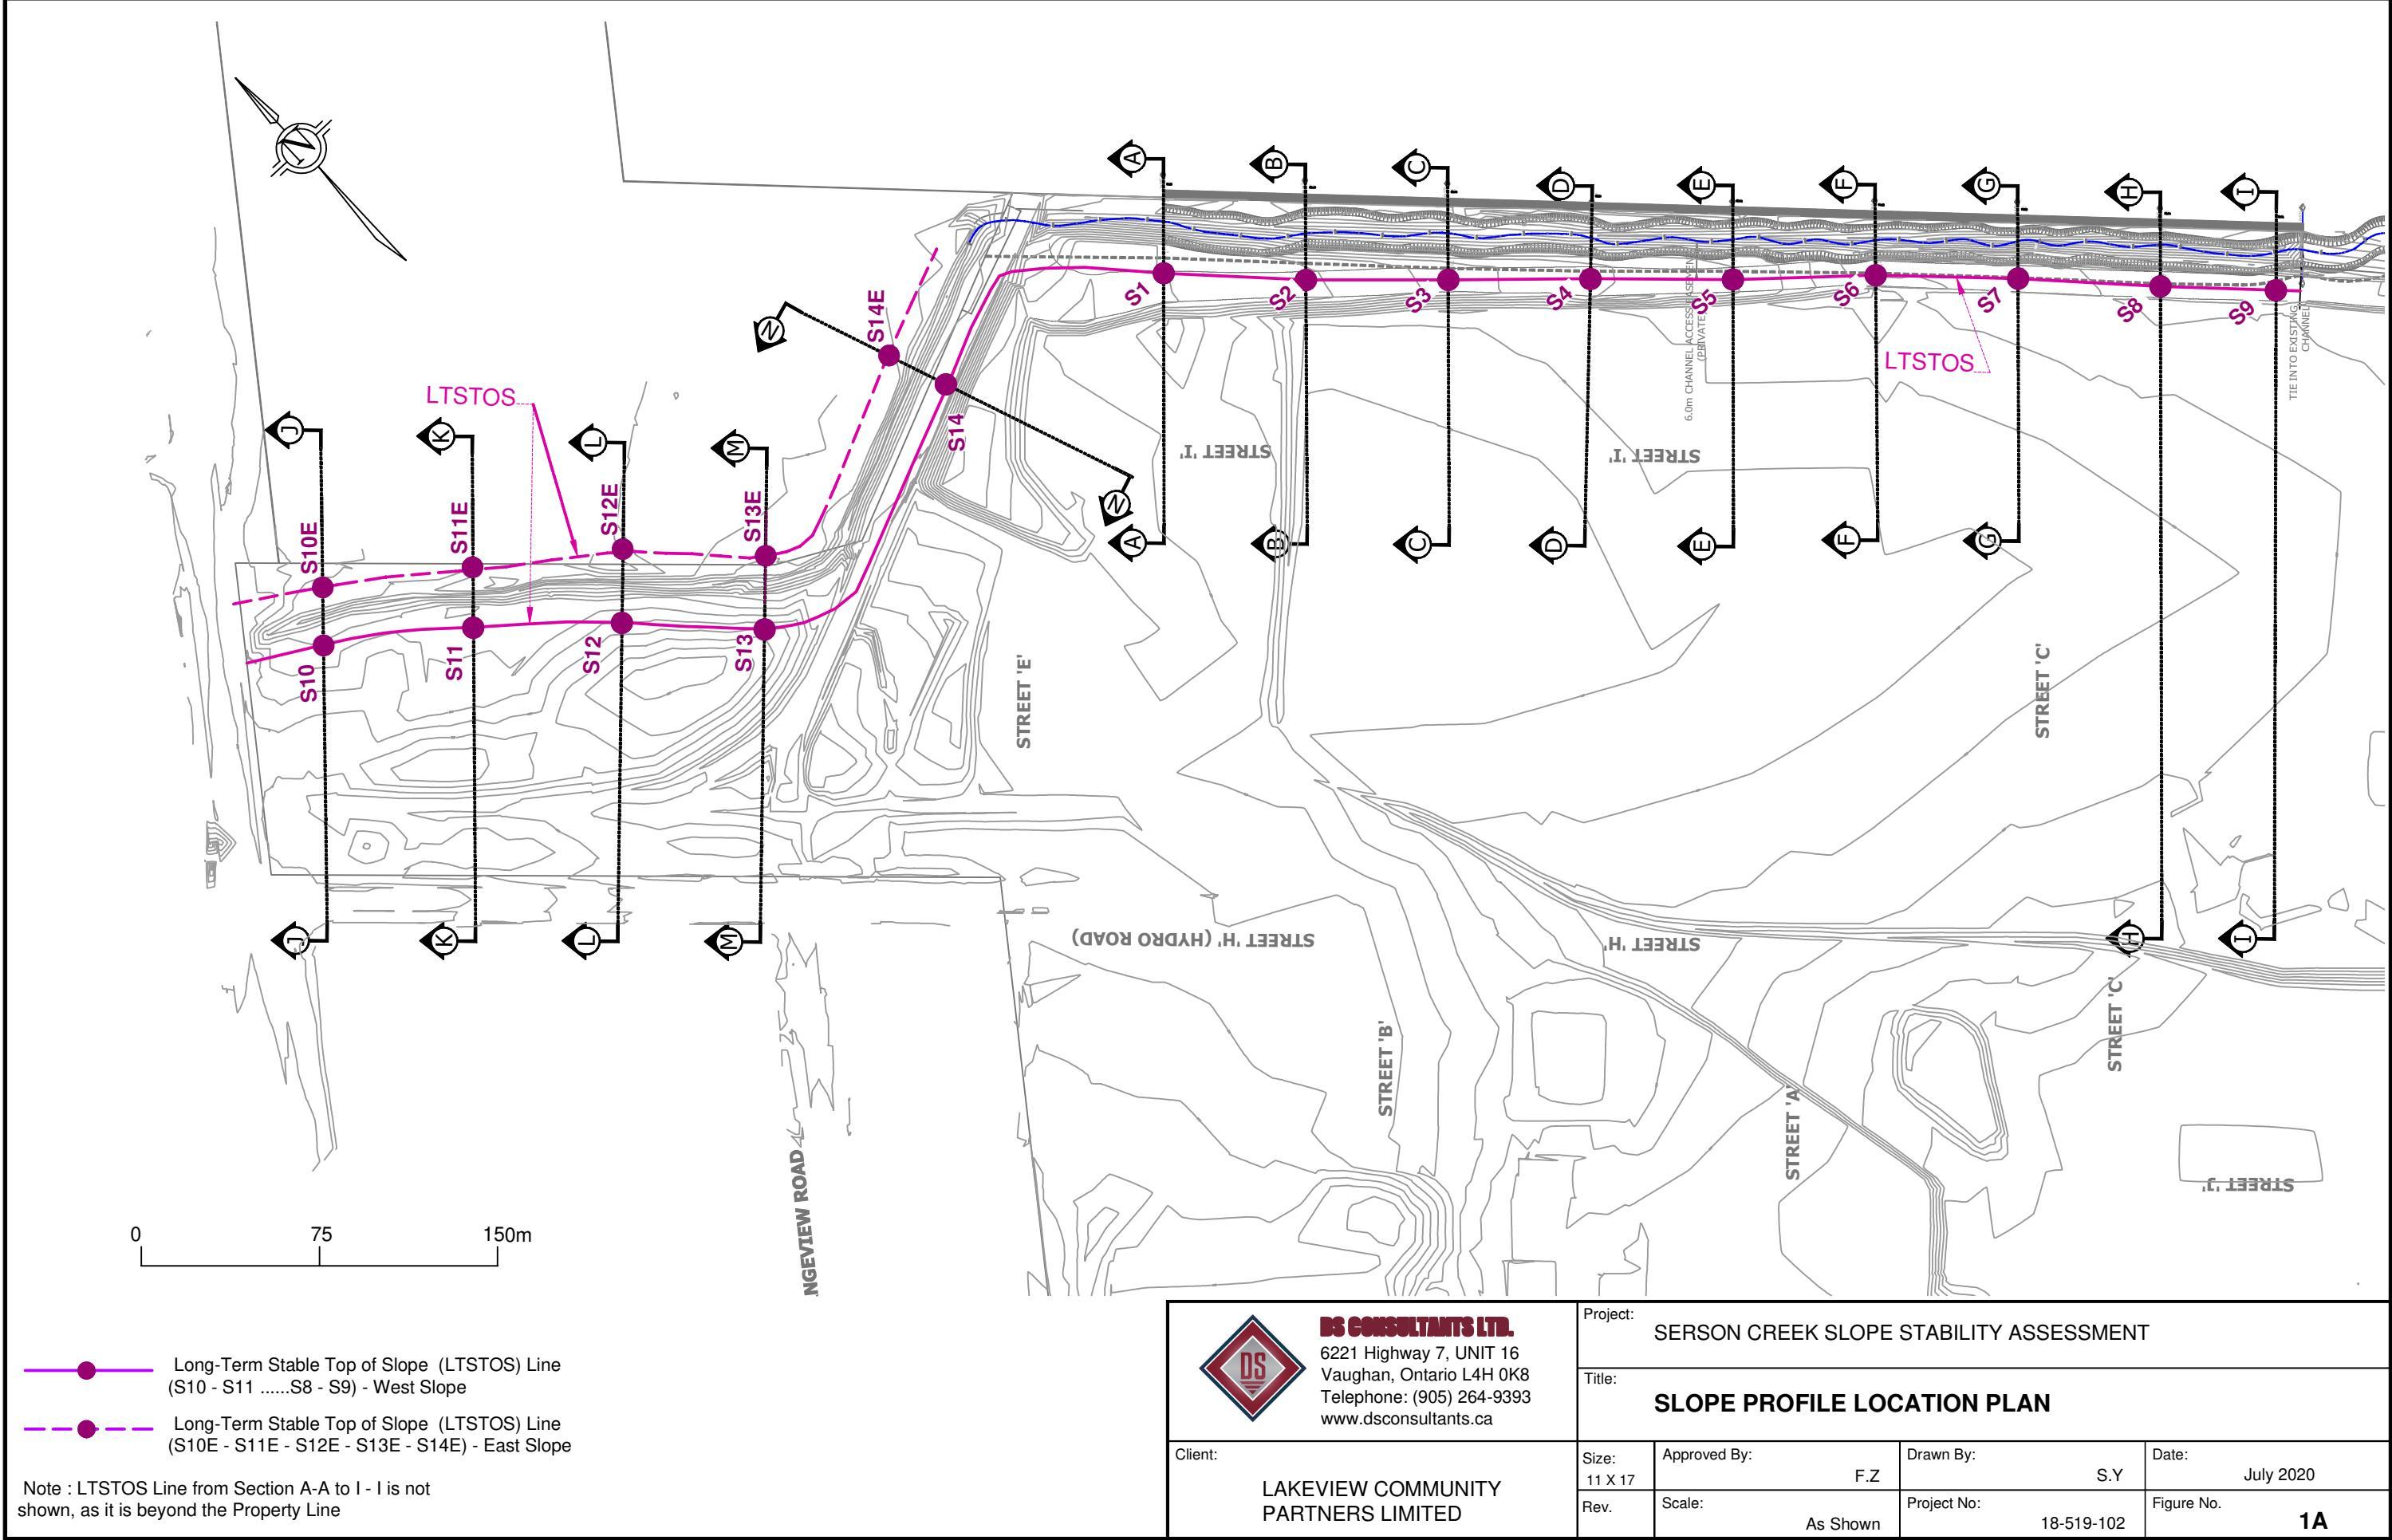
Drawn By:		Date:	
F.Z		S.Y		July 2020
	Project No:		Figure No.	
As Shown		18-519-102		1A

The existing slope profiles at 14 Sections (A-A to N-N, see Figure 1A for locations) were provided to us by Urbantech, as presented on Figures 2A to 15A.

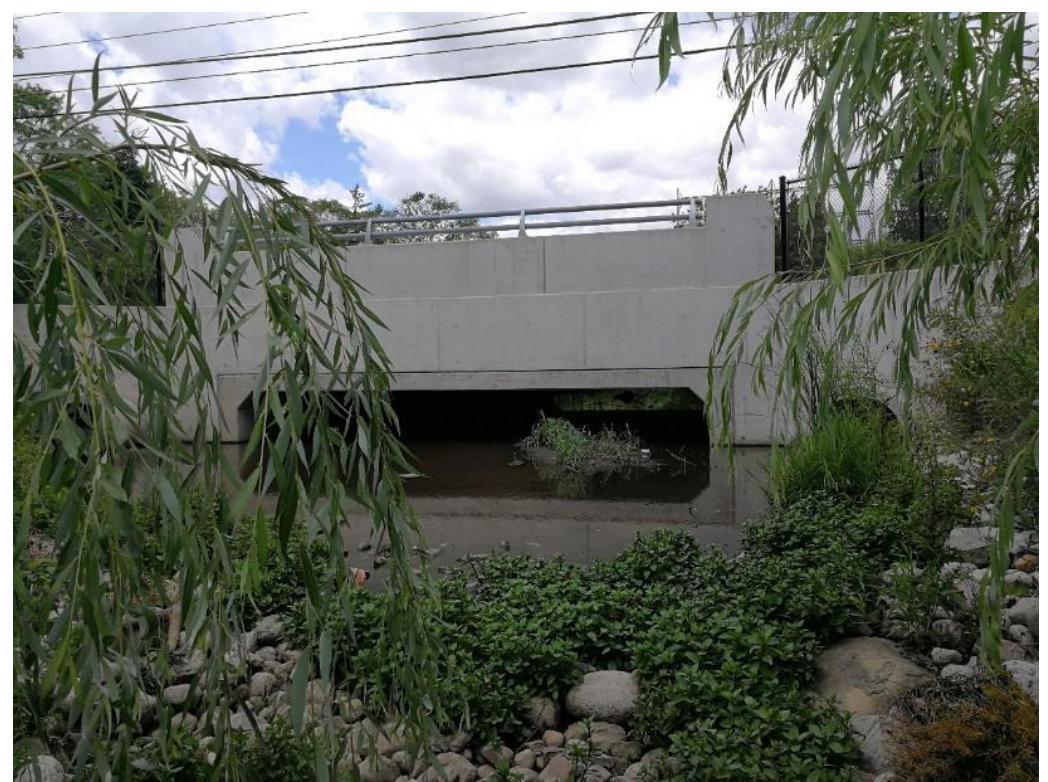
Photo 1: Creek and concrete culvert at Lakeshore Blvd (looking north - upstream)

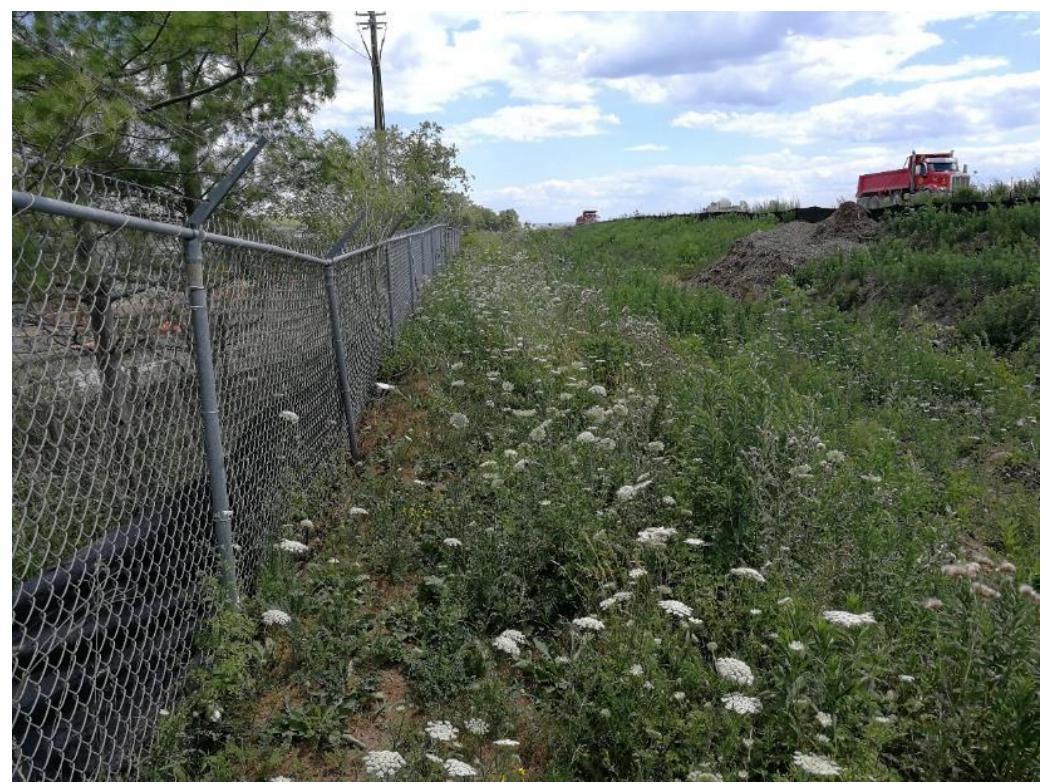
Photo 20: East slope near fence at middle-north part of Reach S2 (looking south - downstream)

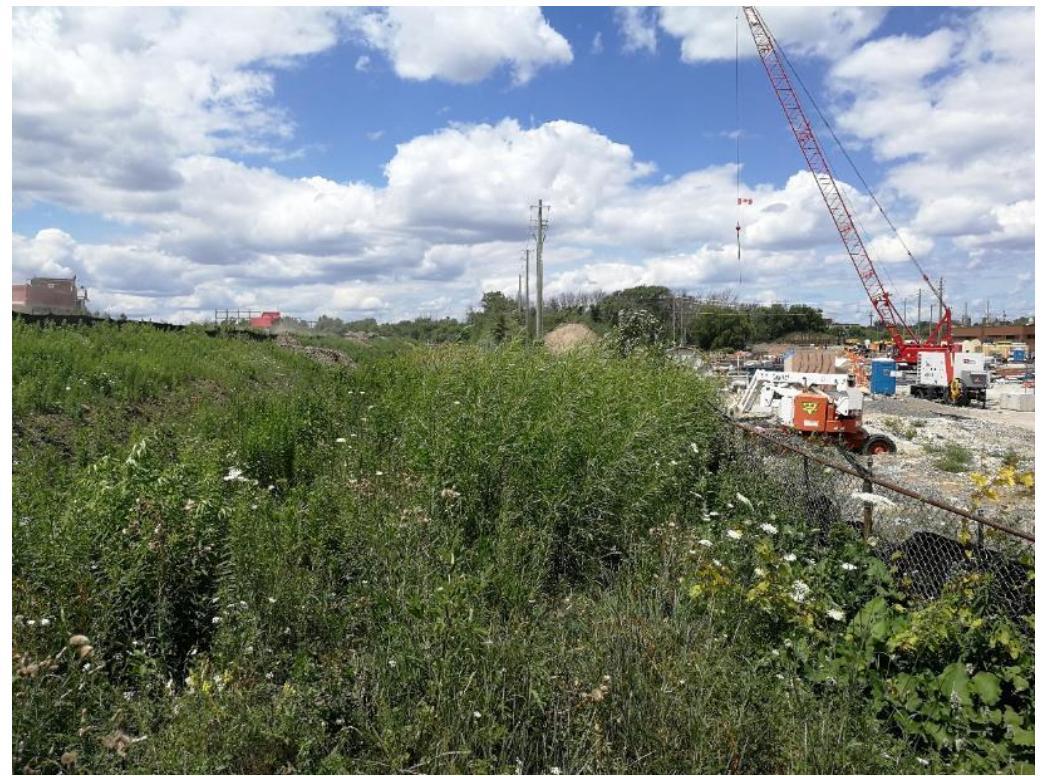
Photo 21: East slope near fence at middle-south part of Reach S2 (looking north - upstream)

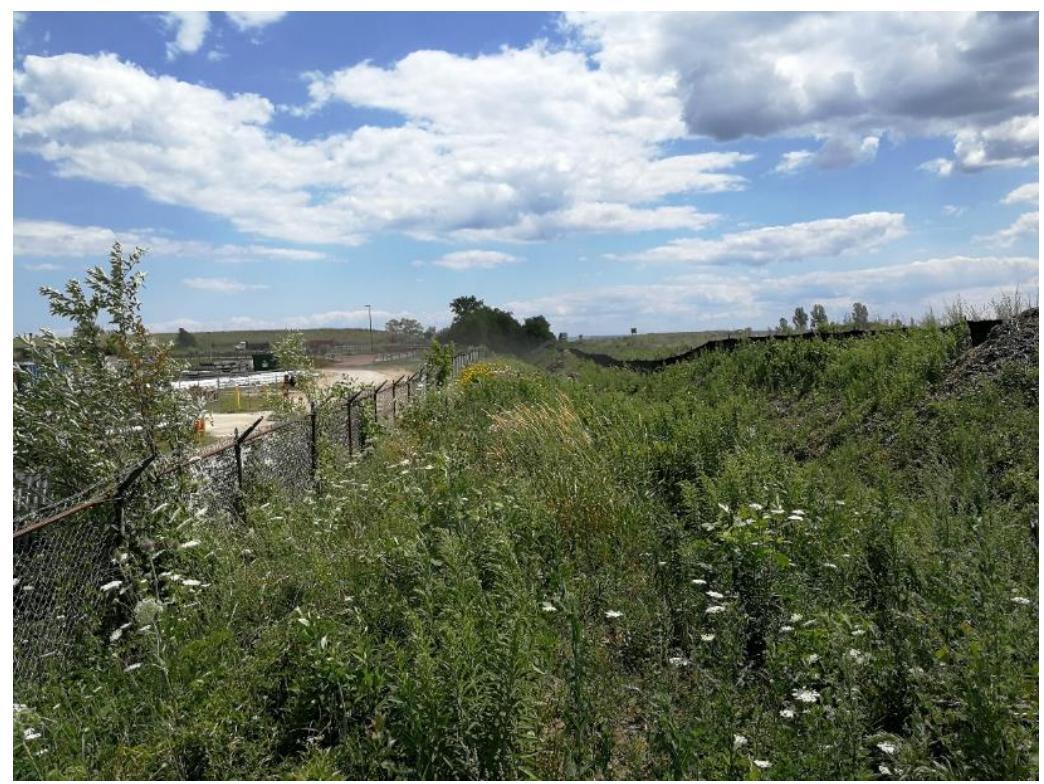
Photo 22: East slope near fence at middle-south part of Reach S2 (looking south - downstream)

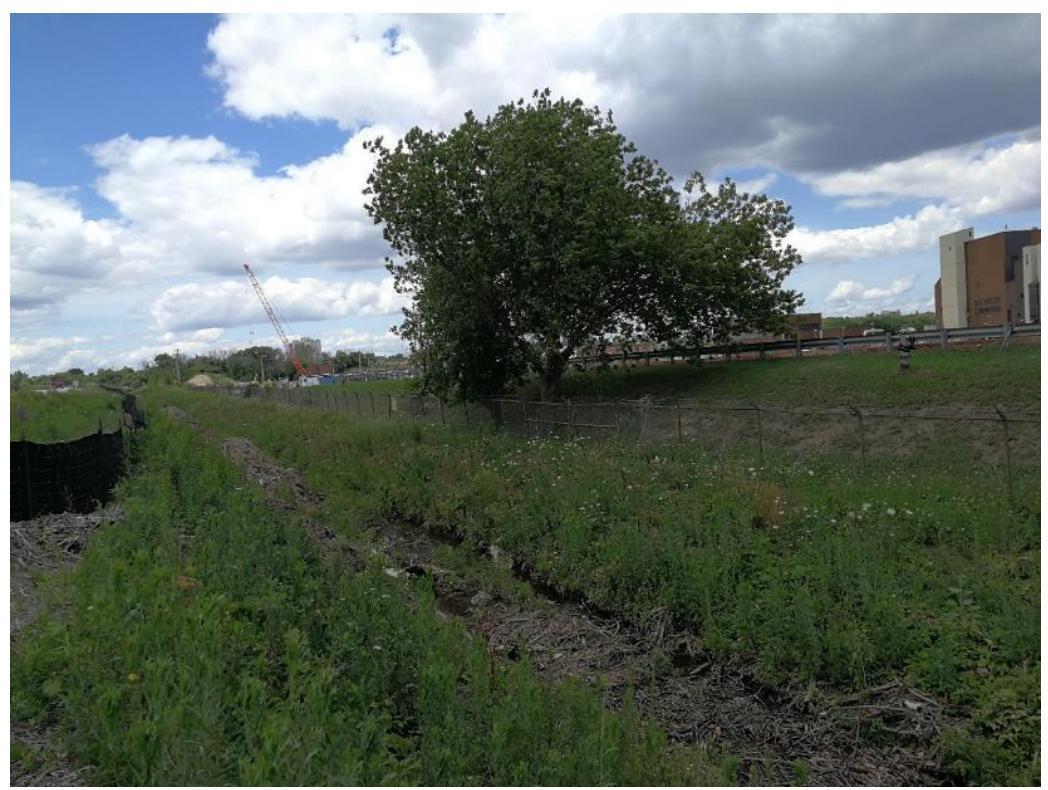
Photo 28: South part of Reach S2 (looking northeast from west side of creek)
