## **HANCOCK PROPERTY (NURSERY) - 2151 CAMILLA ROAD, MISSISSAUGA**

# **Building Condition Report**

**Report Number:** 09-1113-6182(5001)

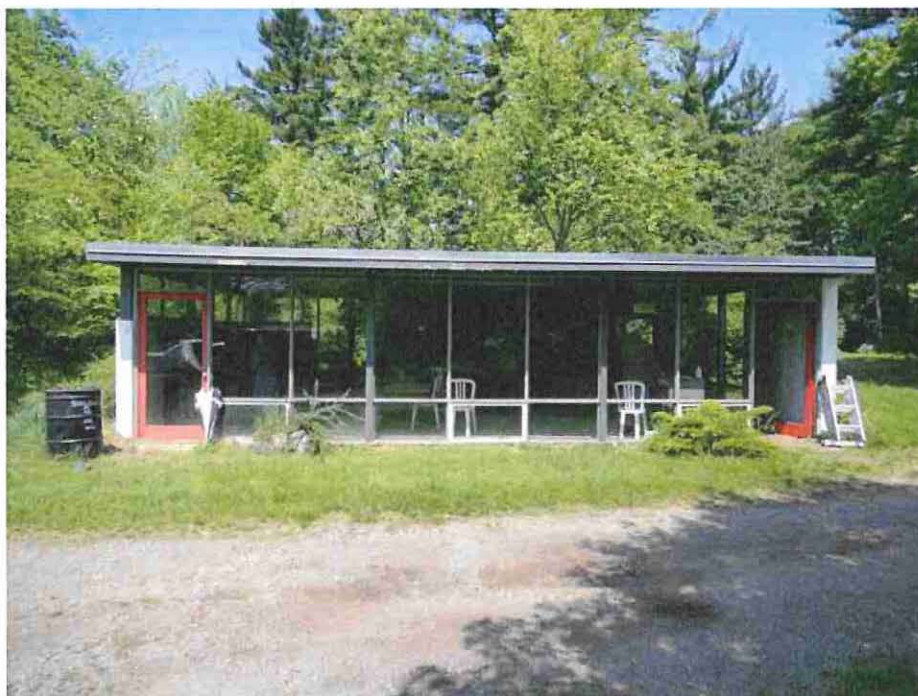
Photograph 1: General view of the front (east) elevation of Bldg. 1.

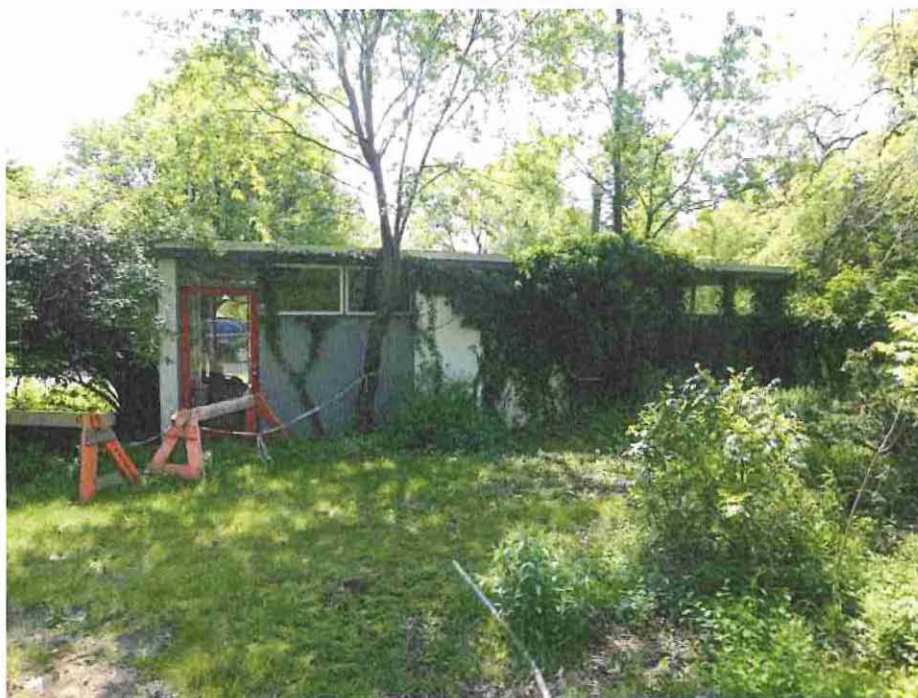
Photograph 2: General view of the back (west) elevation of Bldg. 1.

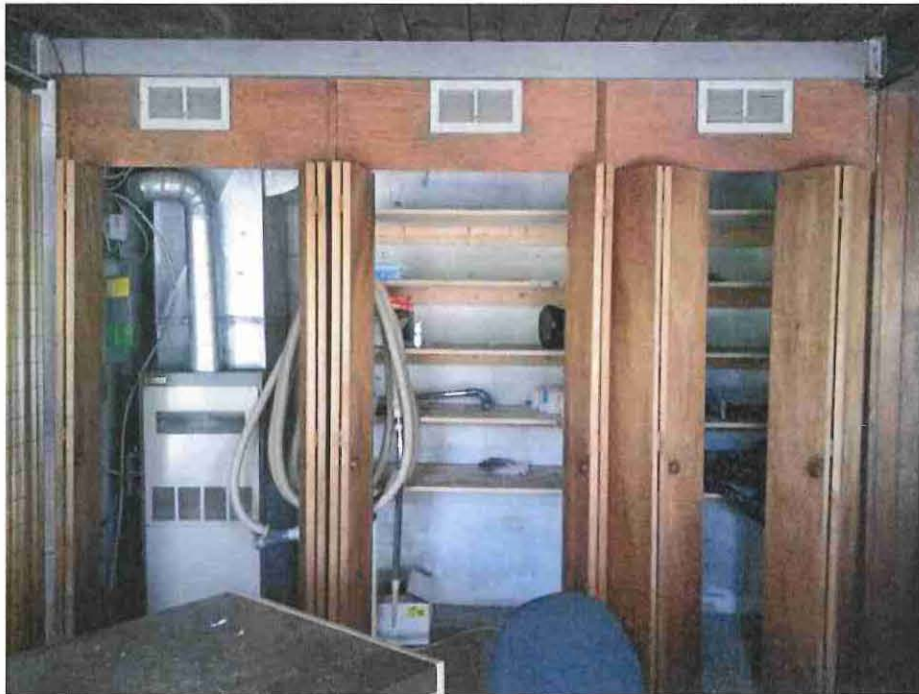
Photograph 9: Air distribution ductwork plus furnace at Bldg. 1.

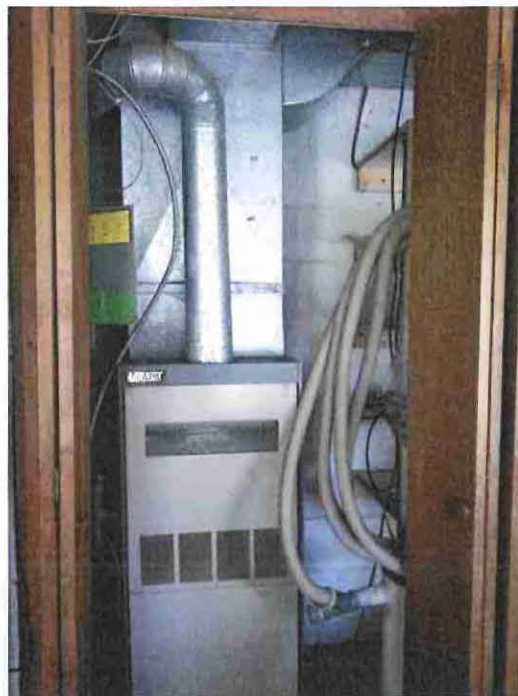
6.0 MECHANICAL	DESCRIPTION	COMMENT/ASSESSMENT
Heating and Cooling Systems	<p><b>Bldg. 1:</b> No cooling system is available for the building. Heating is provided by the gas (possibly propane) fired furnace "LENNOX", ducted to three locations (see photographs 9 and 10). No nameplate was identified for the unit. Furnace appears to have been connected to a former propane gas tank, which was located outside on the west end of the building and was not present at the of the Site visit (see photograph 11). Thermostat "White-Rogers" for the heating system is available inside the main room.</p> <p><b>Bldg. 2:</b> No cooling system is available for the Building #2. Heating is provided by two "TRANE" unitary unit heaters (see photograph 24). In-wall AC unit was found in one of the greenhouses. No nameplates were found on the unit. One of the greenhouses also contains finned tube hydronic radiators. Thermostats "White-Rogers" for the heating system are available inside the main room and greenhouses.</p> <p><b>Bldg. 3:</b> N/A</p>	<p>The "LENNOX" heating furnace in Bldg. 1 is in an acceptable condition based on Golder's high level assessment. However, gas furnace must be checked by a qualified HVAC contractor, before it is put back into service. Replacement of the gas furnace should be anticipated. Servicing and remedial repairs can be performed at a cost less than the Capital Threshold.</p> <p>Golder recommends connecting the furnace to the main gas line supplied by Enbridge Gas instead of feeding it off a standalone propane gas tank.</p> <p>The finned tube radiators in Bldg. 2 are rusted in some areas, and appear to be abandoned. Removal of the abandoned equipment is recommended.</p>

Photograph 10: Lennox gas/propane furnace located in Bldg. 1.

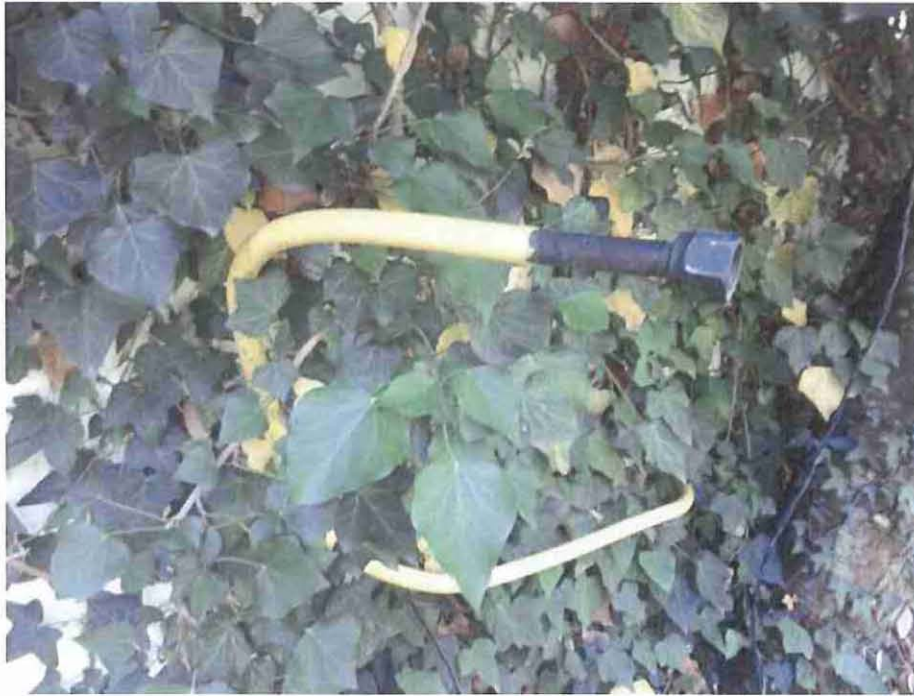
**Photograph 11:** Gas Line from Bldg. 1 furnace, previously was connected to a standalone propane tank.

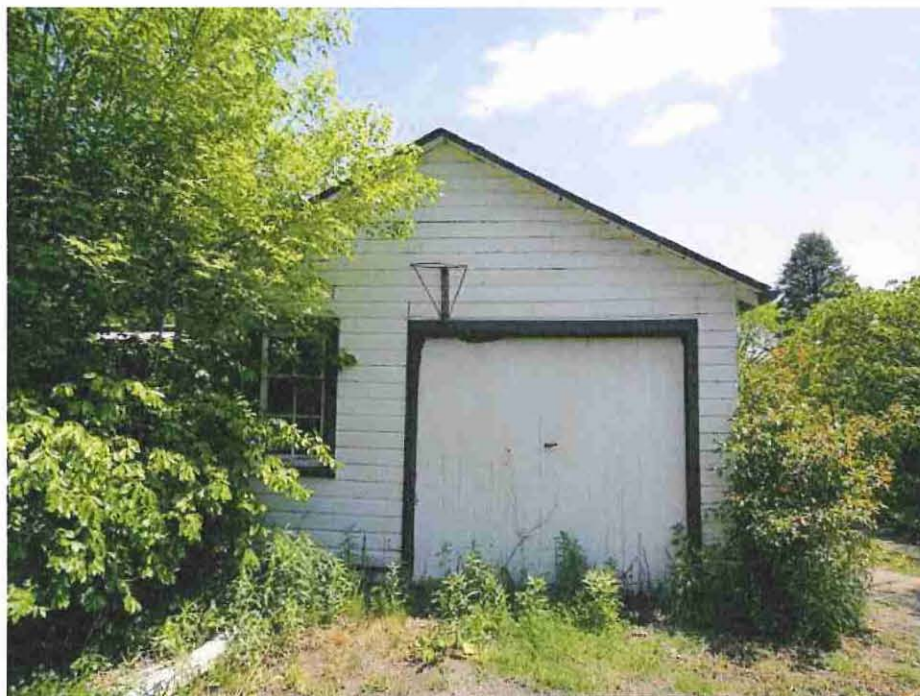
**Photograph 13:** General view of the west elevation of Bldg. 2.

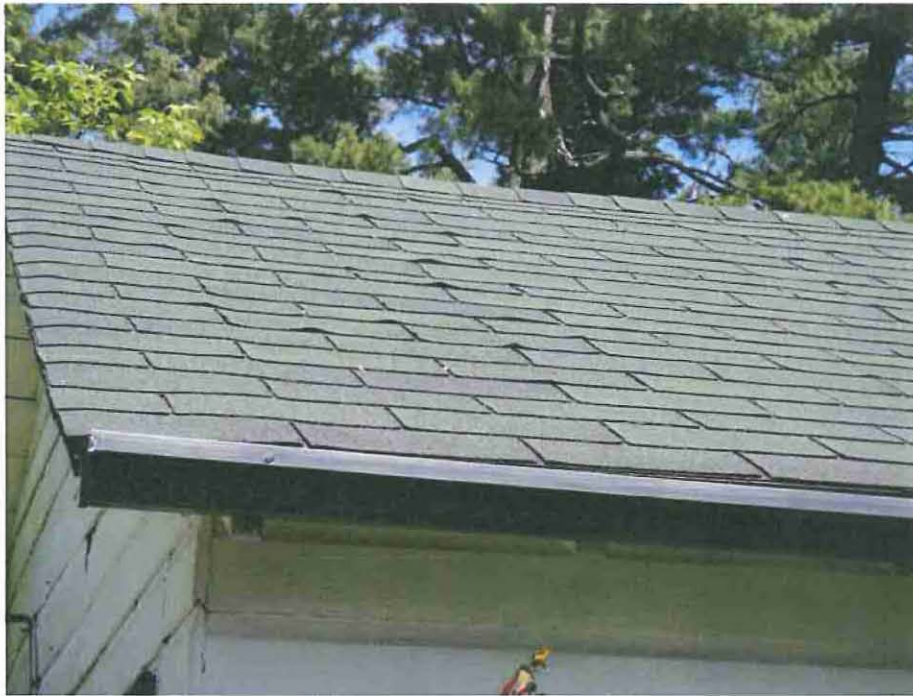
Photograph 15: Sloped gable roof with asphalt shingles over Bldg. 2.

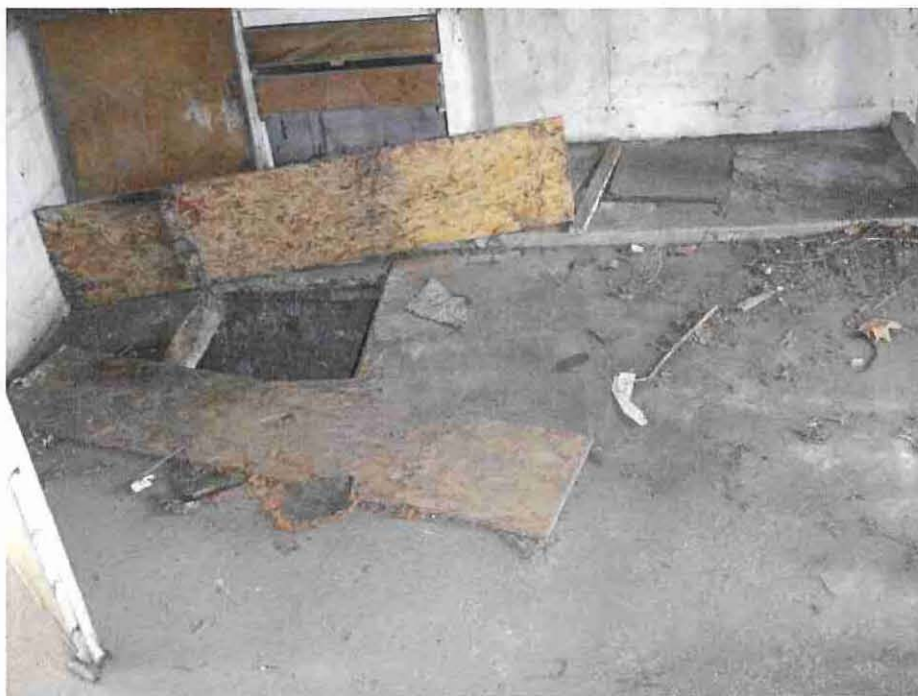
**Photograph 17:** Opening to the underground cistern at the east end of Bldg. 2.

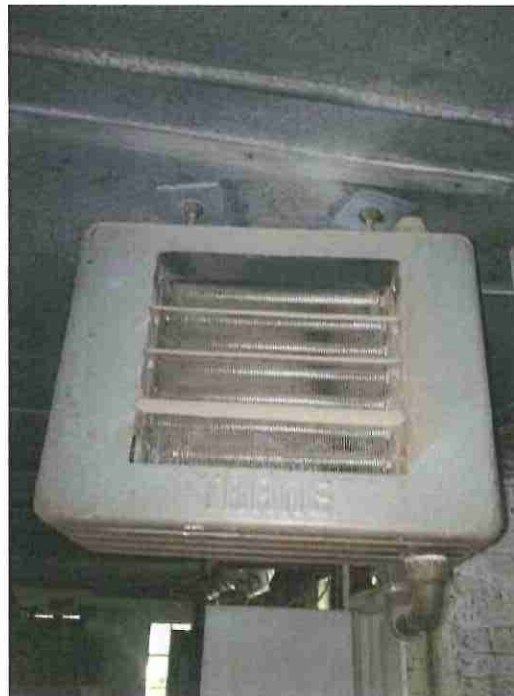
Photograph 24: Typical hydronic unit heater in Bldg. 2.

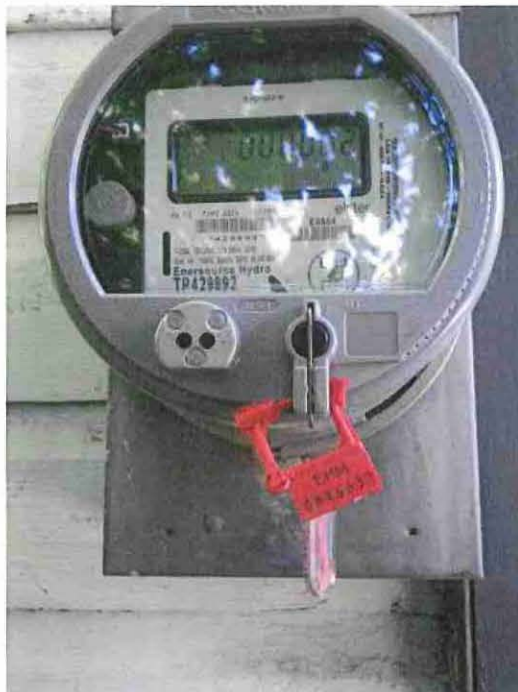
**Photograph 26:** Power meter mounted to the west elevation of Bldg. 2 that serves the entire complex.

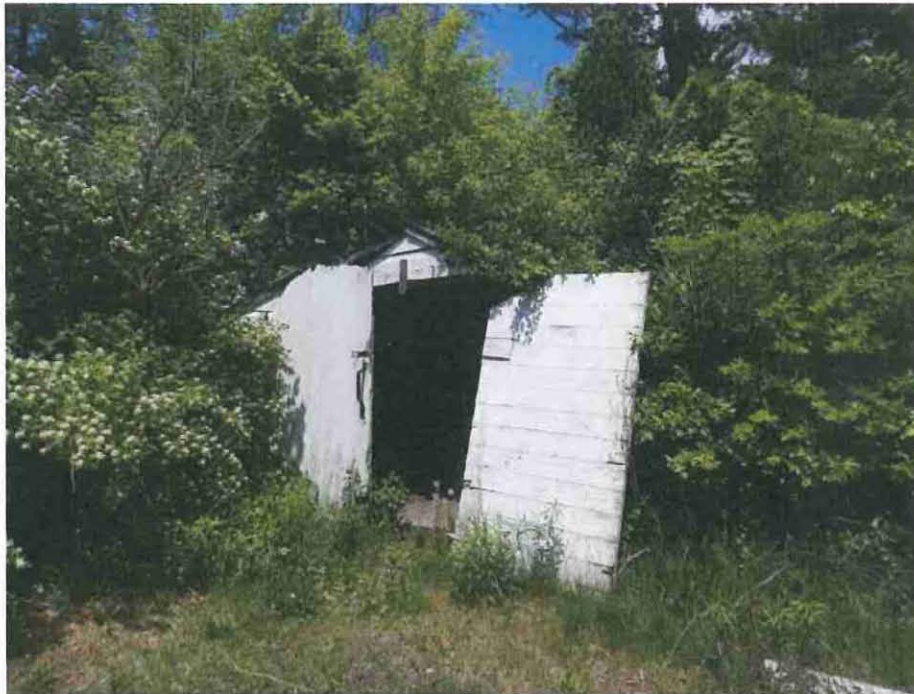
Photograph 27: General view of the front (south) elevation of Bldg. 3.
