Heritage Advisory Committee
OCT 22 2013

Long Branch Outdoor Rifle Range

Cultural Heritage Assessment

Re: Heritage Facilities Restoration and Repairs Report – Benares Estate

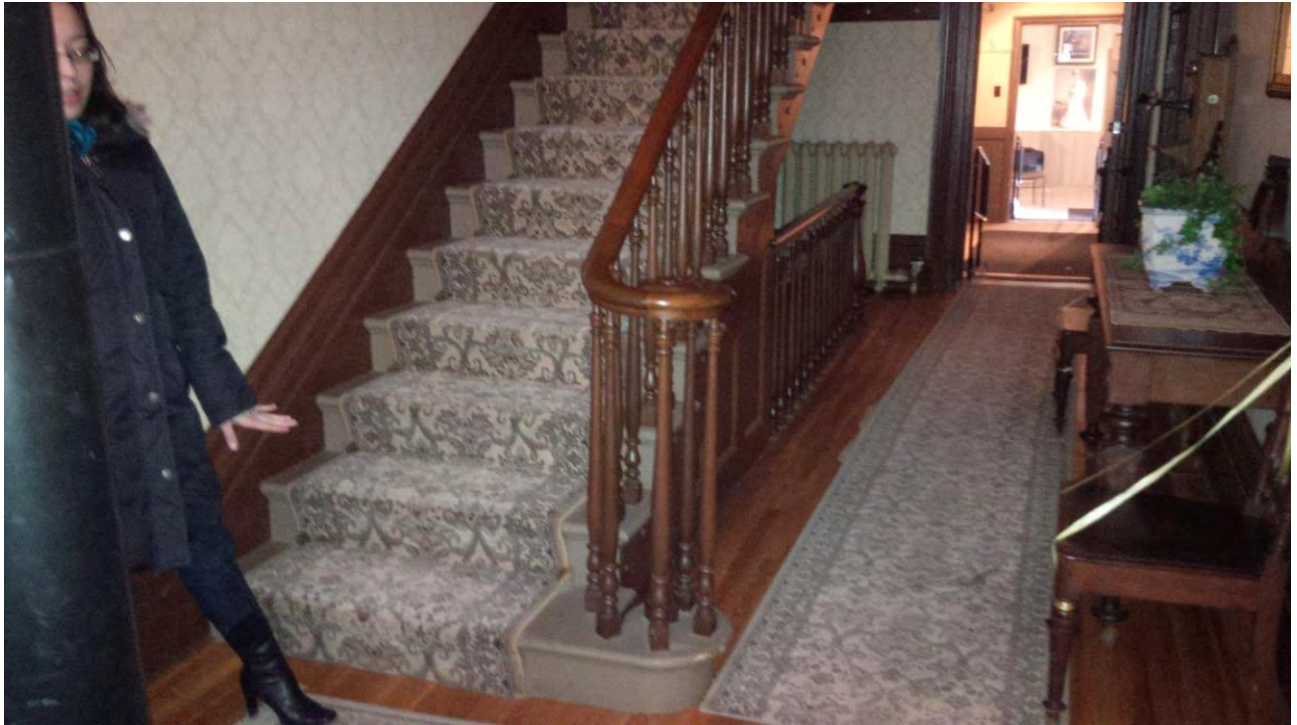
5.2.5. Main House – Existing grand staircase with carpet runner at Ground Floor level.

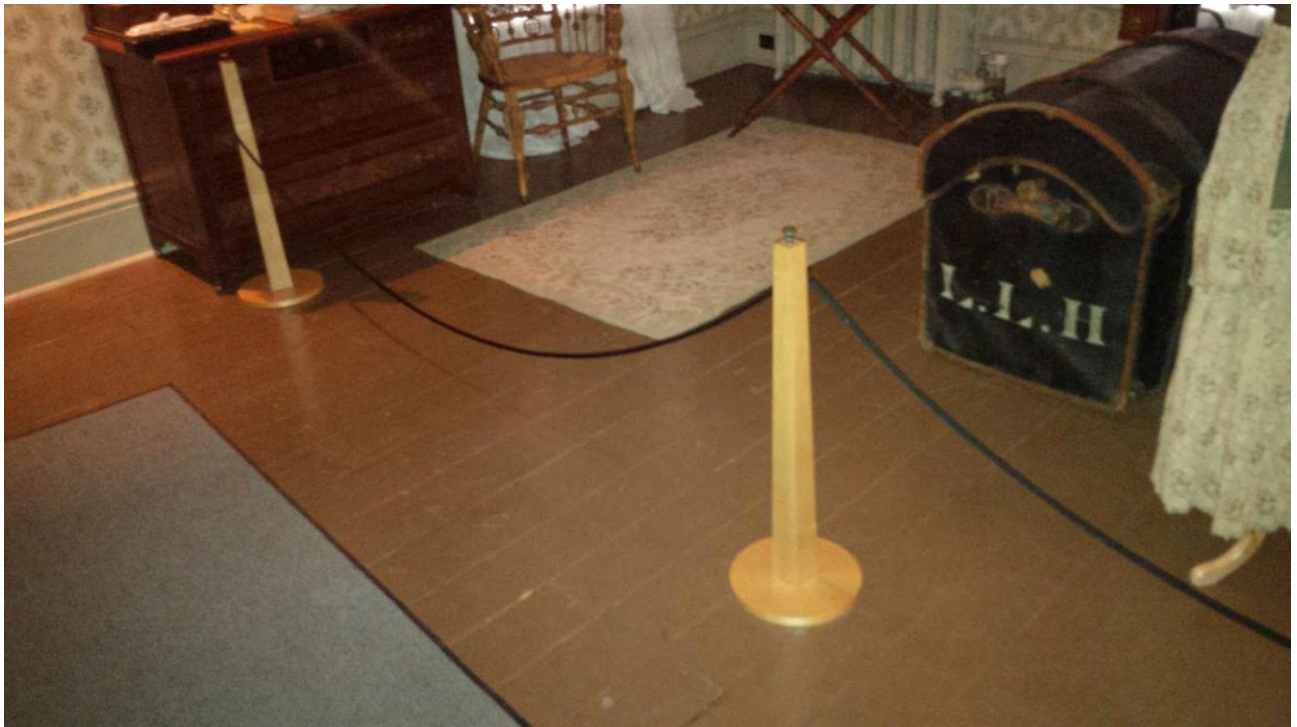
5.2.4. Main House – Example of original plank flooring throughout Second Floor level.

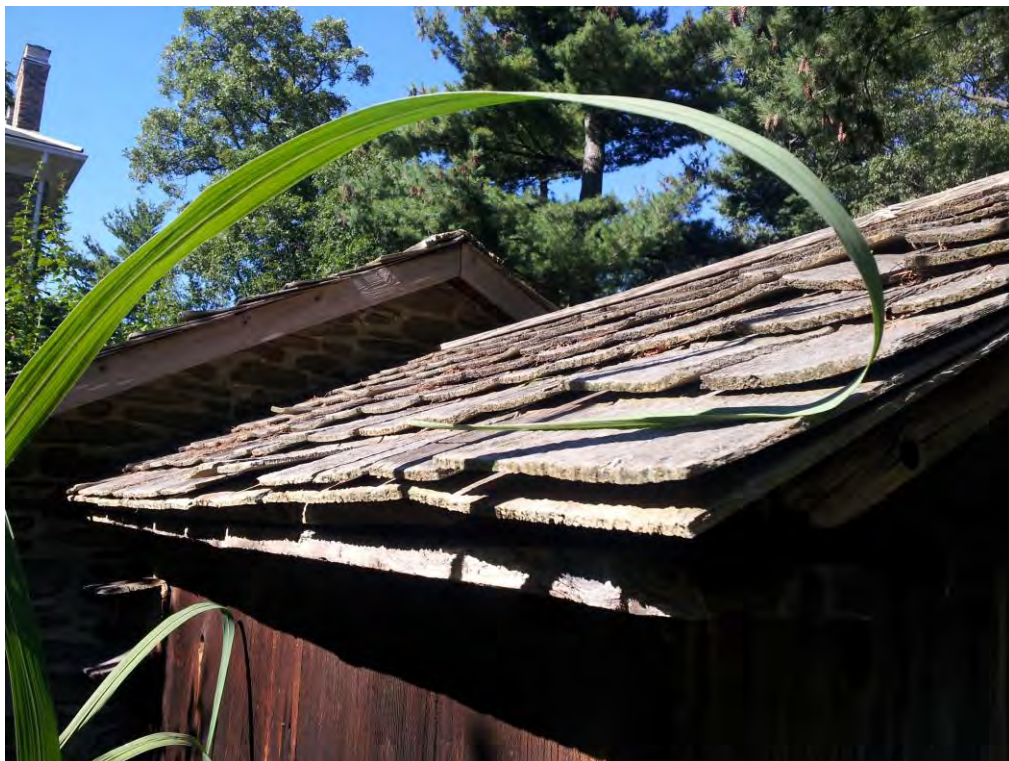
- 2.2 Dairy House – Access to the inside of the Dairy House was not possible as the lock has been seized up and not able to open. In reviewing the exterior structure, the existing cedar shingles appear to be distressed and in need of replacement. The condition of the underlying sheathing boards is not know at this time, as is the condition of the wood roof framing, and would therefore need to be reviewed either during the construction, or prior if possible.

5.2.6. Dairy House – Sample of deterioration and weathering of cedar shingles and fascia boards.

- 3.2 Dairy House – Once access to the inside of the Dairy House is provided, a review of the conditions of the roof structure can proceed. The exterior cedar shingles is to be removed including all trims. The existing board sheathing and fascia boards will be reviewed to determine the extent of repairs and or replacement that is required. New cedar shingles, to match style and appearance of existing, is to be installed including new moisture membranes, ventilation sleepers and flashings per specifications.

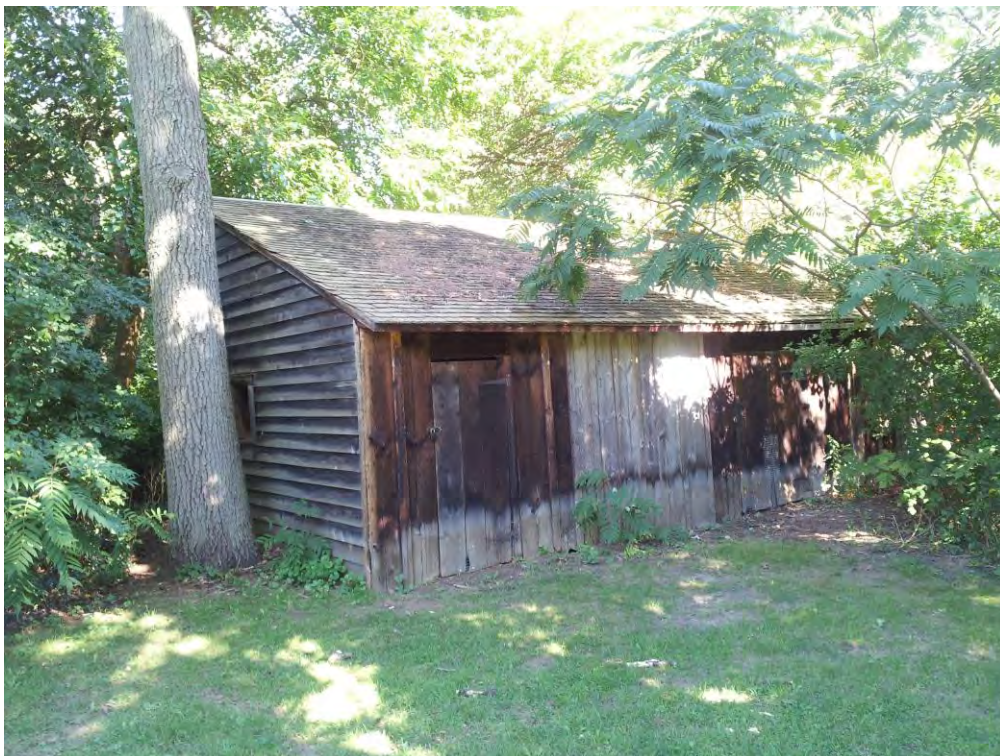
- 2.4 Potting Shed – The condition of the existing wood floor boards in the interior public spaces are of similar condition to that of the Barn. Therefore the restoration and repairs will be of a similar nature to that of the Barn.

5.2.8. Potting Shed – Area to be restored and exposed to public view is through door on left.

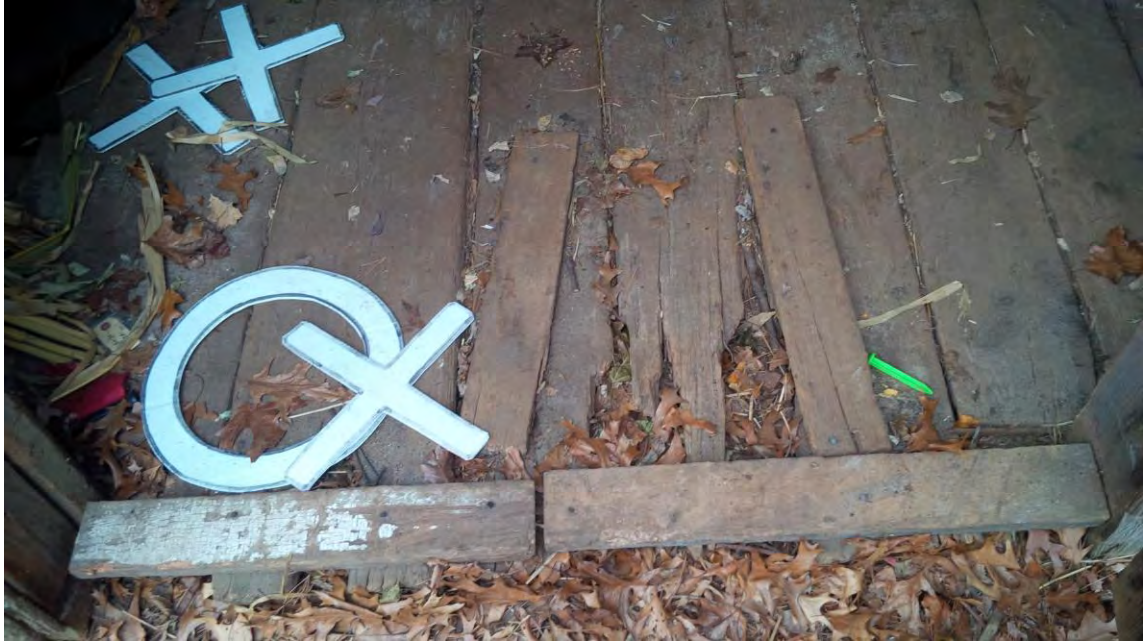
- 2.3 Barn – Upon visual inspection of the interior public spaces of the Barn, it was reviewed that some of the floor boards have deterioration, separation and a need for replacement to maintain a safe environment for the public and City Staff. It was discussed with City Staff that the boards being removed from the Bradley Museum restoration work can be milled for possible replacement at the Benares Barn and Shed.

5.2.9. Typical example of deterioration and wear of Barn and Potting Shed floor boards.

- 3.3 Barn – A review and inventory of existing boards that are deteriorating and in need of repair and / or replacement will be performed prior and during early stages of removal. Once boards have been identified and removed, the condition of the underlying presumed earth will be reviewed and extent of repair and preventative maintenance will take place. It is recommended that a lean concrete mix ‘mud mat’ to help prevent further movement and minimize moisture migration. Existing floor boards are to be modified and re-installed where possible, with excess material coming from milling board material salvaged from the Bradley Museum works.
- 4.4 Potting Shed – Repairs and restoration will be of similar nature and procedures as the Barn above.

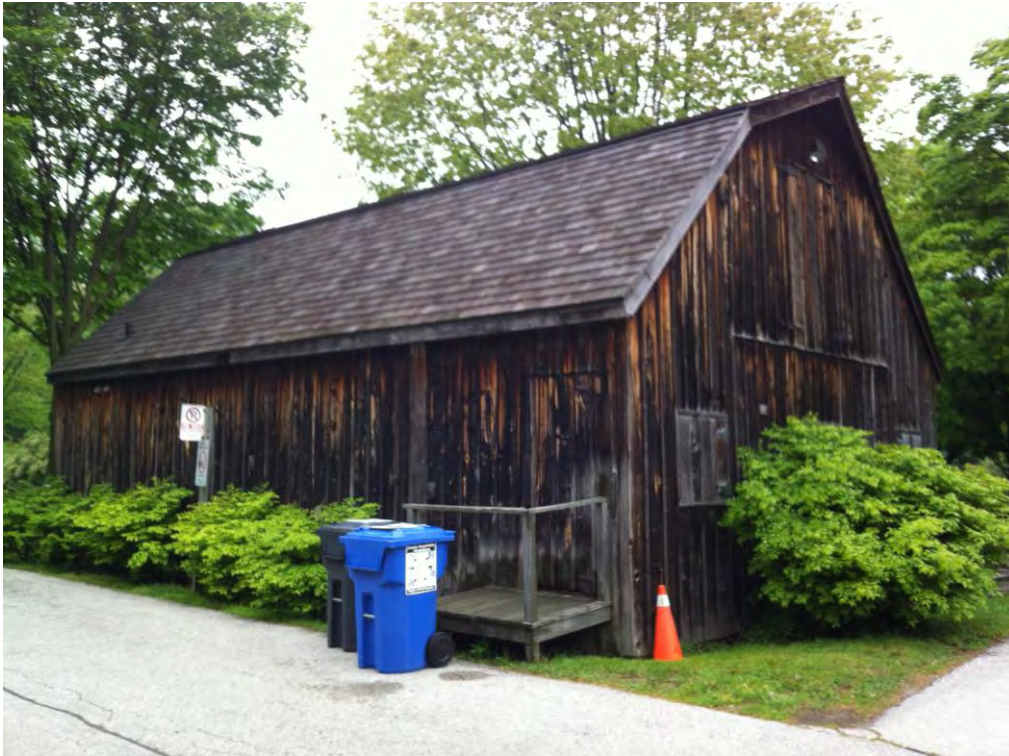
- 2.1 Barn – Upon visual inspection of the roofing assembly, no visual deterioration was noticed and since the shingles have recently been replaced, it was determined that replacement is not necessary at this time. The vertical wood board and batten siding shows signs of deterioration and weathering, and it was determined that removal and replacement is required. This Office will work with the successful Contractor to review and select products for submission to City Staff for final review and acceptance.

5.2.1. Barn – Elevation showing discoloration and uneven weathering.

- 1.1 Barn – Removal of existing vertical board and batten wood siding, and replace with new wood siding to match profile, composition, finish and colour. Repair any framing members as required prior to new siding installation. Review condition of roofing assembly.
- 1.2 Wood Shed – Removal of existing vertical siding and replacement with boards removed from Barn above to be installed in similar direction and composition as existing. Repair any framing members as required prior to siding installation. Review condition of roofing assembly.

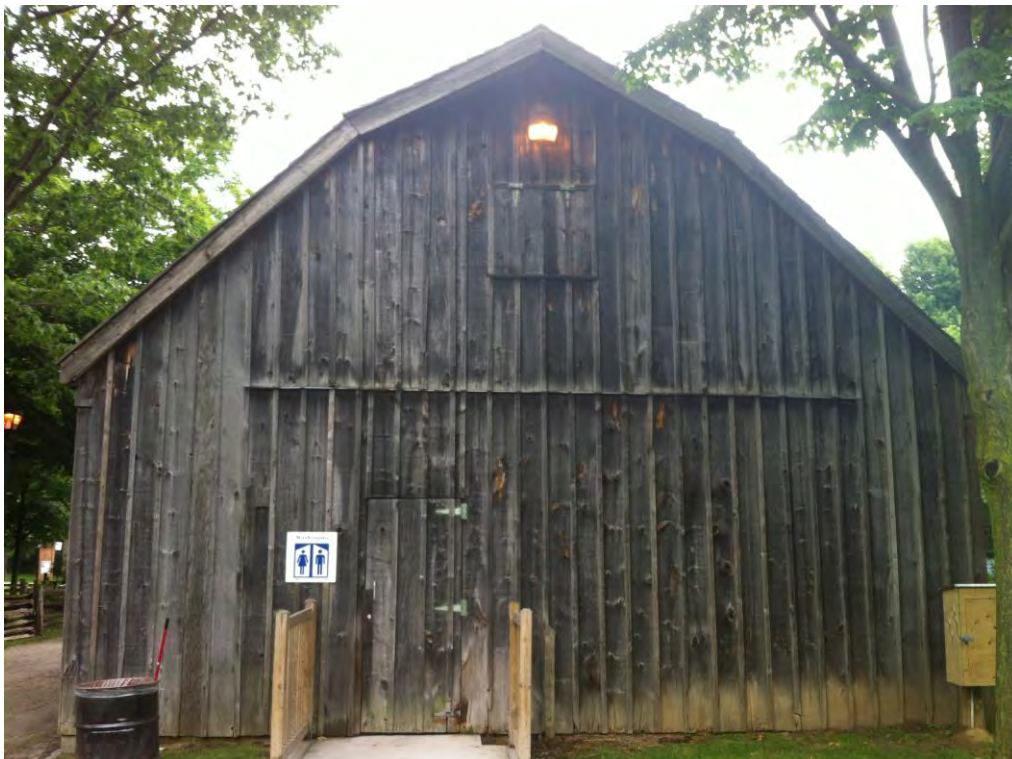
5.2.2. Barn – Elevation showing uneven weathering and separation of joints.

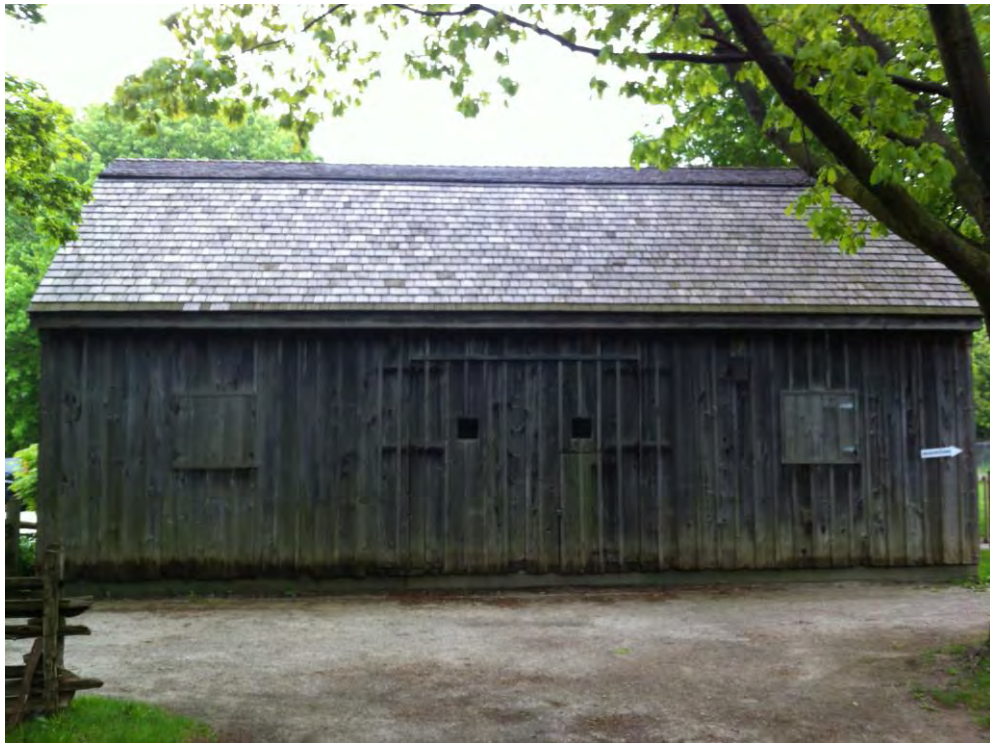
5.2.3. Barn – Elevation showing features to be maintained and replicated.

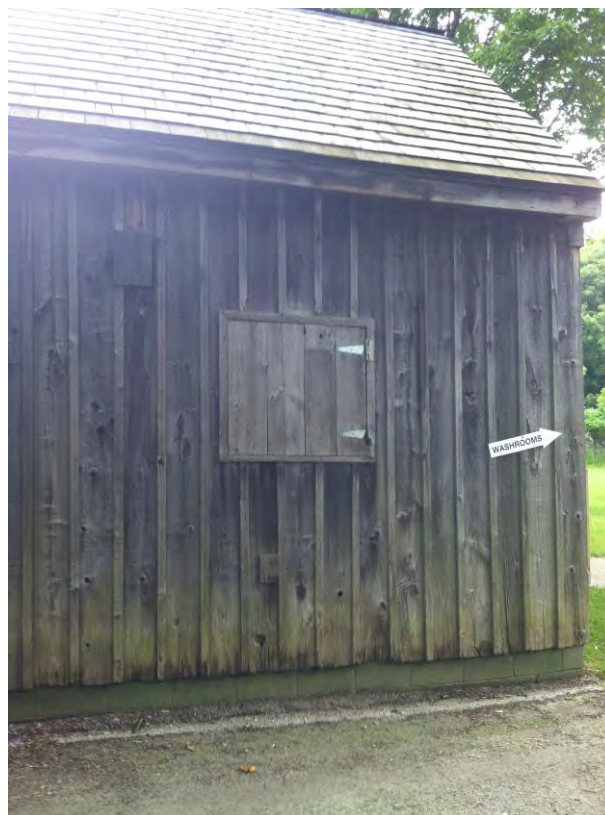
5.2.4. Barn – Detail elevation showing weathering of boards at base of exterior walls.

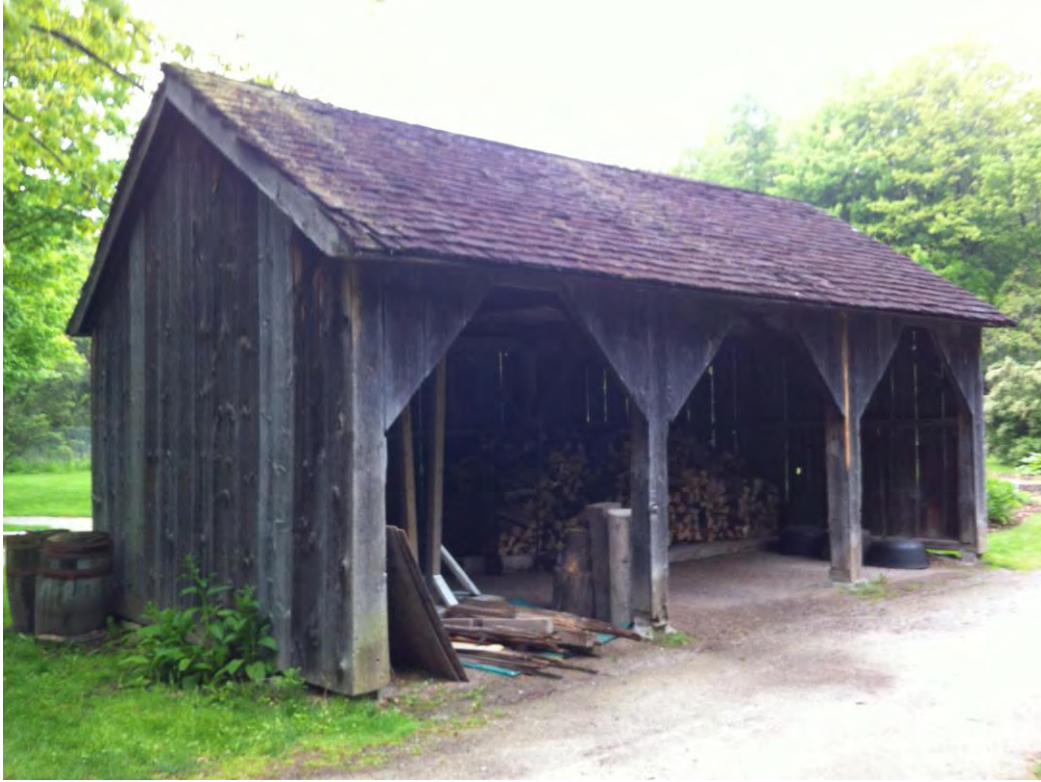
5.2.5. Shed – Elevation showing weathering of boards and on walls and columns and uneven discolouration.

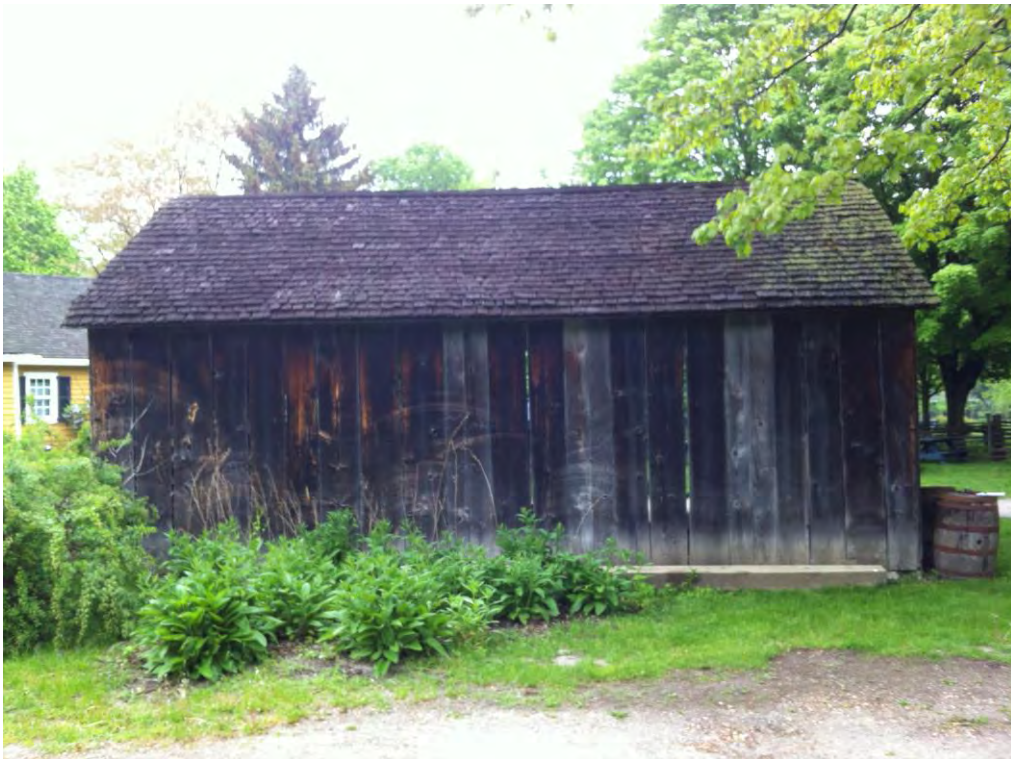
5.2.6. Shed – Elevation indicating uneven discolouration and separation of boards.

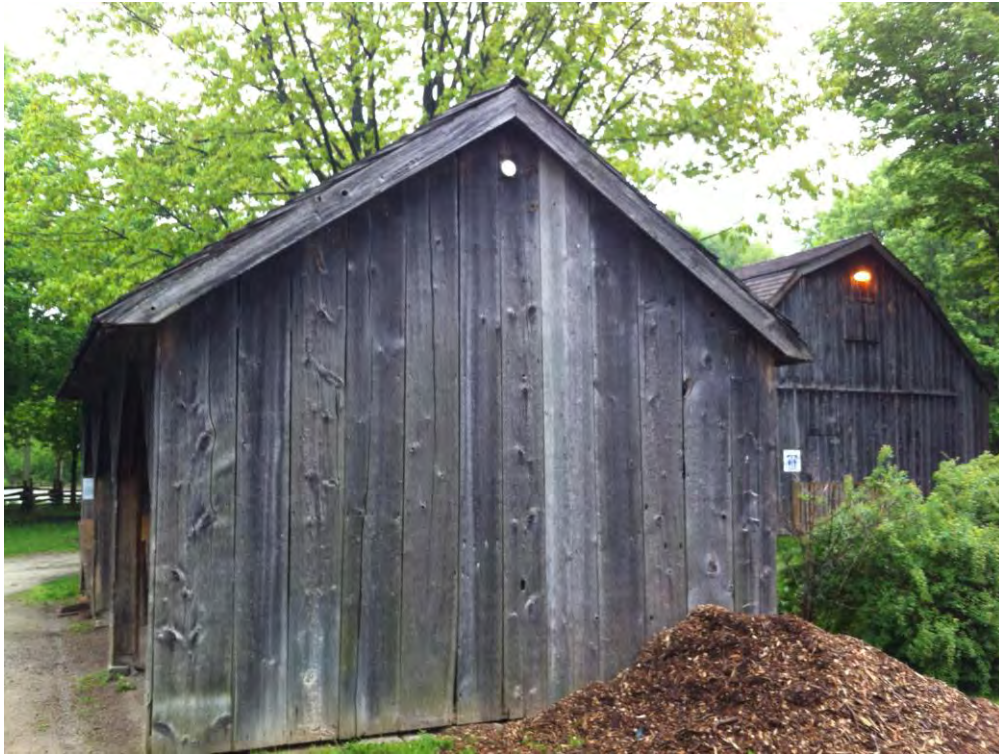
5.2.7. Shed – Elevation showing separation of boards and wear.

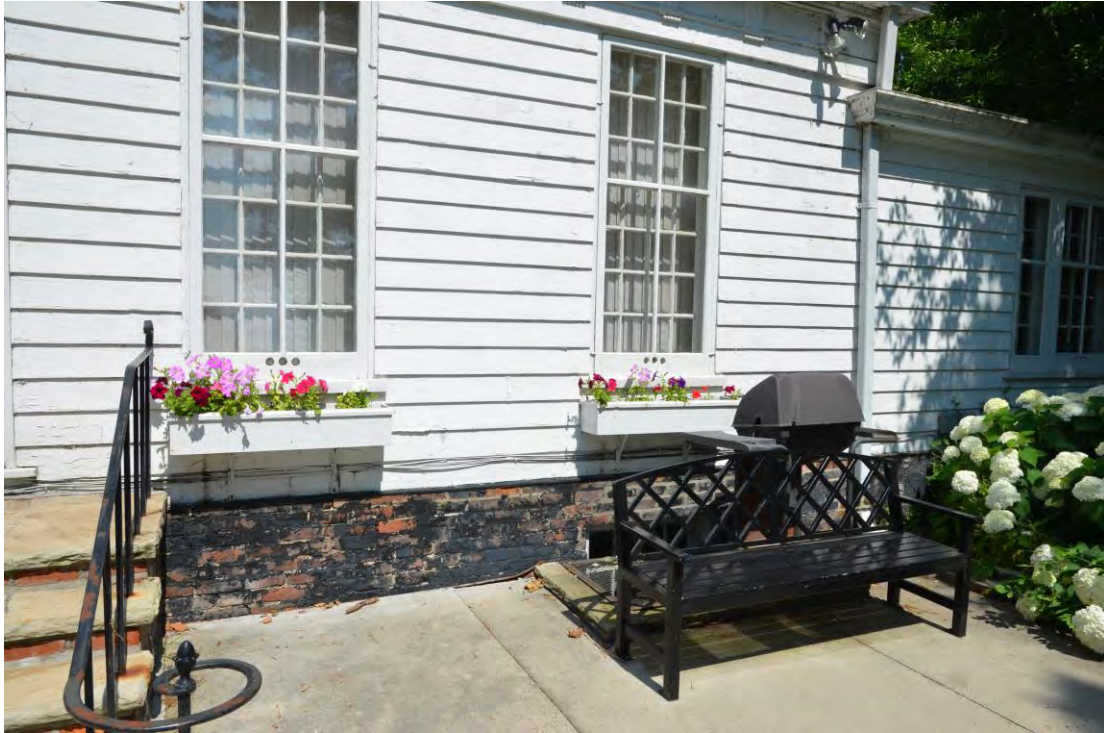
5.2.1. North Building Elevation – Sample of existing window well condition, foundation wall, and existing stair.

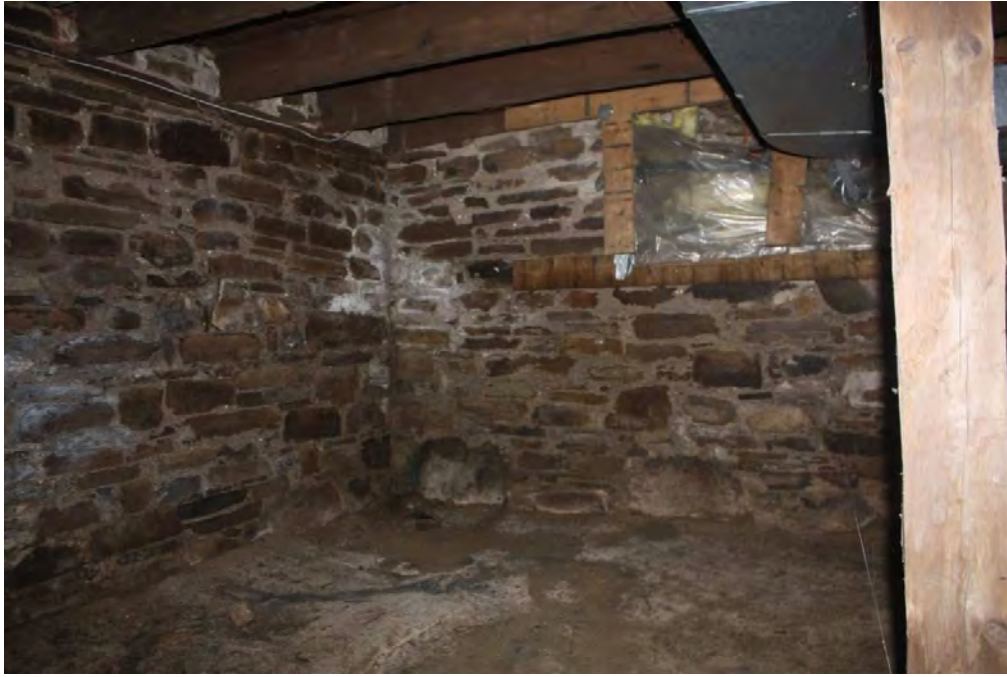
Figure 48 The basement of the original farmhouse, 2013 (Photo by author.)

Significant flooding occurred in the basement in 2010 and timbers have been introduced to stabilize the building.²⁵ There is also an interior brick wall in the basement of the original farmhouse, part of which has collapsed or been removed. The structural integrity of the

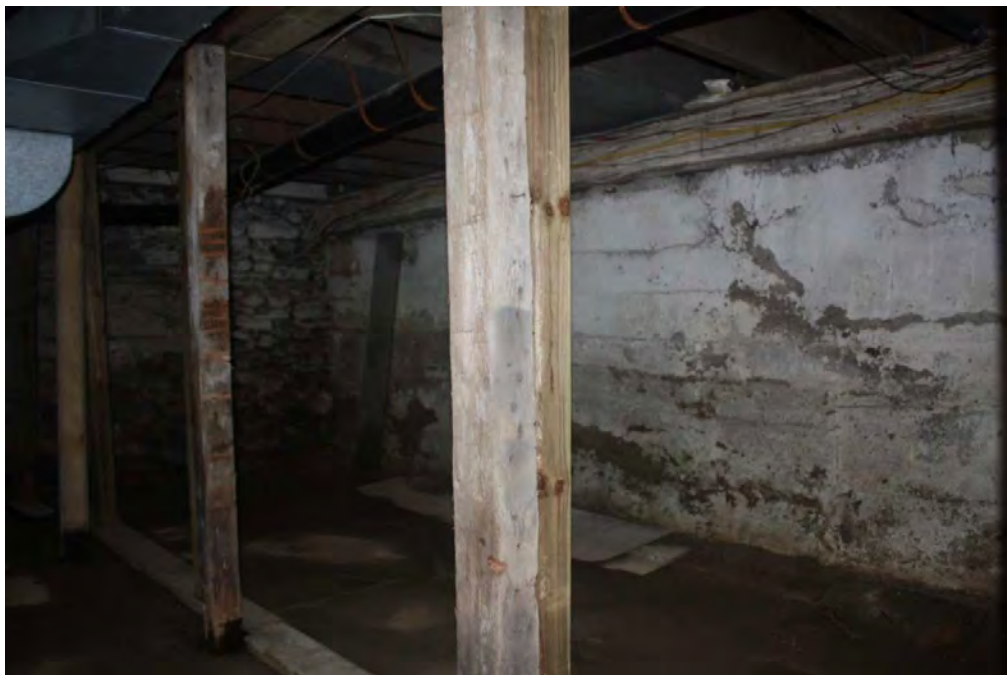
Figure 49 The basement of the addition, 2013. Timber had been inserted to support the structure (Photo by author.)

farmhouse and its addition may have been compromised by this water damage, but an engineering study would be required to determine this. There is visual evidence, shown above, of recent stabilizing efforts .
